Proposal:

8 Historic England Listing details.

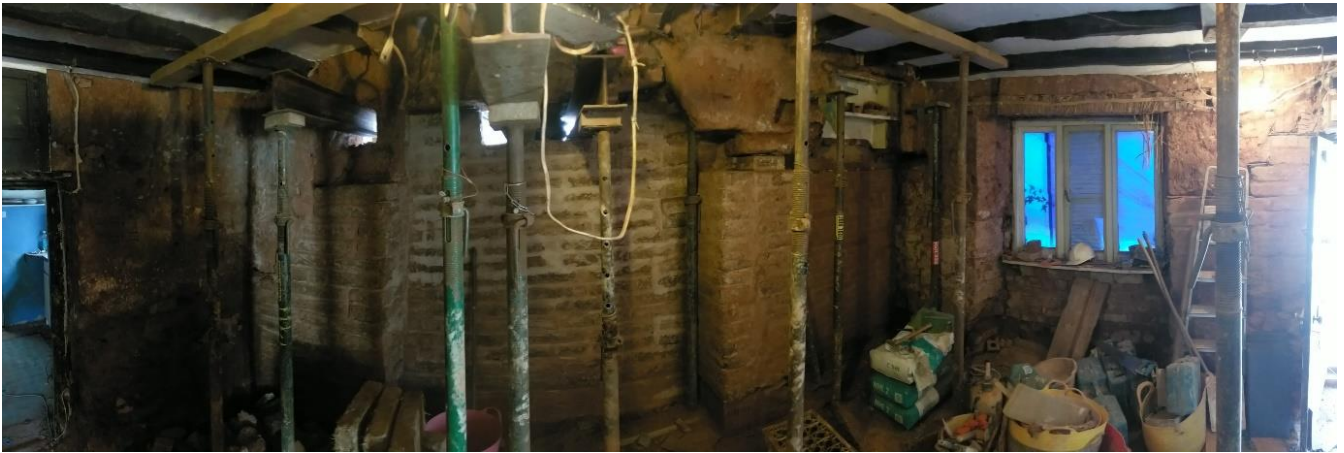
- 1.2 Essential stabilisation work was completed as detailed below and the external render was replaced as permitted.
- 1.2.1 The base of the walls, outlined in drawing 1A (2 Bridge Cottages existing), required immediate underpinning using cob blocks and lime mortar to replace well degraded cob. Photo of this work attached below.

- 2.12 There is now a new lime putty render on the whole original terrace replacing the old failing and incorrectly over painted render.
- 2.13 The walls were underpinned with new cob to replace the soft and rotten cob and much of the inside faces of the cob walls have had a backing coat of lime putty plaster.

9.1 1.2.1 Replacement of rotten cob using cob blocks and lime mortar.

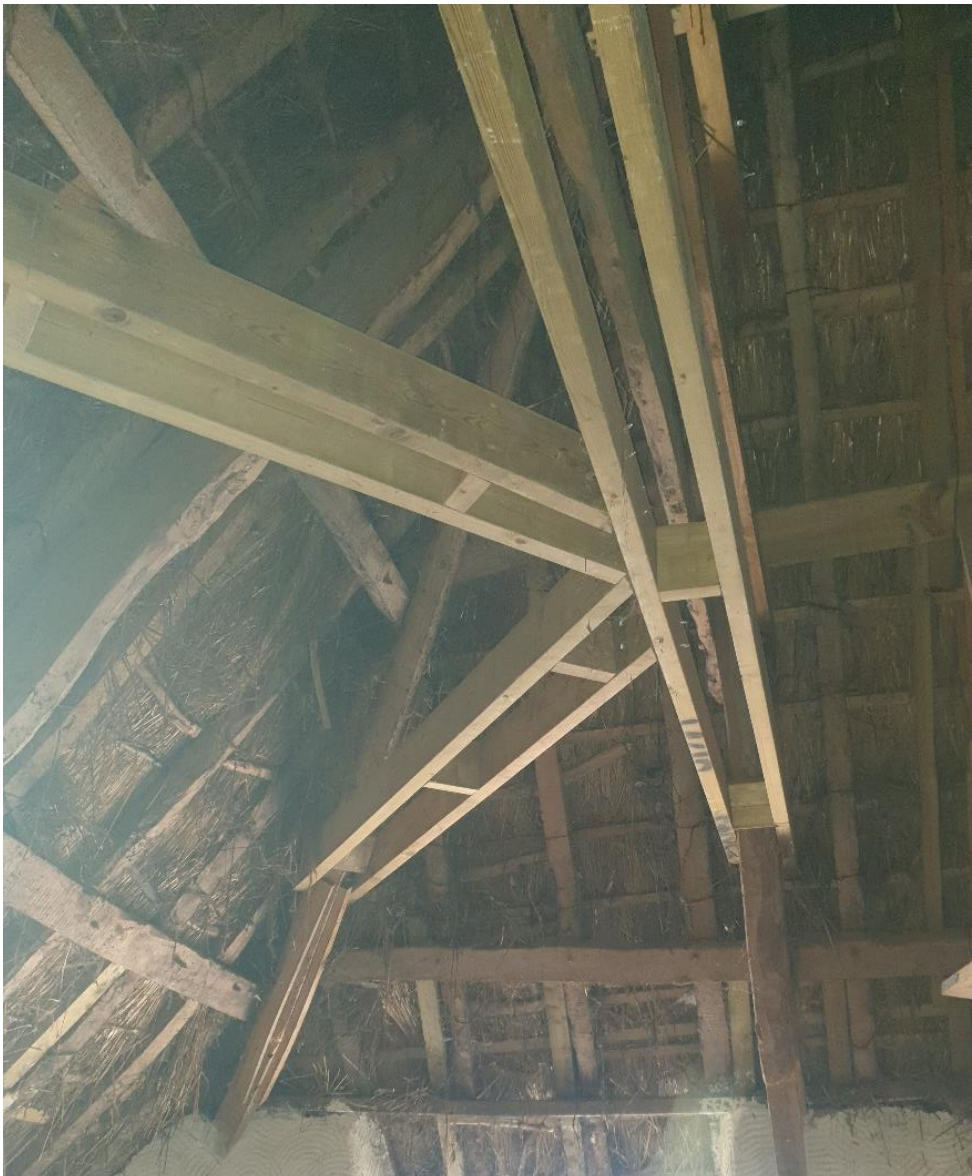
- 1.2.2 Under condition 2 of the consent for Number 3 (16/1373/LBC) investigations into cracking were carried out. The roof was deemed to be unstable along the whole terrace (Engineers report attached) and thus work was carried out as per the report and specification. Photo attached.

- 2.20 The 1st floor ceiling was sagging lath and plaster but was removed to allow for essential structural roof ties.
- 2.21 On the front of the house there are 2 windows and one front door.

9.2 1.2.2 Roof strengthening work plus lack of ceiling

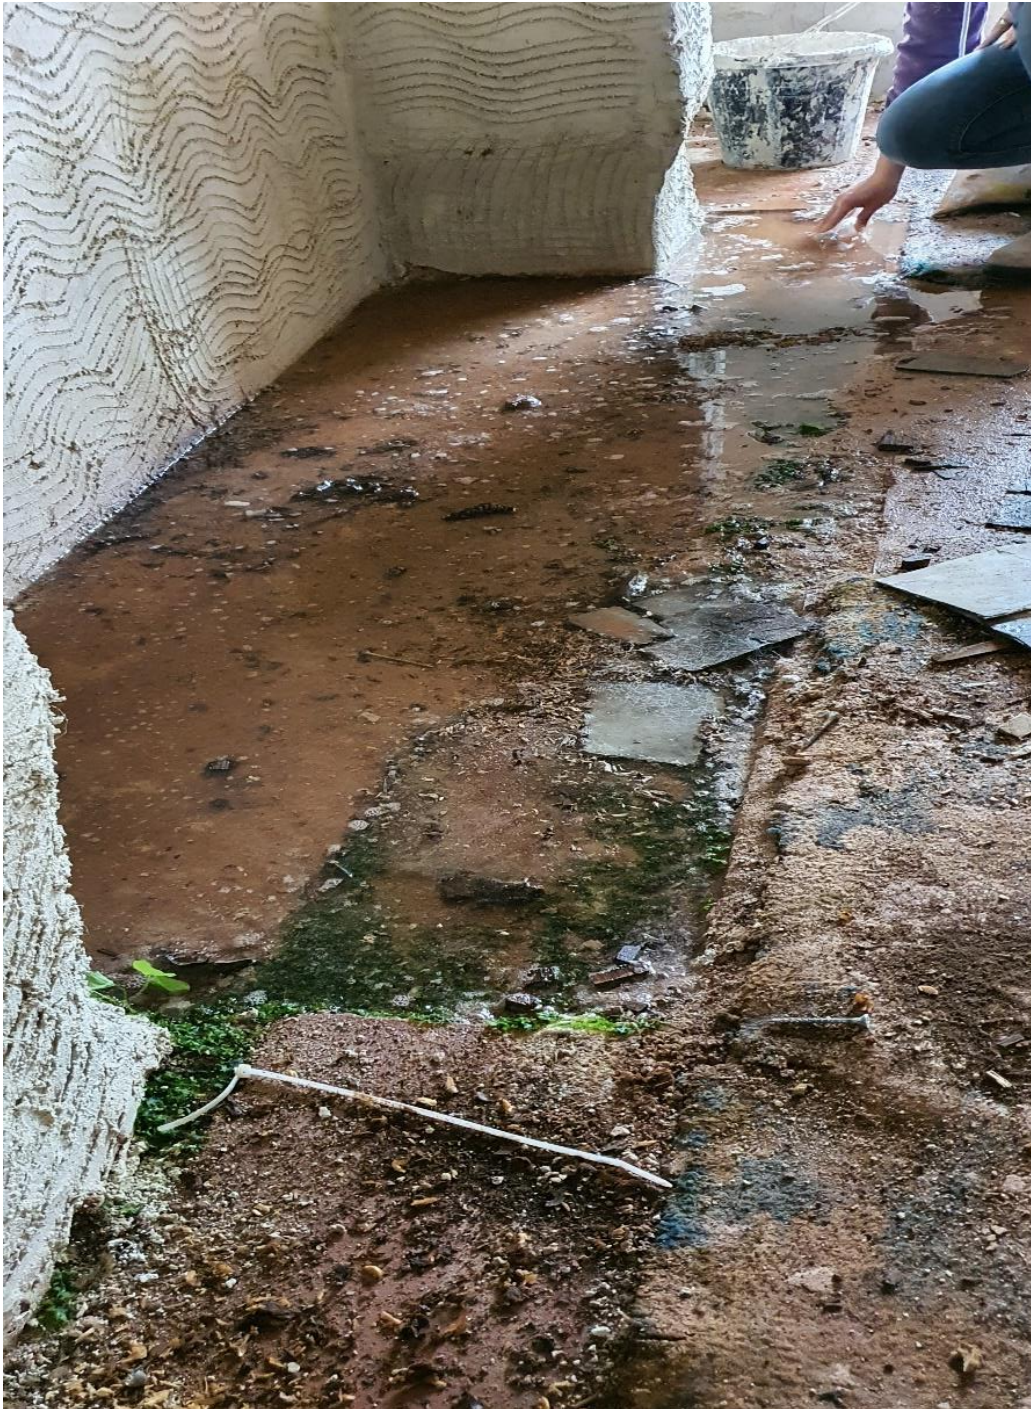
- 2.14 The ground floor of the main cob part of the building is a basic concrete slab assumed to have no damp proofing or insulation.
- 2.15 The enclosed staircase is very unstable through a combination of wet rot and wood eating insects.

9.3 Existing floor condition.

- 1.6 Update all kitchen and bathroom fixtures and fittings.
- 1.7 Update all wall, floor and ceiling finishes. Material specification included.
- 1.8 Replace very wet, un-insulated concrete floor slab in main part of the building with an insulated limecrete equivalent. Specification included.

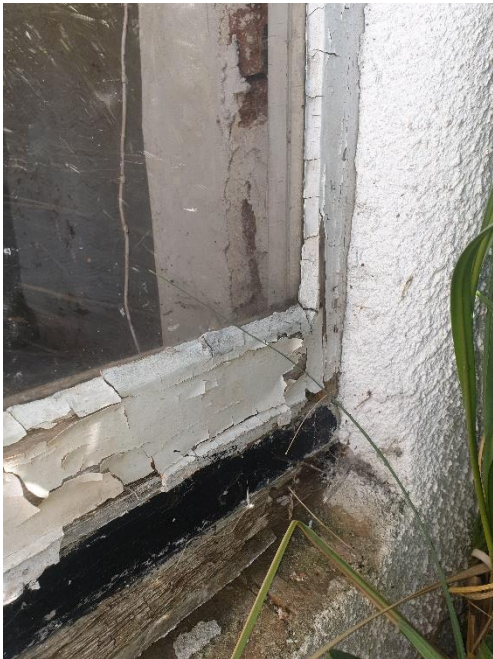
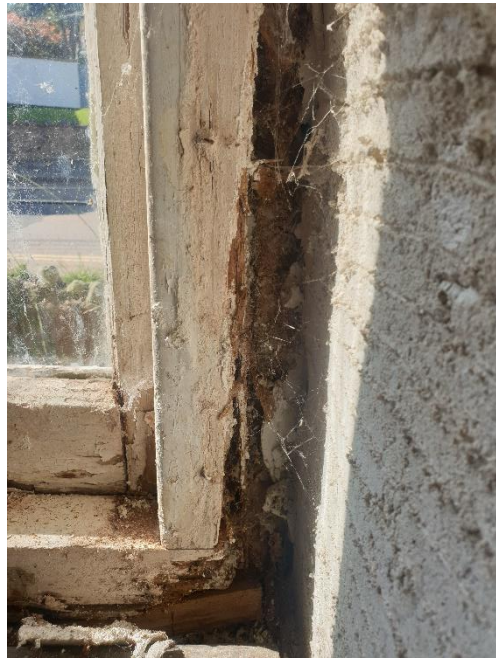
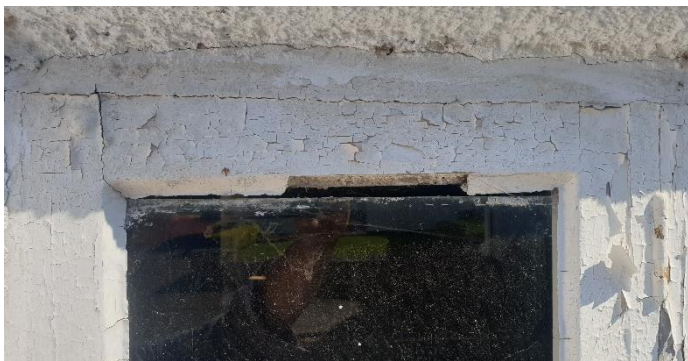
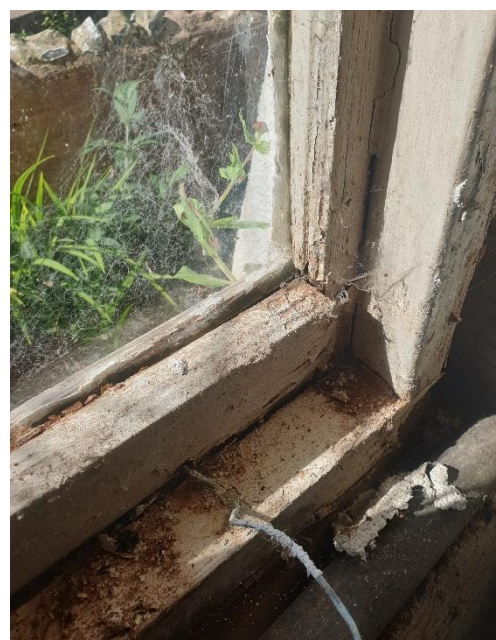
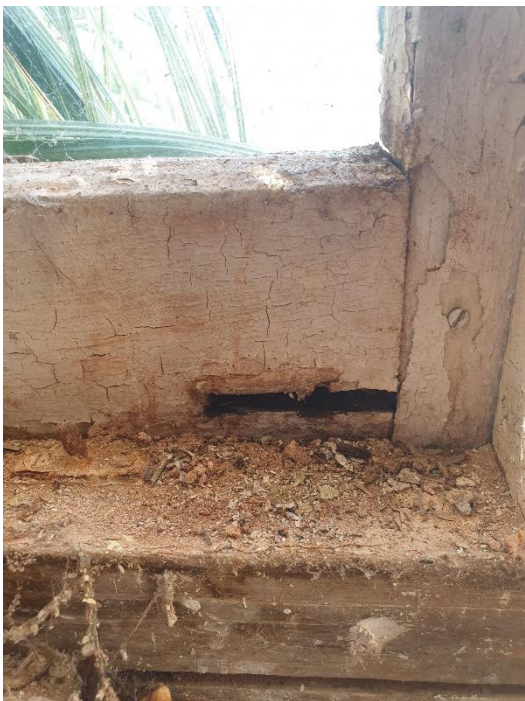
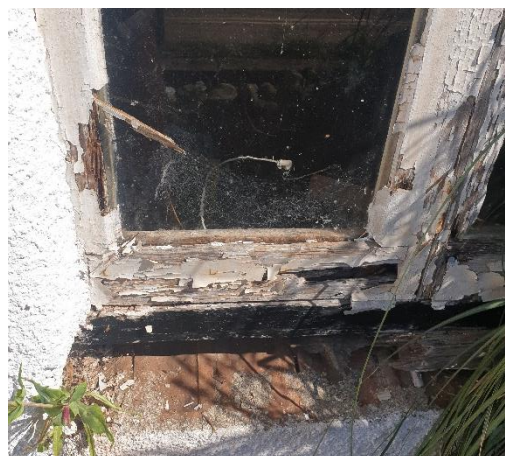
- 2.24 The one window on the ground floor is of the same 3 casement design without any bars and is likely to be the original frame with new or adapted casements accommodate larger panes of glass with no bars.

- 2.25 Heavy rot to the structural frame of this window renders it in need of replacement as repair would be unreasonably extensive.

- 7.5 Window W1, is neither air, nor watertight and its location on the ground floor level and heavy structural deterioration represents a significant security risk for the building.

9.4 Window condition.

- 1.15 Convert ground floor shower to a utility room for laundry facilities etc.
- 1.16 Repair or replace heavily decayed and unstable staircase.
- 1.17 Replace or repair 1no timber casement window in front of property as like for like. Plan attached.

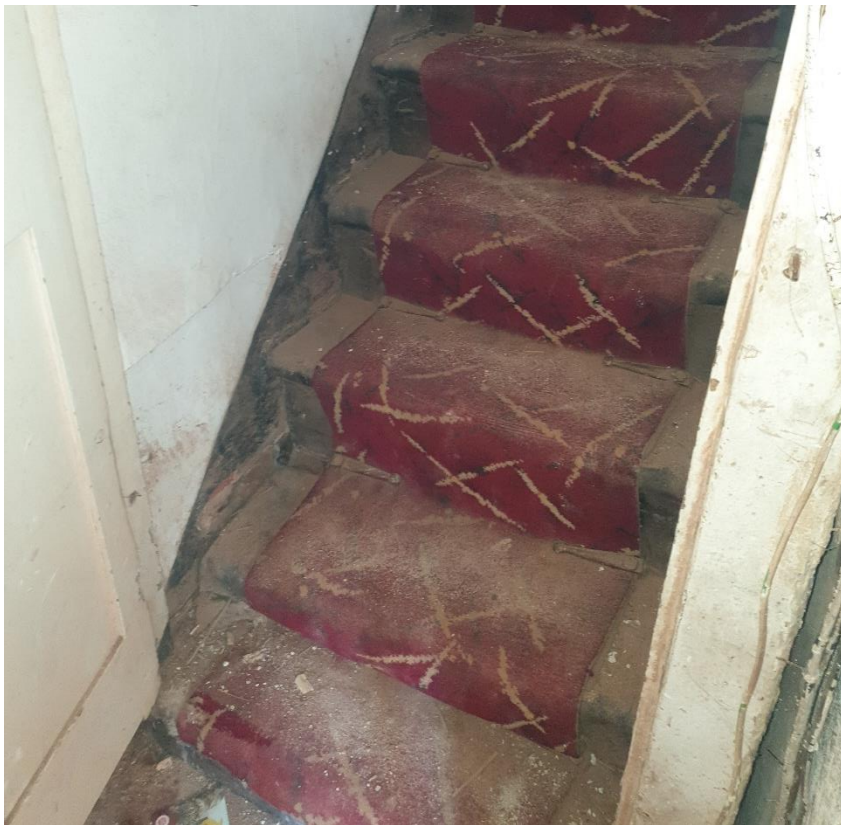
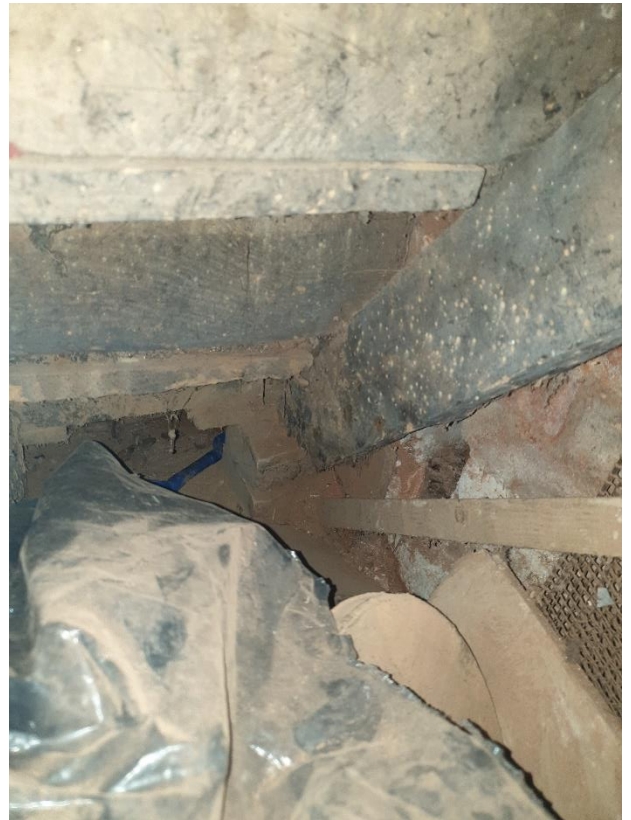
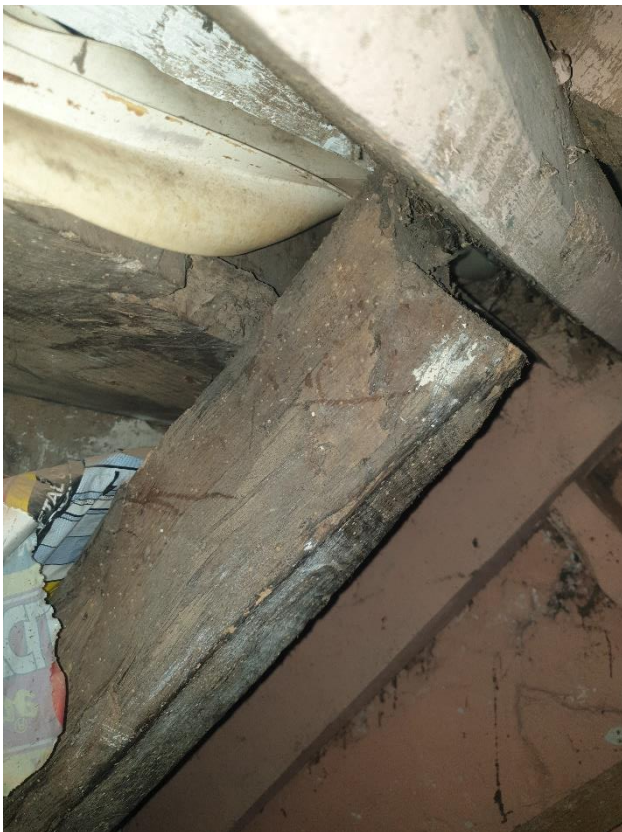
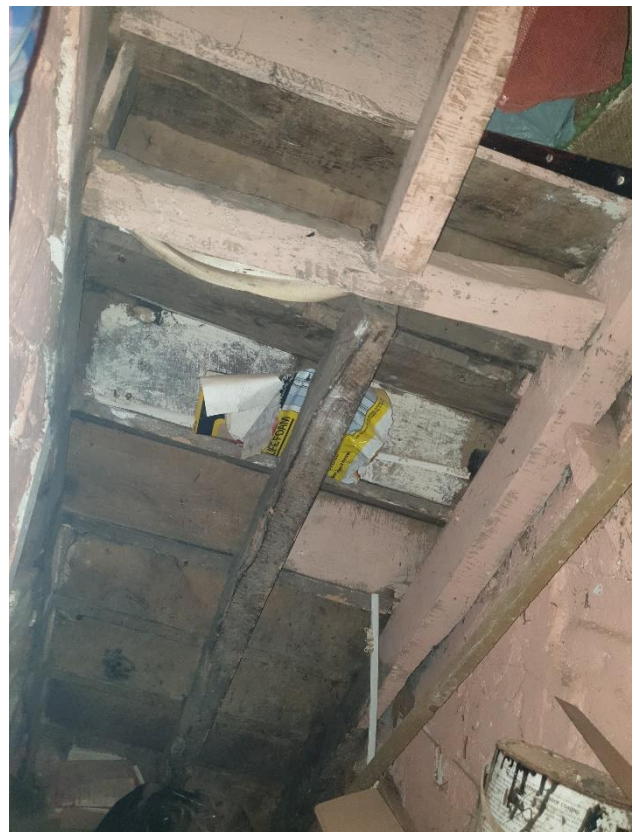
19.5 Stairs condition: Drop at lower end, decay from worm and damp in structure.
