6 Bull's Head Cottages
BH-01 Updated Floor Plan – since rebuilding making the house safe, dry and habitable 2018-2020

Original application surveyors 2013-2014:

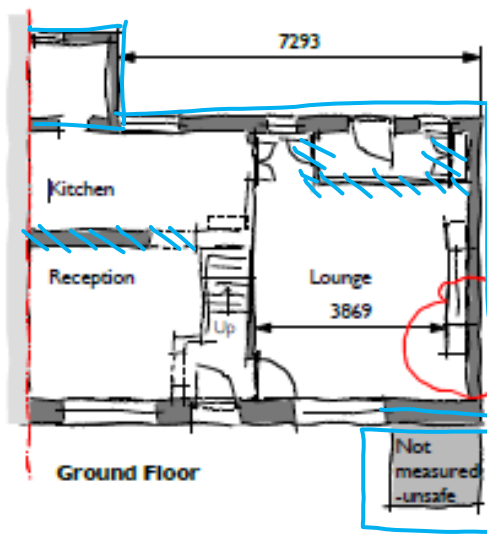
Rear outrigger utility has been totally rebuilt in breeze block, insulated, with a new floor and reclaimed Welsh slate roof. Kitchen and reception dining room inner wall removed to make up one larger room. Oak joists and beams (with pad stone) have been reinstated. Full first floor flooring replaced to sit on existing oak and new oak beams and joists. Rear wall and front section of wall have been rebuilt in breeze block and insulated. Gable end has been rebuilt in single skin block work as this becomes the internal wall. Lintels have been added to the gable ready for the extension to be knocked through to.

Rear door has been removed and made into a window. Rear vestibule area has been removed. The chimney has been rebuilt.

Front outrigger has been demolished.

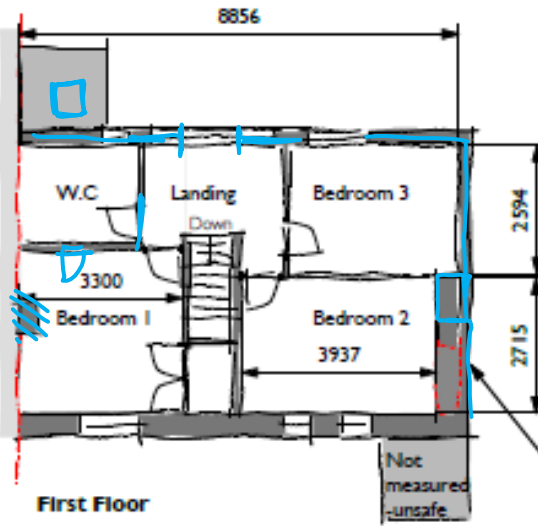
The pattern (rhythm) of the windows matches the original, approved planning permission from 2014. Velux window added to the utility outrigger and WC. Entry to the WC is through the bedroom 1. First floor chimney breast has been removed. A gallow bracket is within the loft area. The chimney in bedroom 2 has been reduced in size at first floor level.

The front elevation remains untouched apart from the rebuilding near to the gable end and the demolished outrigger. Plumbing and electrical services have all been renewed throughout the property. United Utilities will replace lead pipework to the property when the extension is built.

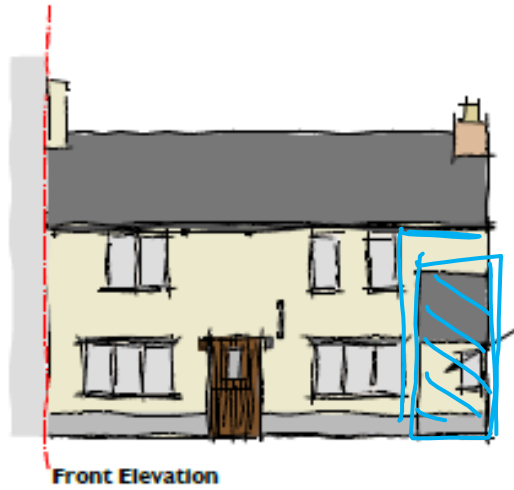
Store not measured - unsafe

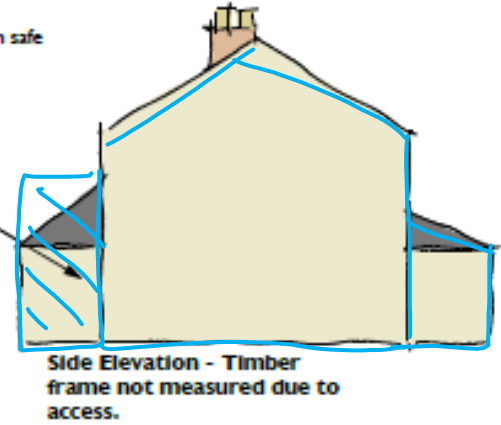
Side Elevation - Timber frame not measured due to access.

Rear windows are set in the pattern of the planning permission from 2014. Velux windows in roof of utility and main roof WC.
