BS5837:2012 Tree Survey
 Land off Vasey Close
 Bassingham
 Lincolnshire
 NGR SK91346 59663

Report prepared by: C Barker	Date Issued: 10 September 2021 Report Version: V1
	Reviewed by: KLB	C B E Consulting Highbank, 5 Grantham Road, Navenby Lincoln. LN5 0JJ. Telephone (01522) 810086. www.cbeconsulting.co.uk
	Report ref: P2346/0921 /02

BS5837 Tree Survey, Land off Vasey Close, Bassingham

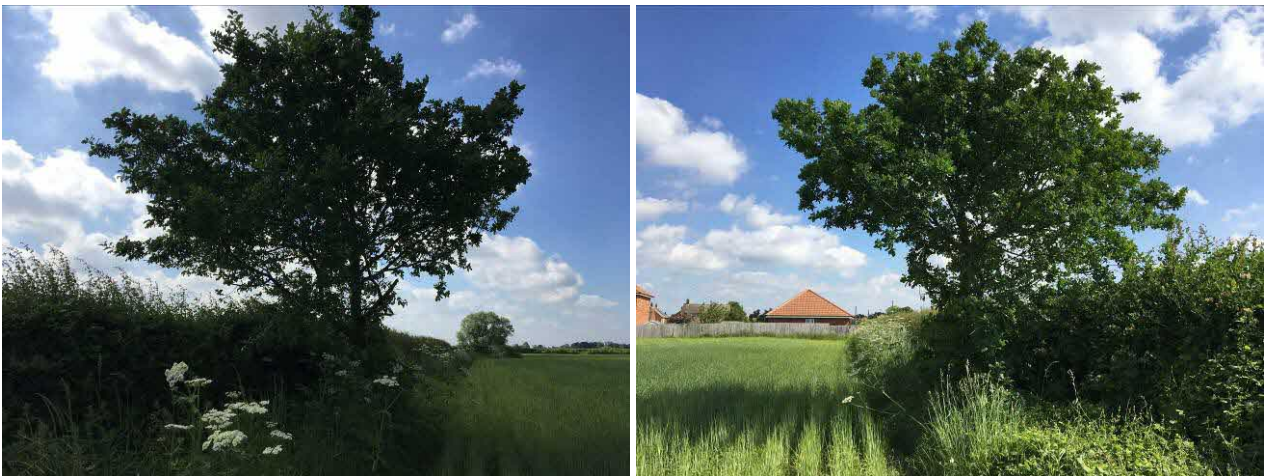
Oak T1 and Hedgerow H2 are situated along the eastern boundary of the survey area. The Oak is a young specimen situated just inside the boundary hedgerow along the field margin. This has a small round canopy of good shape and currently has sufficient space to continue to develop although it is noted that the edge of the cultivation line is very close to the root bole of this tree. It has been placed into Category B2.

Hedgerow H2 is a box trimmed hedgerow that appears relatively young. The northern half is almost purely Hawthorn and there is a 1.6m gap from the edge of the cultivation line to the base of the hedge. The southern part of the hedge (south of T1) is still dominated by trimmed Hawthorn but there is occasional Field Rose also present. This hedgerow is placed into Category C2.

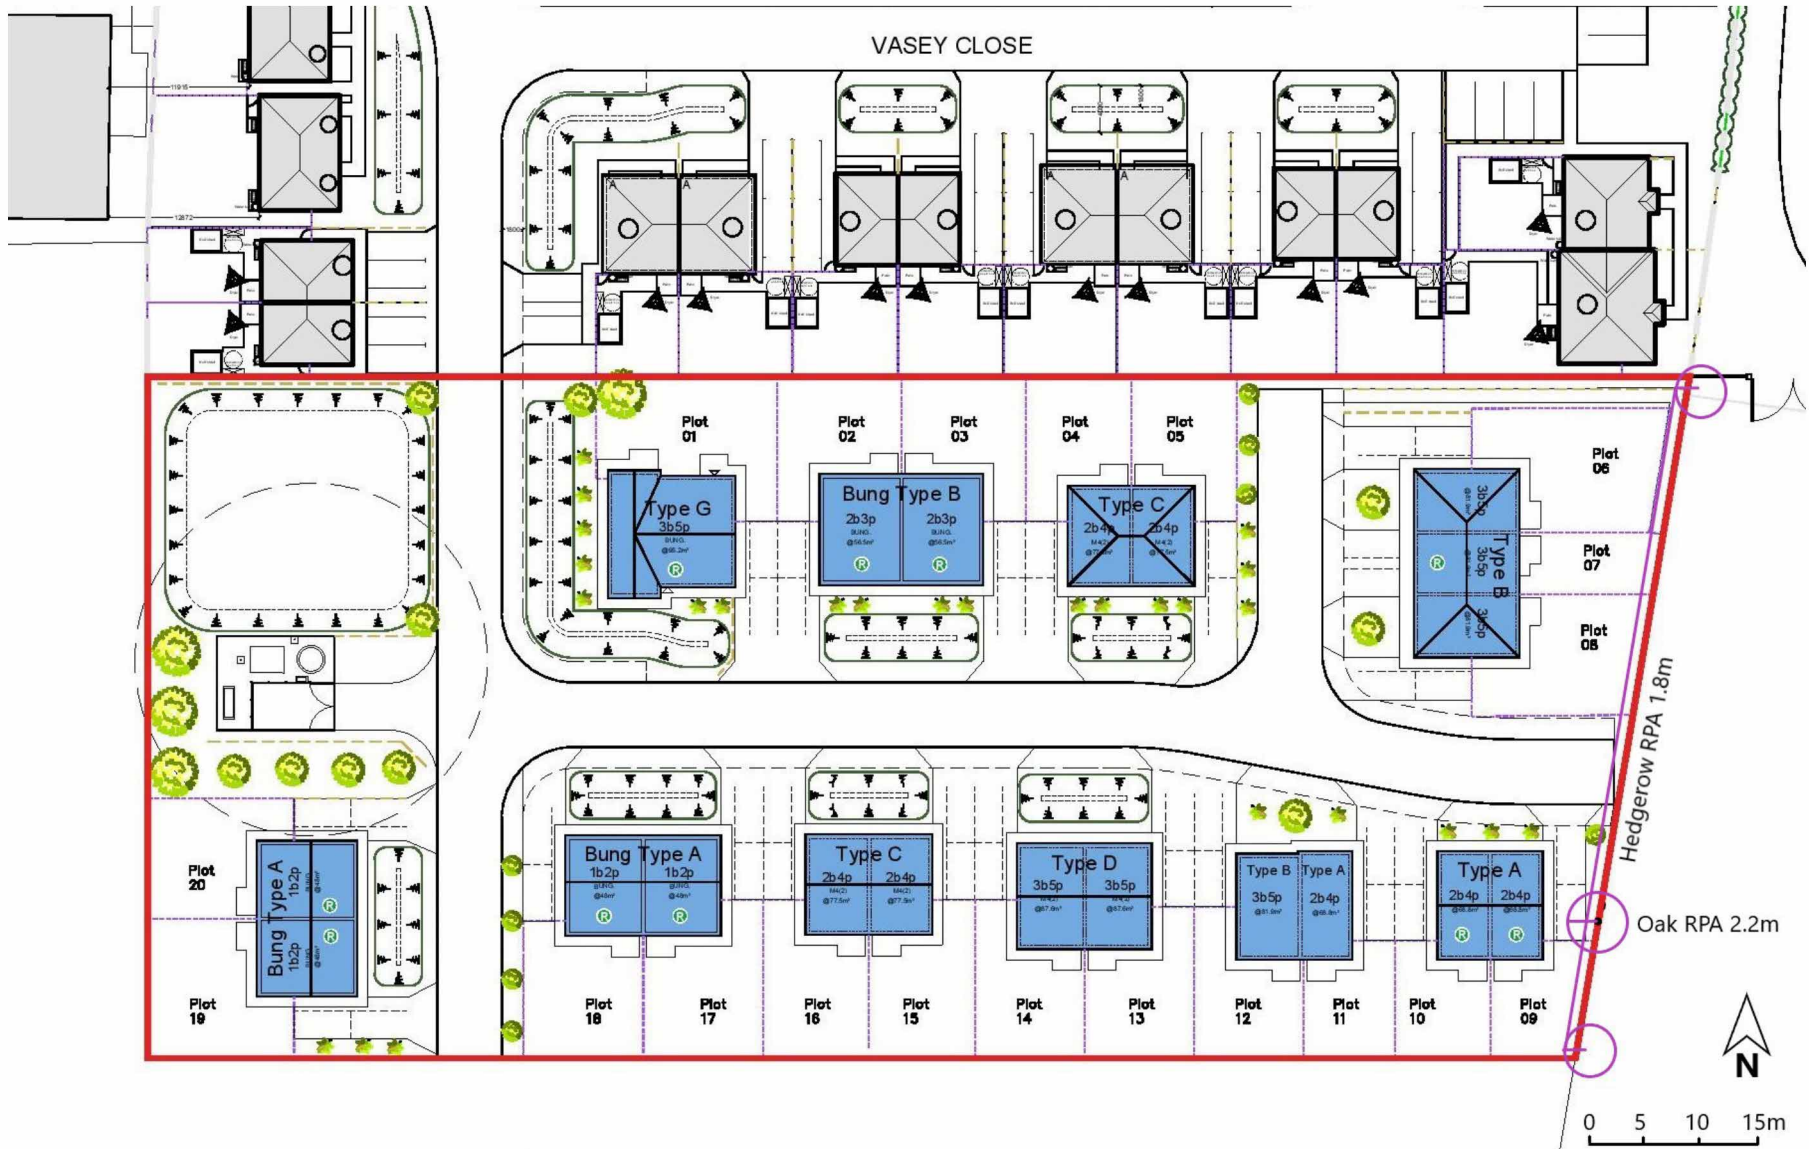
In the context of this site the proposed development will comprise 20 new semi-detached or terrace houses as shown within Figure 4 above with an entrance to the north off Vasey Close. The table below summarises the potential impact of the proposed development on the tree and hedgerow present within the area surveyed.

The position of the Oak so close to Plot 9 is unfortunate. In the short term this tree could easily be retained and with some minor crown trimming / lifting would not present any immediate cause for concern or nuisance to the property. Being a young tree the impact of the construction of the parking bay on this should be minimal, particularly considering the parking bay is positioned within the existing cultivation zone where there should be few, if any, shallow roots to be impacted.

In the longer term this tree may begin to cause a nuisance so close to the house and extending over the parking bay. The edge of the house will be 7m from the base of the tree and the edge of the parking bay only 2m from the base of the tree. It would be prudent to consider planting replacement trees within the hedgerow in locations where these will not cause a problem in the future and they have space to mature.

The hedgerow, and potentially Oak T1 along the eastern boundary of the site area will need to be adequately protected during any approved development works. As a general rule at this site, measures to protect trees should follow the best practice principles set out in BS5837: Trees in Relation to Design, Development and Construction (2012). Prior to any construction or development work proceeding, the RPAs of individual trees to be retained should be marked out using the distances provided in the table within Appendix 1.
