### 1335 Swindon NEV

Technical Note No.38 Rv3: Condition 40 Flood Mitigation Strategy 3rd March 2022

Technical Note 40: Site Visit; Flood Risk Assessment 10<sup>th</sup> January 2022

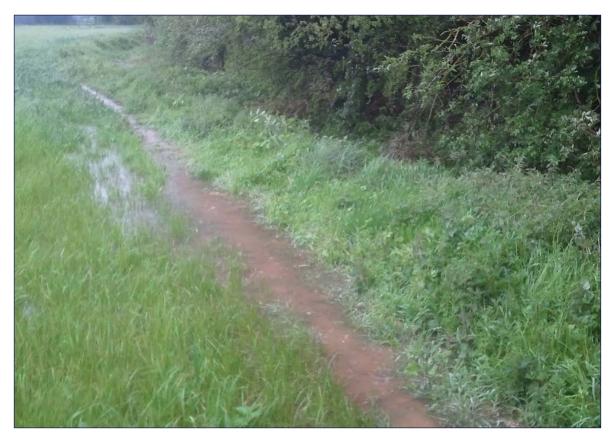
Figure 2.4 Parish Council Photo - Manor Park Ditch Outfall

**2.10** The Parish Council have identified an issue of poor connectivity to the south of Manor Park. There is an existing ditchcourse which runs to the east of the site. It appears that this ditch is blocked and overgrown resulting in flooding in the adjacent field.

- Dredge ditch and trim vegetation
- Ensure ditch connections are provided.
- Connect to site wide exceedance flow network to allow surface water to flow away
- Measures to be to be implemented as part of the delivery of the Phase 1 Open Space.
- The detailed drainage works provided as part of the this first phase of open space.
   The drainage strategy illustrates how this mitigation will incorporated into the wider SW flow network.

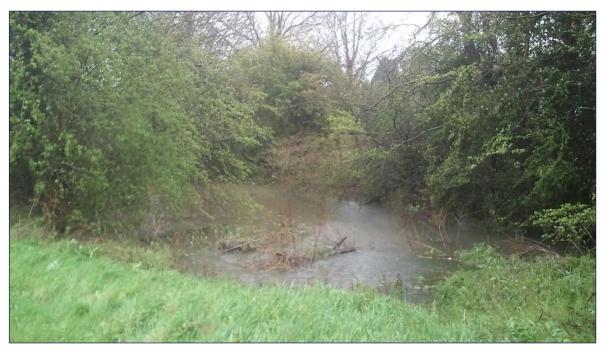
Figure 2.5 Parish Council Photo Manor Park Pond

**2.12** The Parish Council have identified a missing outfall at the existing pond referenced as Manor Park Pond. This outfall should be installed to direct surface water efficiently to the watercourse.

- Establish existing connection and outfall by survey.
- Construct headwall to formalise outfall.
- Measures to be implemented as art of the delivery of the Phase 1 Open Space. The
  detailed drainage works provided as part of the reserved matters for the open space
  will demonstrate how this mitigation will incorporated into the wider SW flow
  network.

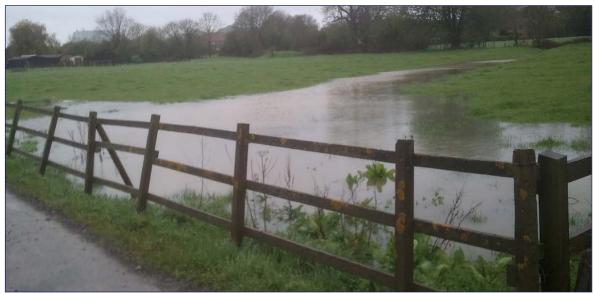
Figure 2.6 Parish Council Photo - Manor Farm

- 2.14 The area to the east of Manor Farm is prone to flooding and it appears there are issues the existing drainage route crossing the existing road. It should be noted that the development does not have rights over this road (bridleway 4) and therefore mitigation works will need to have permission from the owner. The S106 has secured a mechanism between the developer and LPA for land transfer and subsequent delivery of a road connection, which may be delivered directly by the developer, or in the alternative, the Council.
- **2.15** The site wide strategy will provide a betterment to the existing situation as the flow routes are connected and will allow surface water run off to drain away.

- Clear and widen existing 'v' channel within field to ensure connectivity to the proposed Surface Water network.
- Clear pipe crossing under road.
- Potential to replace pipe under road if agreed with owners
- Subject to s106 provisions, if the crossing is to be delivered by developers, the works will take place in parallel with the delivery of phase 1.

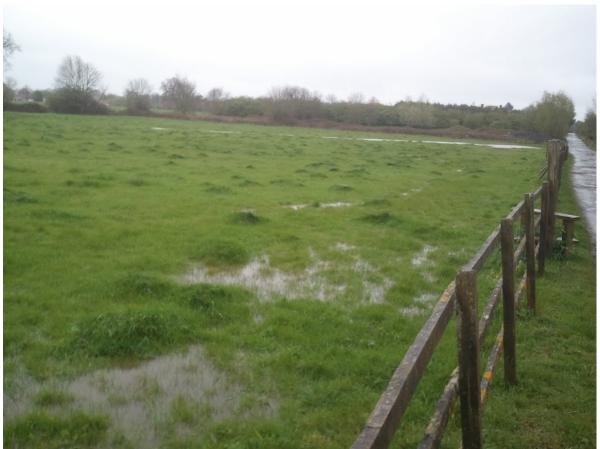
Figure 2.7 Parish Council Photo West of Mercure Site

- **2.17** The Parish Council have raised a potential issue due to the localised low spot at the Former Mercure Hotel site, which is now under construction as a residential development known as Vicarage Gardens.
- 2.18 The recent site visit established that the residential development is underway at this site and that attenuation basins and outfall to existing ditches have been installed. The provision of this development drainage will ensure flows from this are site are managed to ensure no flood risk downstream of the site.
- 2.19 The land to west of the site has a natural low point that appears to pond as per the photo below. The works to the new site will improve the situation, however a route should be provided to allow water to drain away from the low point to the site wide network.

- Ensure connection of low point to the exceedance route network to allow surface water to drain away.
- Measures to be implemented as part of the delivery of Phase 1 open space. The
  detailed drainage works provided as part of the reserved matters for the open space
  will demonstrate how this mitigation will incorporated into the wider SW flow network.

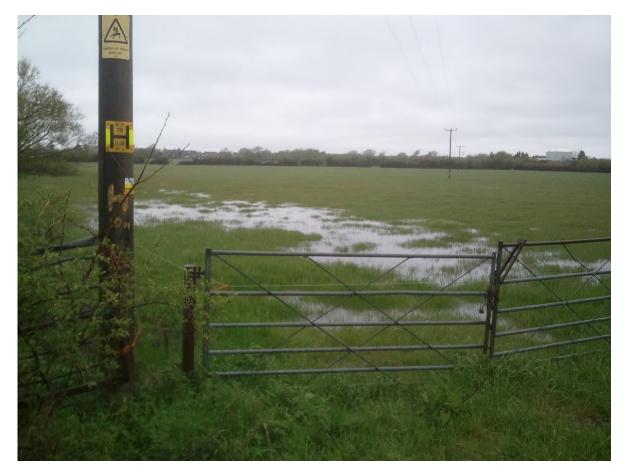
Figure 2.8 Parish Council Photo Old Vicarage Lane

**2.21** The Parish Council have identified flooding issues as a result of a truncated ditch along Old Vicarage Lane. This ditch should be reinstated to provide the connection.

- Restore truncated section of ditch to match existing profile. Where necessary pipe to allow access crossings.
- To be implemented as part of the S278 new access works to create a new junction from Old Vicarage Lane to Phase 1 of the new development.

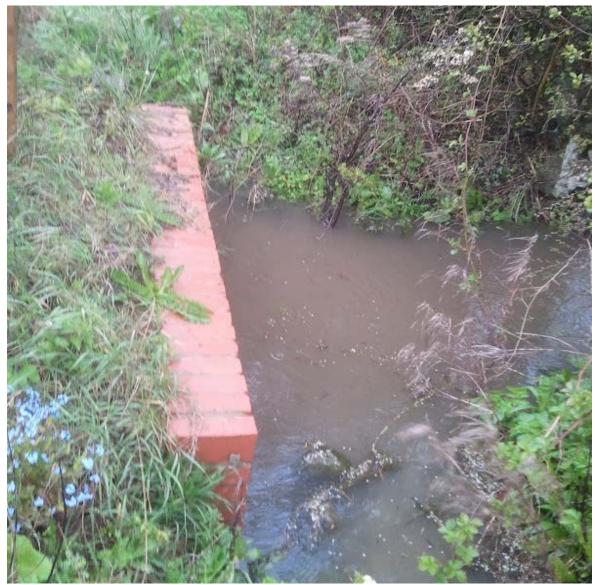
Figure 2.9 Parish Council Photo Carpenters Arms Culvert

- **2.26** The report from 2012 identified issue with a blocked culvert at the Carpenters Arms.
- **2.27** The site visit found that this culvert was still blocked and almost fully submerged.

- Clear existing pipe
- A CCTV survey to be undertaken to assess the condition of the existing culvert and understand if any repairs are required. If repairs are required, the works will need to be agreed with the highway authority.
- Clear and dredge the ditch up and downstream to ensure connectivity.
- Works To be undertaken when first phase works commence on S278 for A420/OVL works

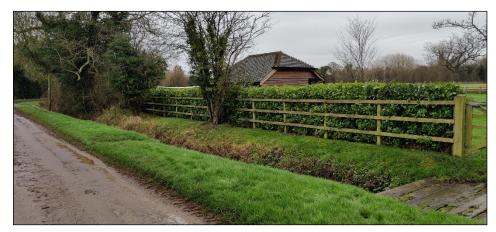
Figure 2 - Rowborough Swale ref. 1

Figure 3 - Rowborough Swale ref. 2

Along Rowborough lane there is a swale roughly 1-1.5 meters wide and deep, along the bend in the road seen in Figure 1 there is a culvert which can be seen in Figures 3 and 4. Both Inlet and Outfall seem to be partially blocked with vegetation, however, culvert seems to have no function and could be removed.

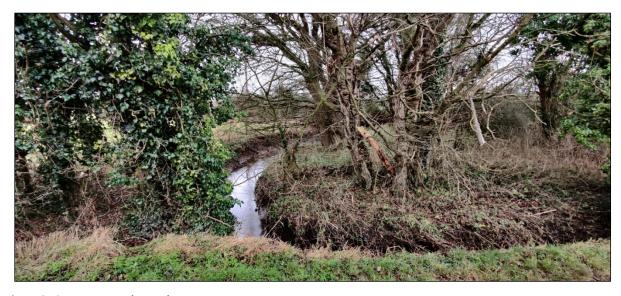
Figure 6 - Stream on Rowborough Lane

The figures below show the stream running along and through Rowborough Lane, even in rainy conditions, the stream showed no signs of overflowing. Approximately 1-1.5 meters wide and deep. Culvert and Headwall in good condition and with no signs of blockage.

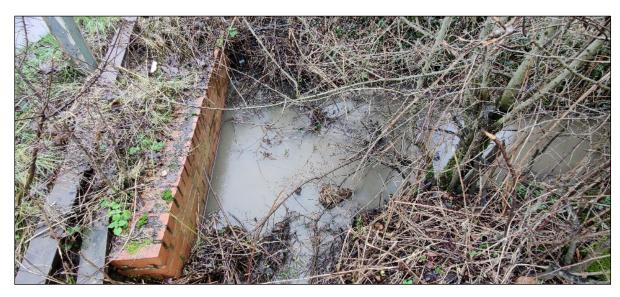
Figure 10 - Blocked Culvert at Vicarage

Figure 10 and 11 shows a culvert located Old Vicarage Lane near the Carpenters Arms which appears to be blocked or at maximum capacity, outfall is also submerged and covered with dense vegetation.

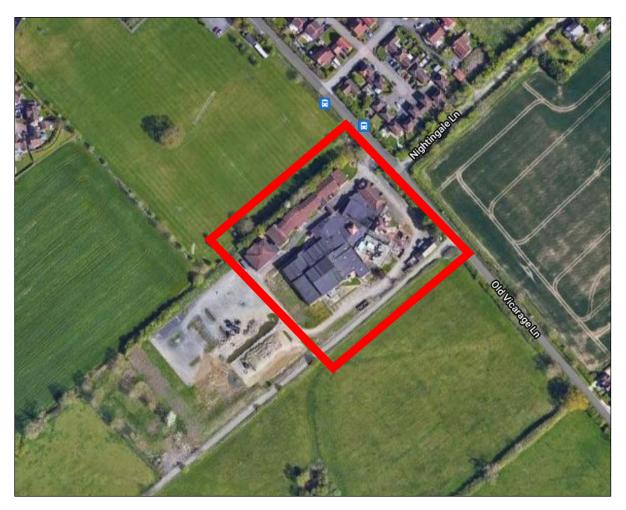
Figure 12 - New Development

Mercure Hotel is now a development under Bellway Homes. It is unsure if Bellway has changed the drainage layout within their site, but it is to be noted that one of the headwalls had been redone and that the development now contains an attenuation pond.
