**HERITAGE STATEMENT**  
**IN SUPPORT OF**  
**PROPOSED WORKS**  
**AT**  
**NUTTERCOTE COTTAGE THORNTON-IN-CRAVEN, NORTH**  
**YORKSHIRE BD23 3TT**

**Date:** 29 March 2022

**Our Ref:** 211436

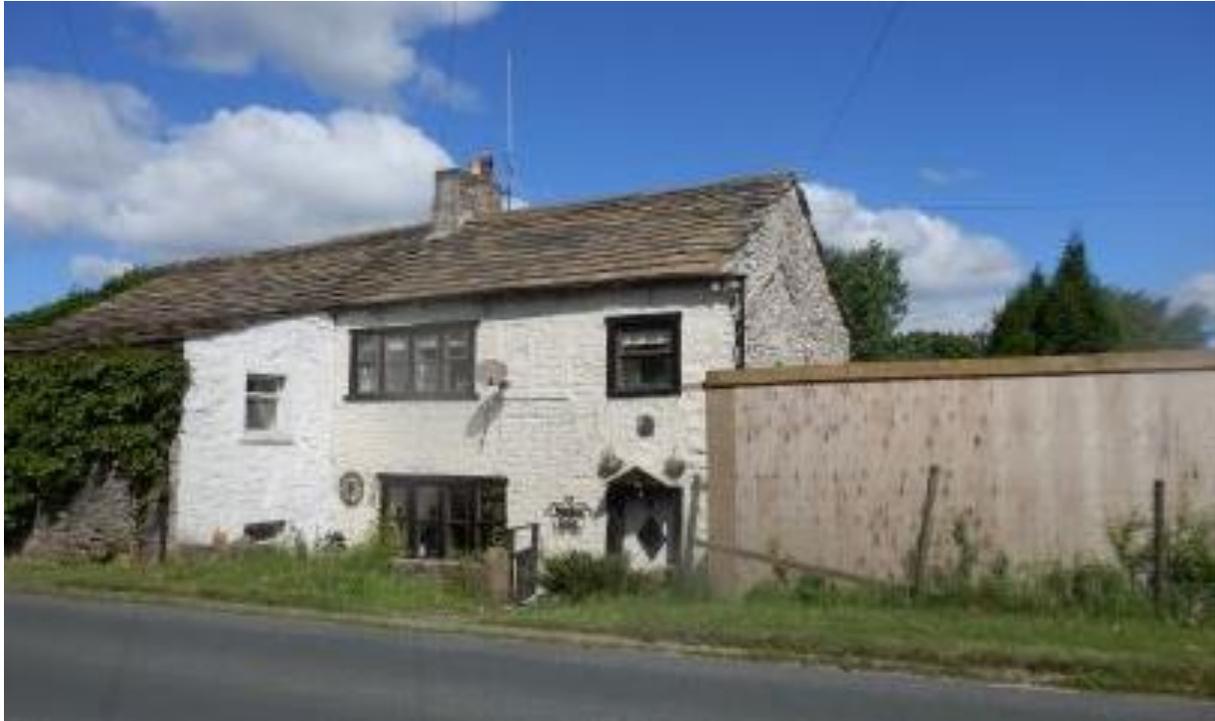
*Image 1 Nuttercote Cottage as at June 2018. Nuttercote Farm was to the right of the property before its demolition.*

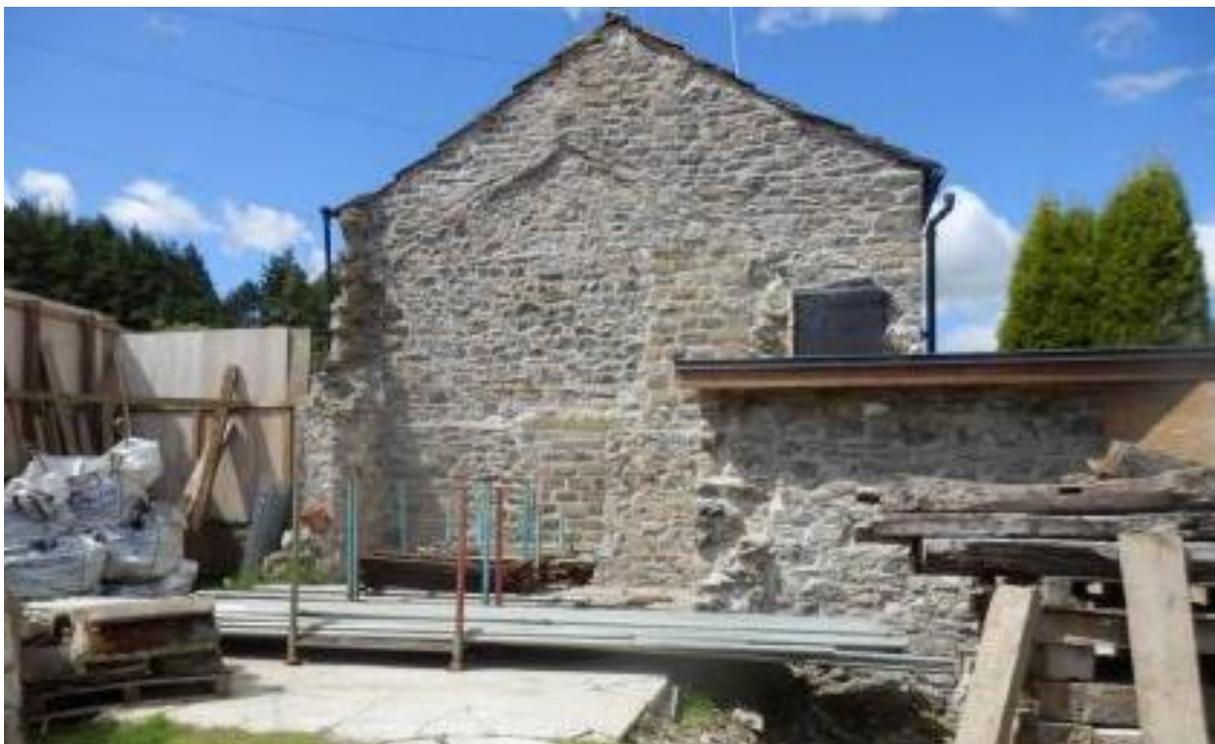
*Image 2 Exposed party wall as at 21 June 2018. Dining Room to the property is in the single storey addition to the right of this photograph.*

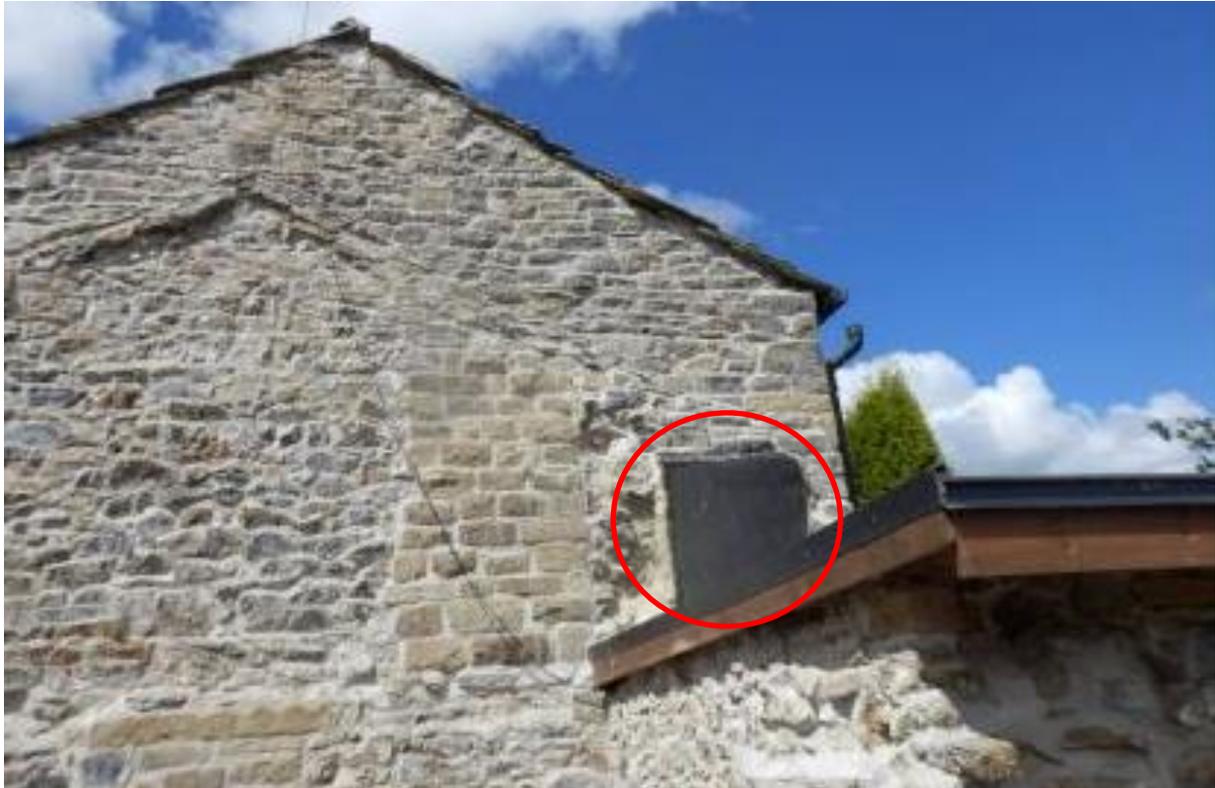
*Image 3 View of infilled hole in the party wall when exposed following demolition of Nuttercote Farm.*

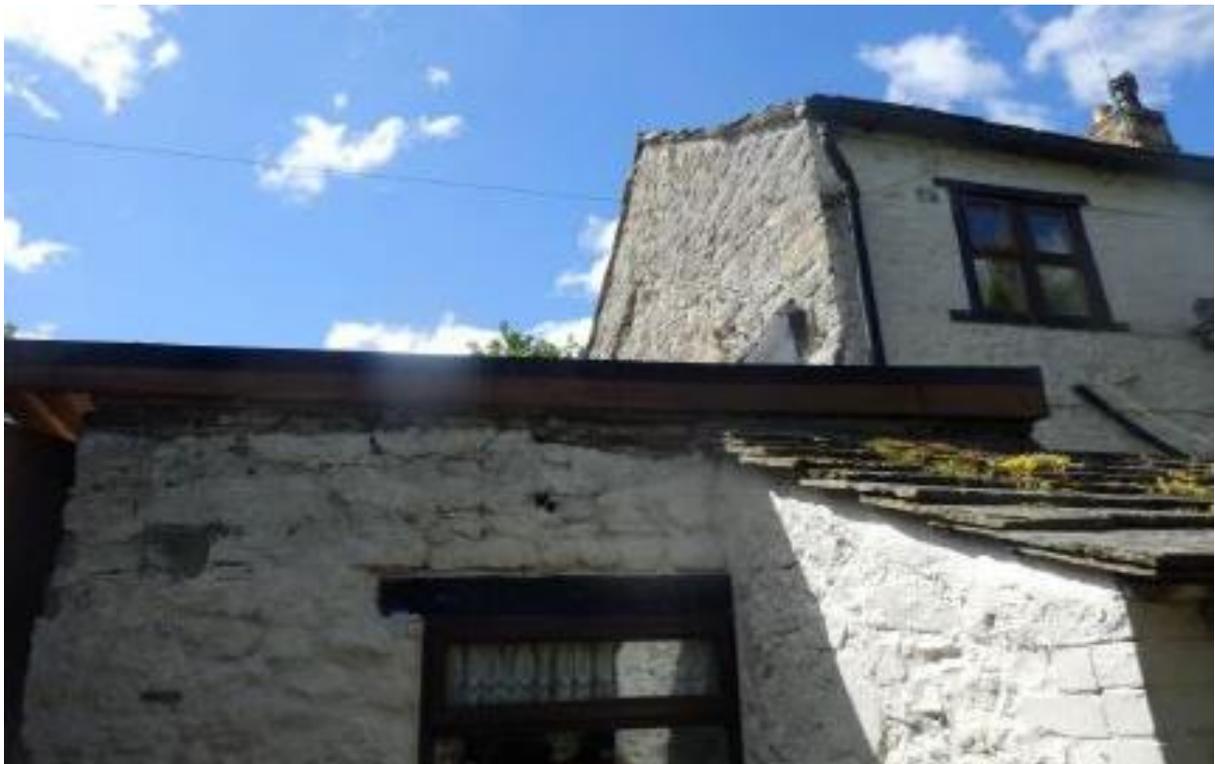
*Image 4 Lean to and rear of the Dining Room with temporary roof over above.*
