23 Patch Lane,
Bramhall

Bat Scoping Survey Report

16th May 2022

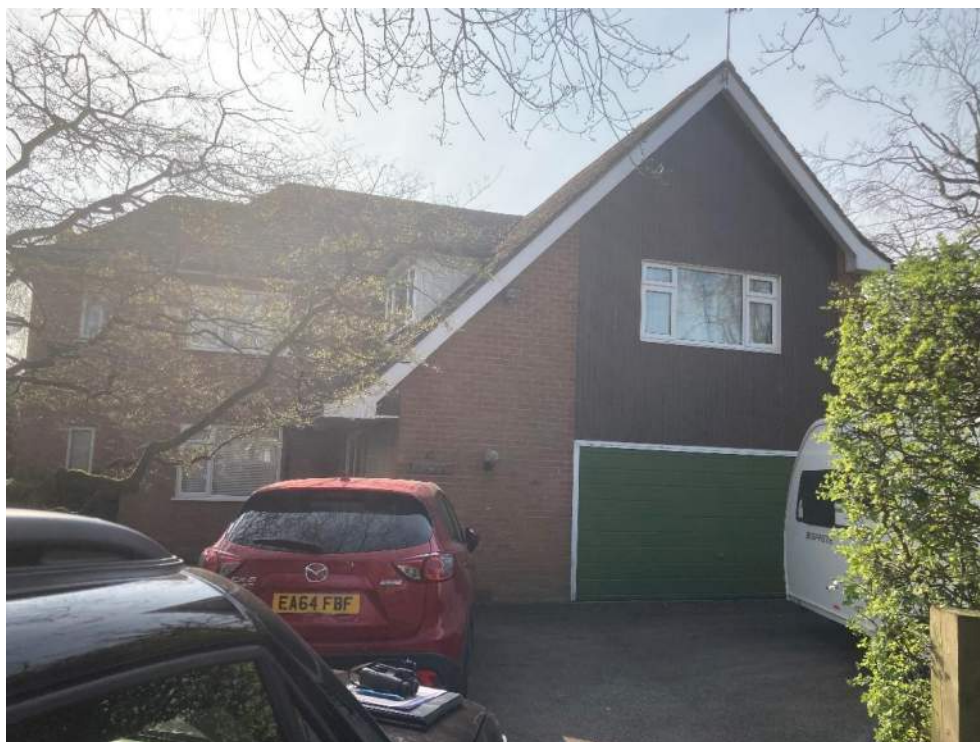
Photograph 1- Front face of the house

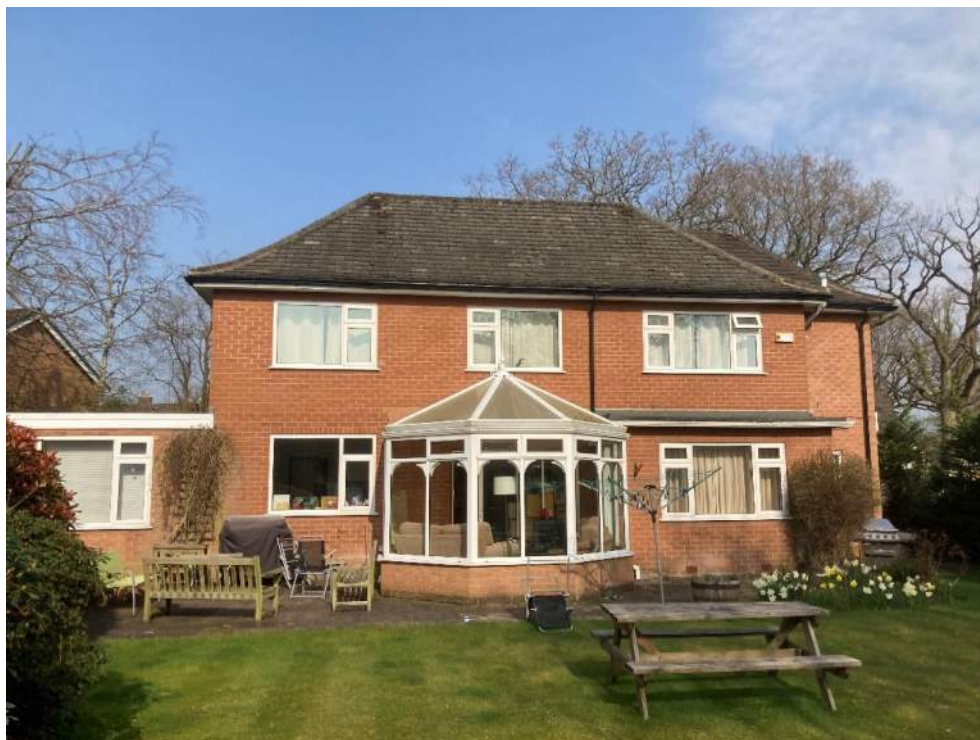
Photograph 2- Rear face of house

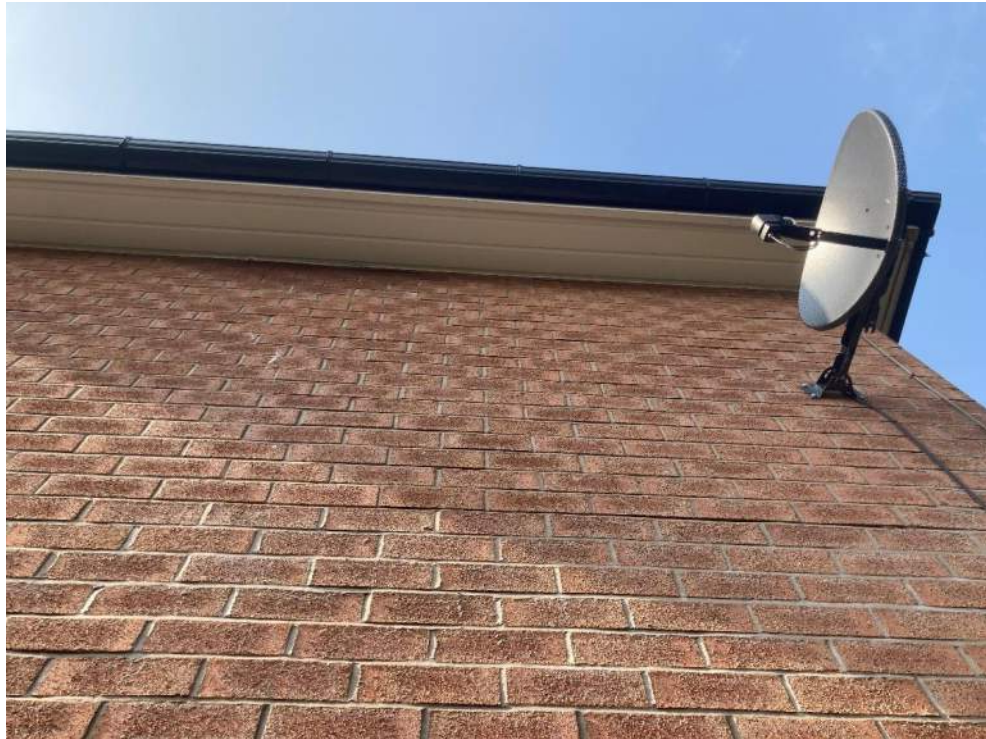
The house has UPVC soffits running beneath the eaves. These were observed to be tightly fitted with no crevices between the soffits and the masonry walls. The house has a north facing gable; the verge mortar at the gable is well sealed and intact. The gable itself is clad in tightly fitted wooden boarding with no obvious crevices or gaps. The house has a dormer window at the east face of the gable; there are some small areas of raised lead flashing beneath the dormer window. However, these were inspected with a powerful torch and binoculars. The raised areas were observed to be cobwebbed indicating no recent usage by bats. Other than this location, the house is well sealed with no other obvious potential bat access points or potential bat roosting locations.

Photograph 3- View of tightly fitted soffits

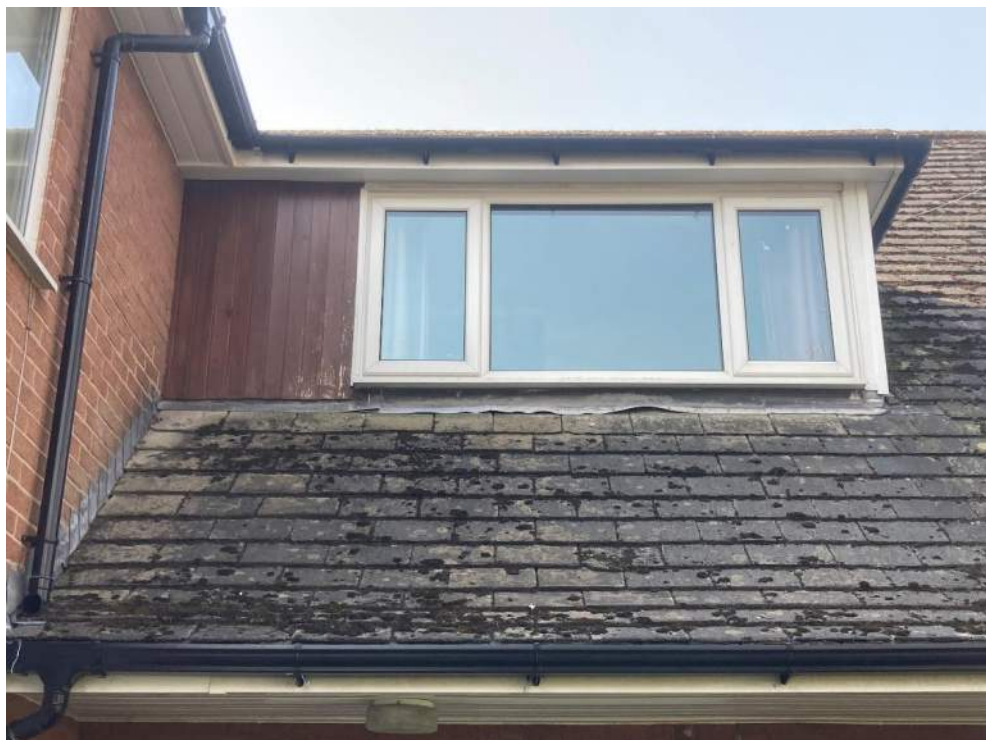
The house has a dormer window at its east face; there are some small areas of raised lead flashing beneath the dormer window. However, these were inspected with a powerful torch and binoculars and the raised areas were observed to be cobwebbed indicating no recent usage by bats.

Other than the minor area of raised lead flashing, no other obvious potential bat access points or bat roosting locations were identified.

Photograph 4- Dormer window showing raised lead flashing

Nevertheless, as a precaution, it is recommended that the lead flashing beneath the dormer window is carefully removed by hand prior to demolition of the house. In the unlikely event that any evidence of roosting bats is found, works should immediately stop and further advice should be sought from a licensed bat ecologist.

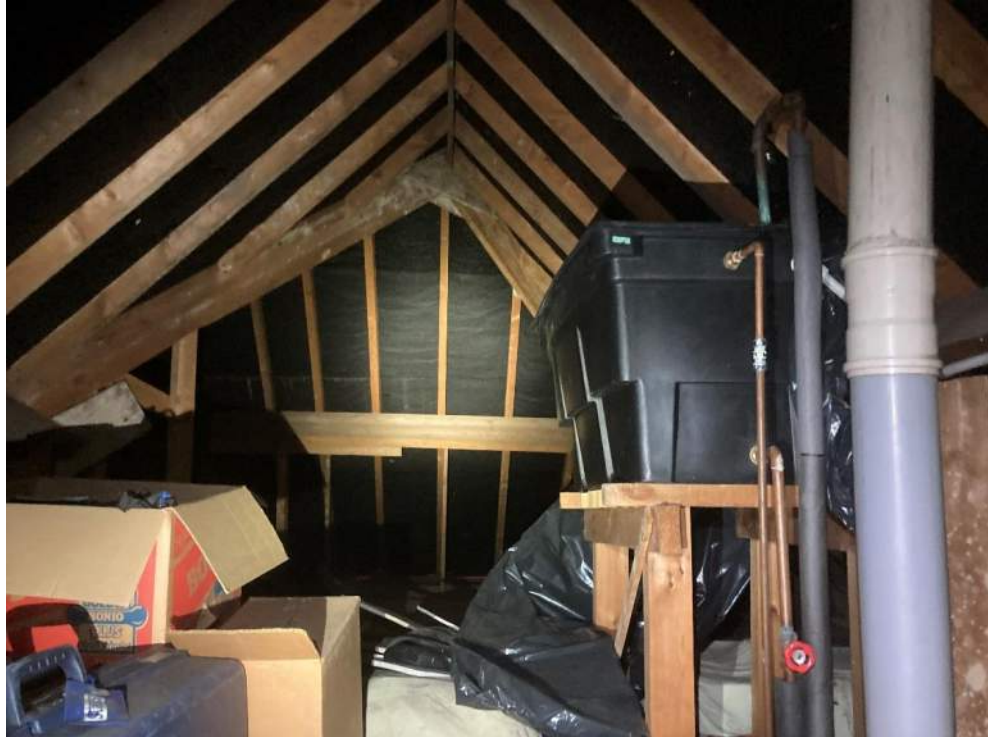
The house is roughly L-shaped in layout and is arranged over two stories with a loft space running above the upper floor rooms. The loft space is approximately 2.5 m in height and extends over approximately 15 m. The internal face of the roof is lined in tightly fitted bitumen hessian felt. The loft is insulated with fibrous loft insulation. The loft space was observed to be lightly cobwebbed including along the ridge and with cobwebs extending across the internal void space. An old wasp's nest was identified at the east face of the loft space. No obvious potential bat access points to the loft space were identified.

The house has a large loft space, however no obvious potential bat access points to the loft were identified.

Photograph 5- Loft space of house

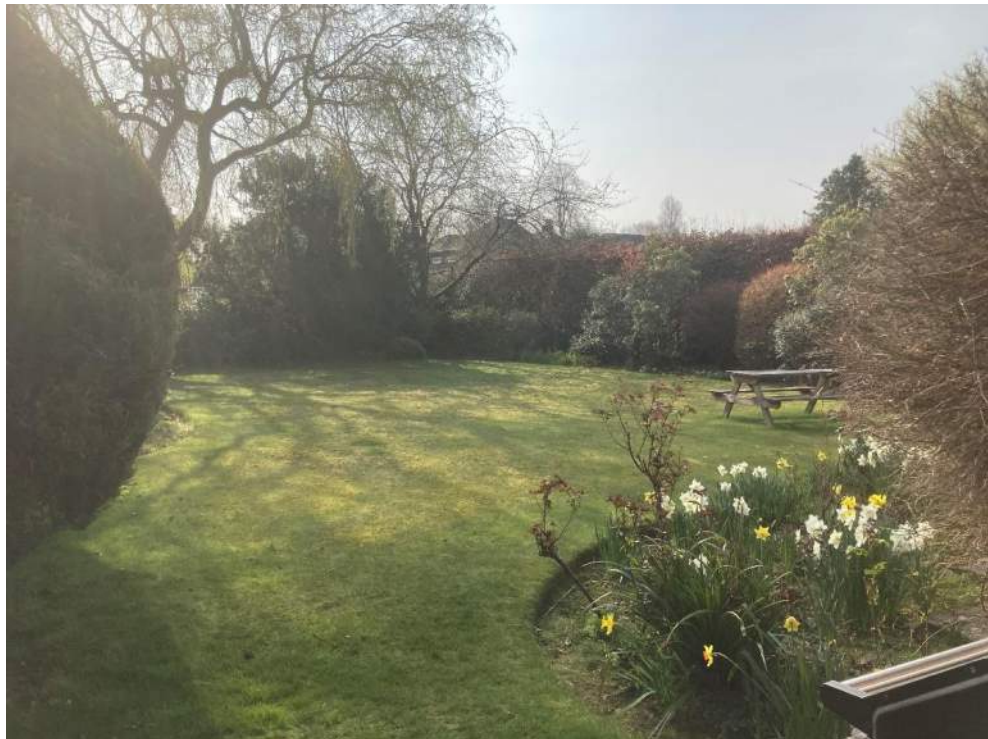
The house has lawned gardens to the front and rear. Within the rear garden, the borders are planted with ornamental shrubbery and there is a mature weeping willow and a semi-mature cherry tree present. The garden boundaries are marked with cypress, beech and privet hedges. There is a short section of hawthorn hedgerow located at the front of the house where it faces onto Patch Lane. There are also three mature oak trees in front of the house on Patch Lane itself.

None of the trees within the gardens were observed to support any obvious features suitable for roosting bats. The trees and shrubbery could support nesting birds during the breeding season. The oak trees on Patch Lane are considered to be features of high ecological value.

Photograph 6- Rear garden at site

Habitats within the front and rear gardens of the site are considered to be of limited biodiversity value. However, the trees and shrubbery present offer suitable nesting habitat for breeding birds. Therefore, it is recommended that any works to remove or manage any tall vegetation takes place outside of the breeding bird season (March-August inclusive). Where this is not possible, a check for nesting birds should be completed by an appropriately qualified ecologist prior to the start of works.
