02 EXISTING SITE / ROOF PLAN 1:100

PROPOSED REINSTATEMENT WORKS TO CASTLE BUILDINGS
LLANRHAEDR - YM-MOCHNANT 02.21

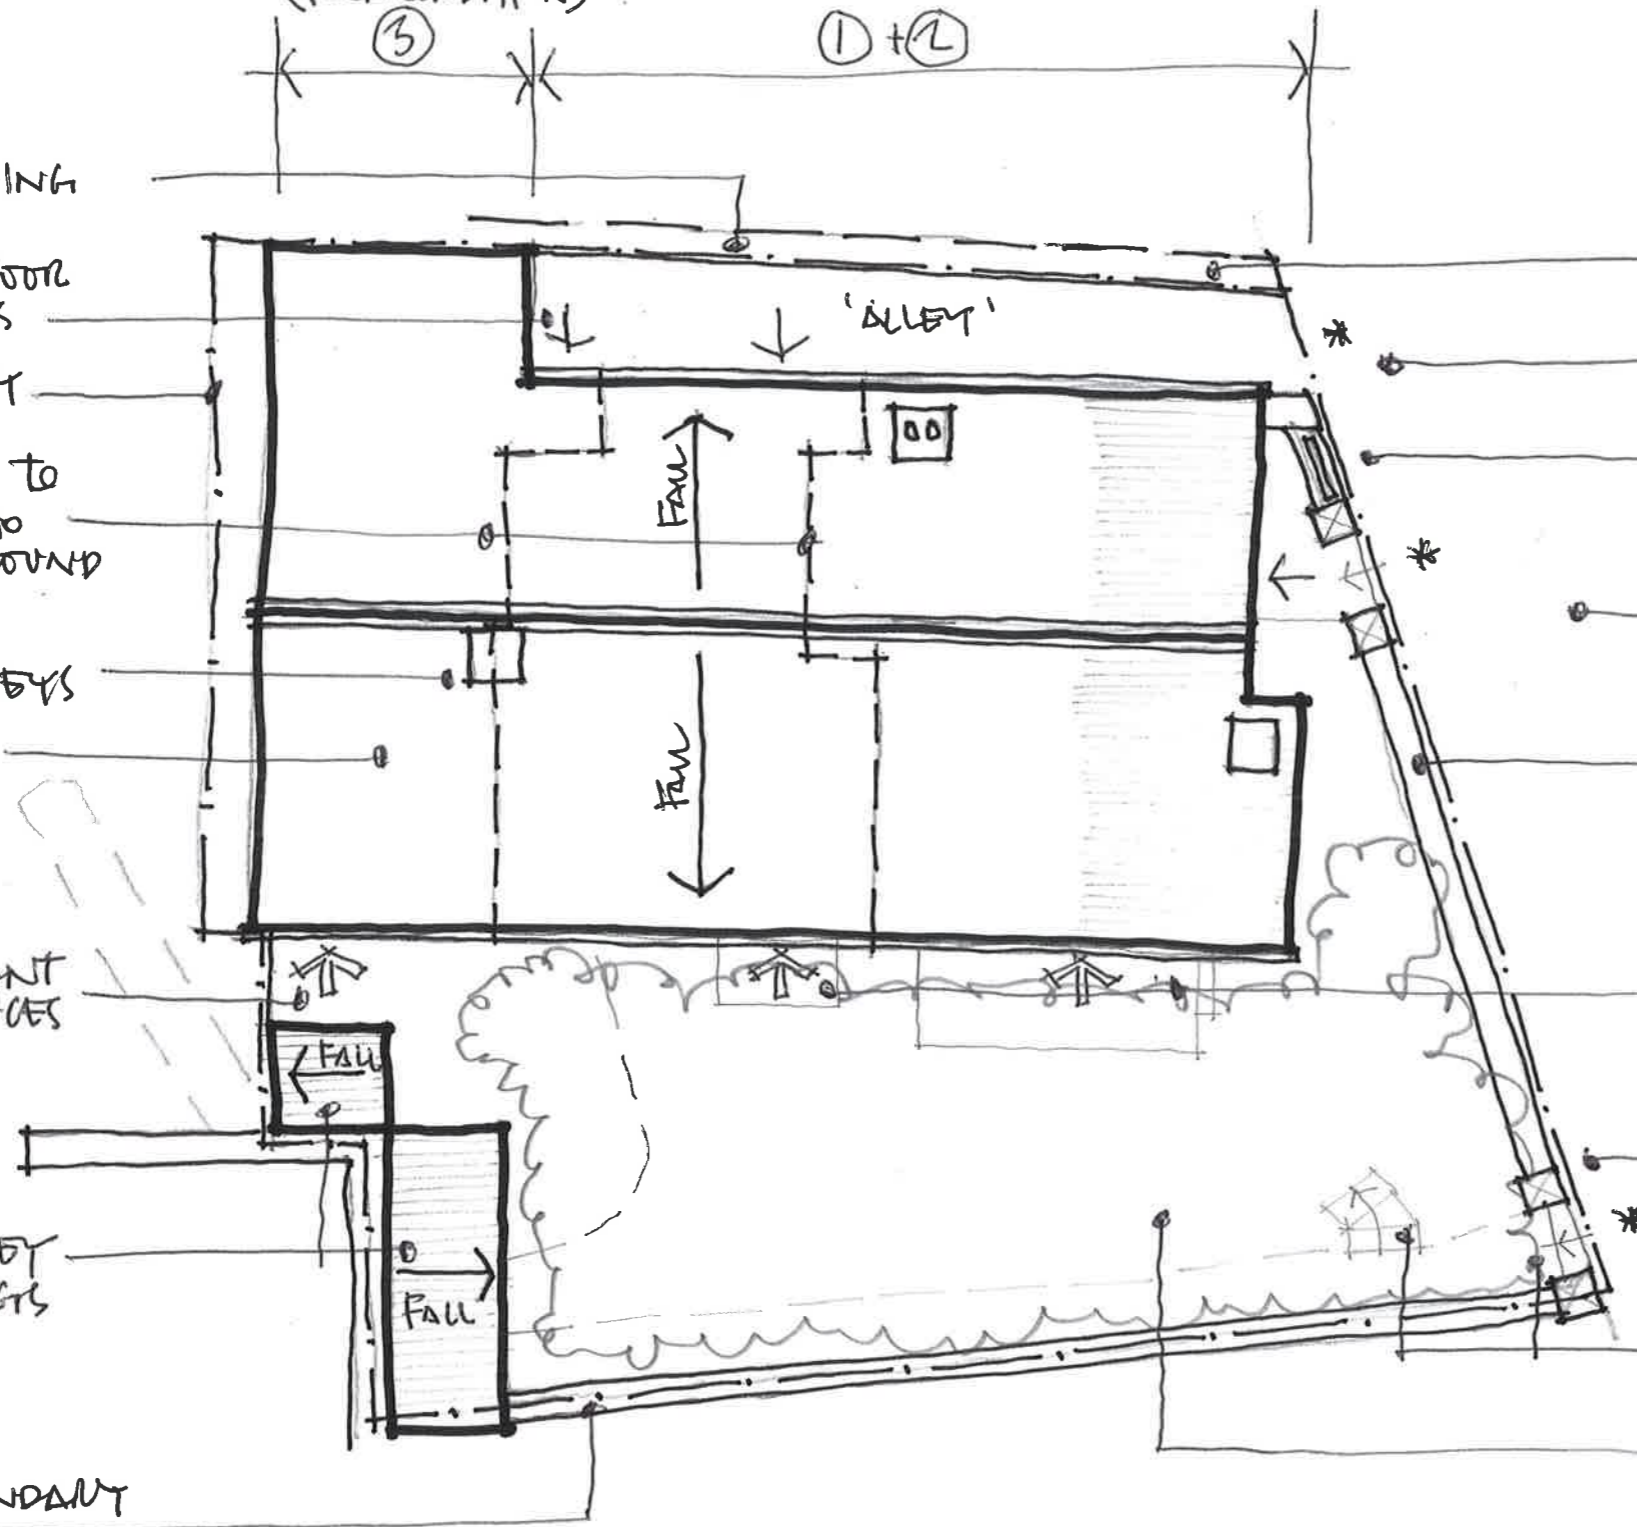
• SEPARATE DWELLING (POOR CONDITION)

• PREVIOUS ABANDONED ATTEMPT TO CREATE SINGLE DWELLING.

• DAMAGED RAILING.

• BRICK PIERS WITH RENDERVED FACING AND PYRAMIDAL CAPPING. VERY POOR CONDITION.

• EXISTING HEAVY OVERGROWN GARDEN.
