APPENDIX 2 – PROPOSED WORKS

GROUND FLOOR

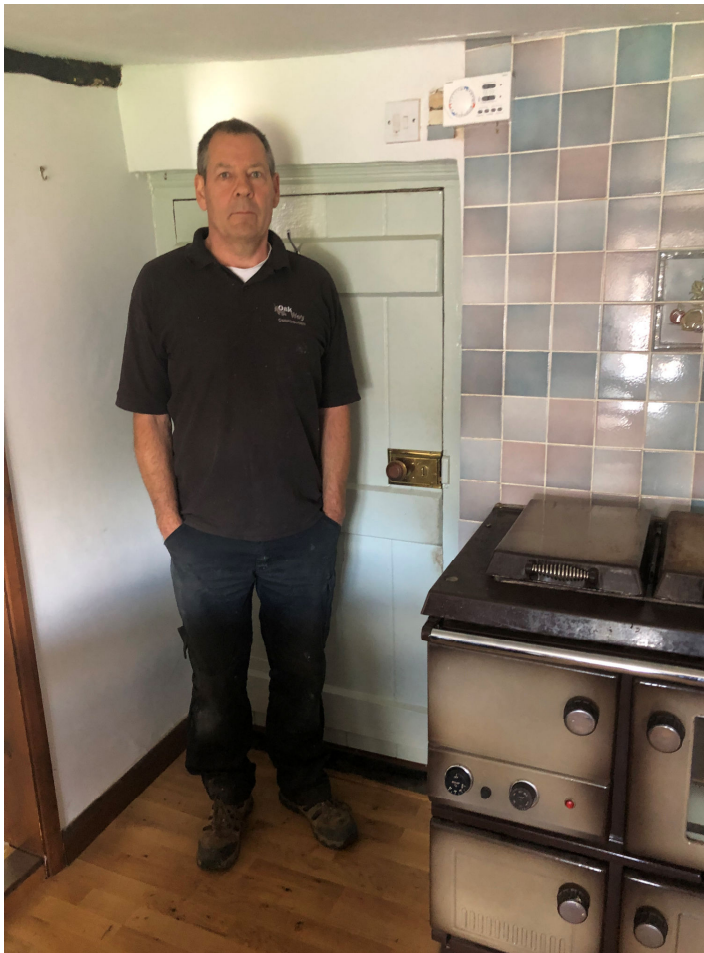
Fig 1 Door from room 2 to room 6 showing restricted height and Rayburn in front of original fireplace.

Remove concrete and tiled floor and expose original floor height. If flag stones exist, photograph and record position of each stone slab. Carefully lift each slab and set aside for reinstatement as original position. Excavate floor to achieve level surface, install Damp-proof membrane and 75mm insulation and relay original Flag-stone paving at original height in 75mm lime and sand bed on insulation. If Flag-stone flooring has been removed prior to existing concrete floor construction, Lay 100mm concrete floor to finish at original floor level as external door threshold. (NOTE: It is anticipated that the original floors (if they survive) were laid to a slope to allow water to drain out through the door opening, when this room was a Dairy). Raise lintel over door to room 6 and extend existing door frame to suit. Replace 20th C door to suit new height.

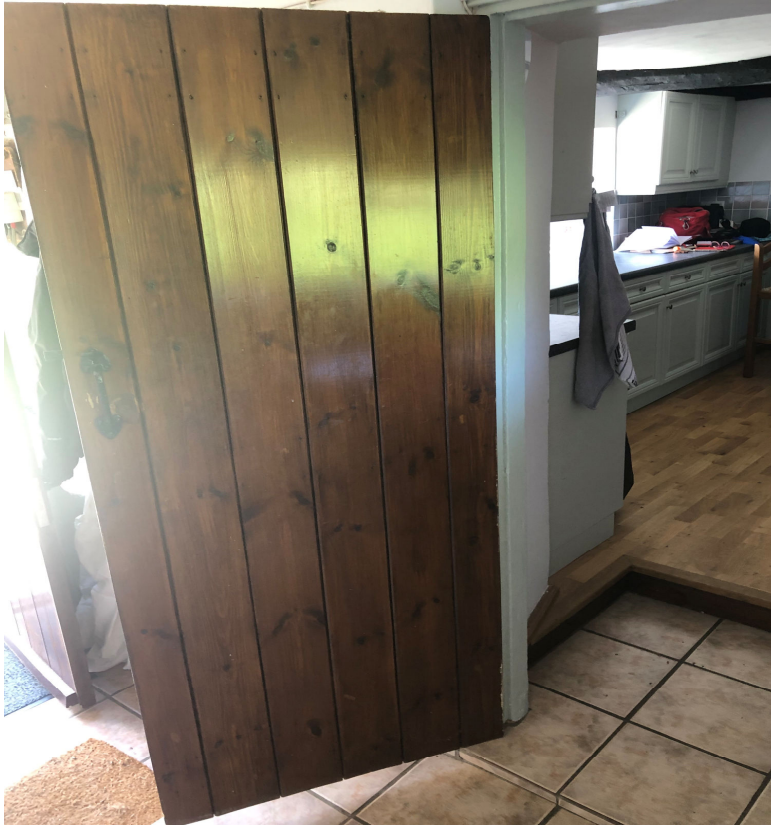
Fig 2 20th C Door between rooms 1 and 2 showing 2 unequal steps within wall thickness.

Remove fitted kitchen units and Rayburn Cooker/boiler. Remove concrete floor as Room 1 above, and relay level with room 1 new floor. Fit new door and frame between room 1 and 2. Investigate and expose original fire hearth (currently behind Rayburn cooker) and restore fire opening. (If cast iron range is still in place this is to be preserved).

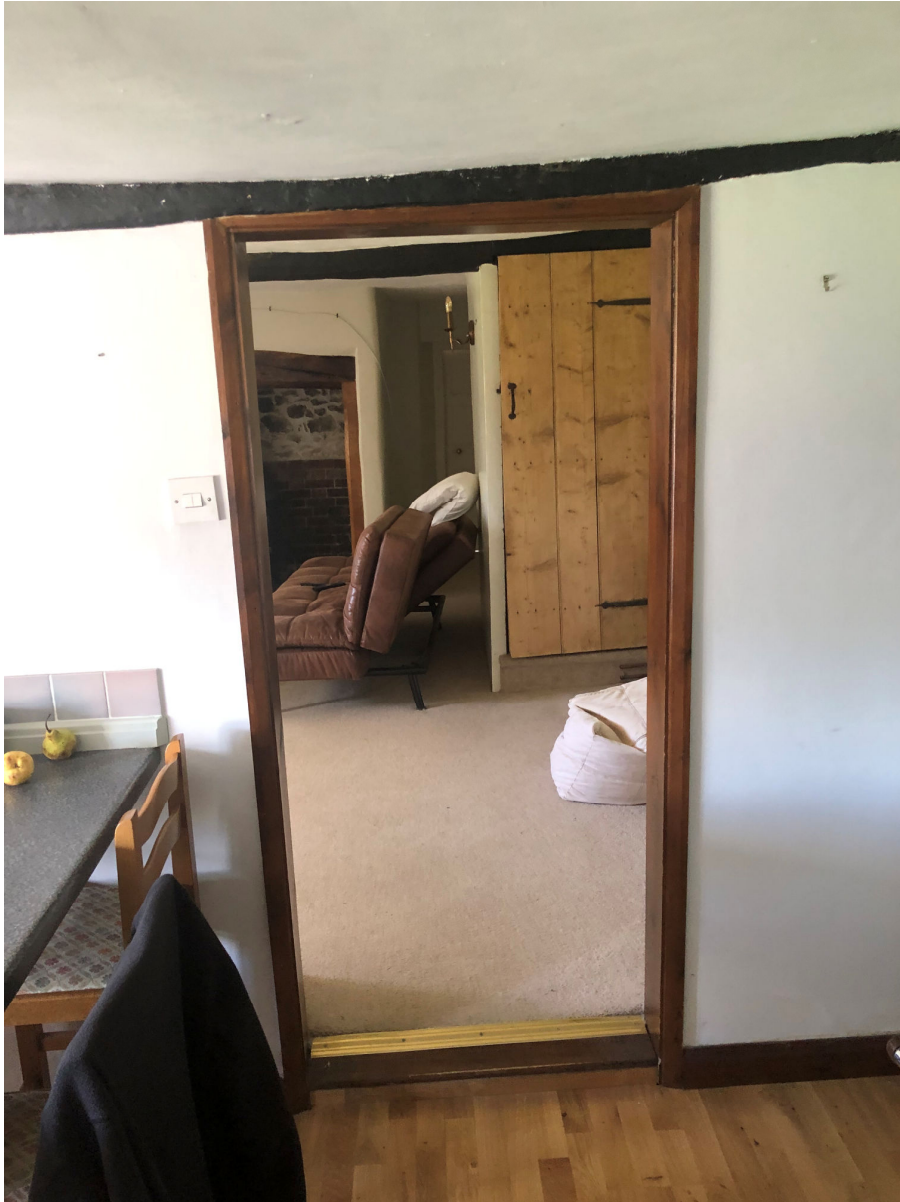
Fig 3 view from room 2 into room 3 showing replacement door to stair in original frame.

Remove all coverings to staircase (19th C) and expose timbers for further assessment. Repair and adjust staircase if possible to make structurally sound and fit for purpose and safe to use. Remove door (20th C) at bottom of stairs and preserve door frame (19th C). Form matching step to suit adjusted floor level at base.

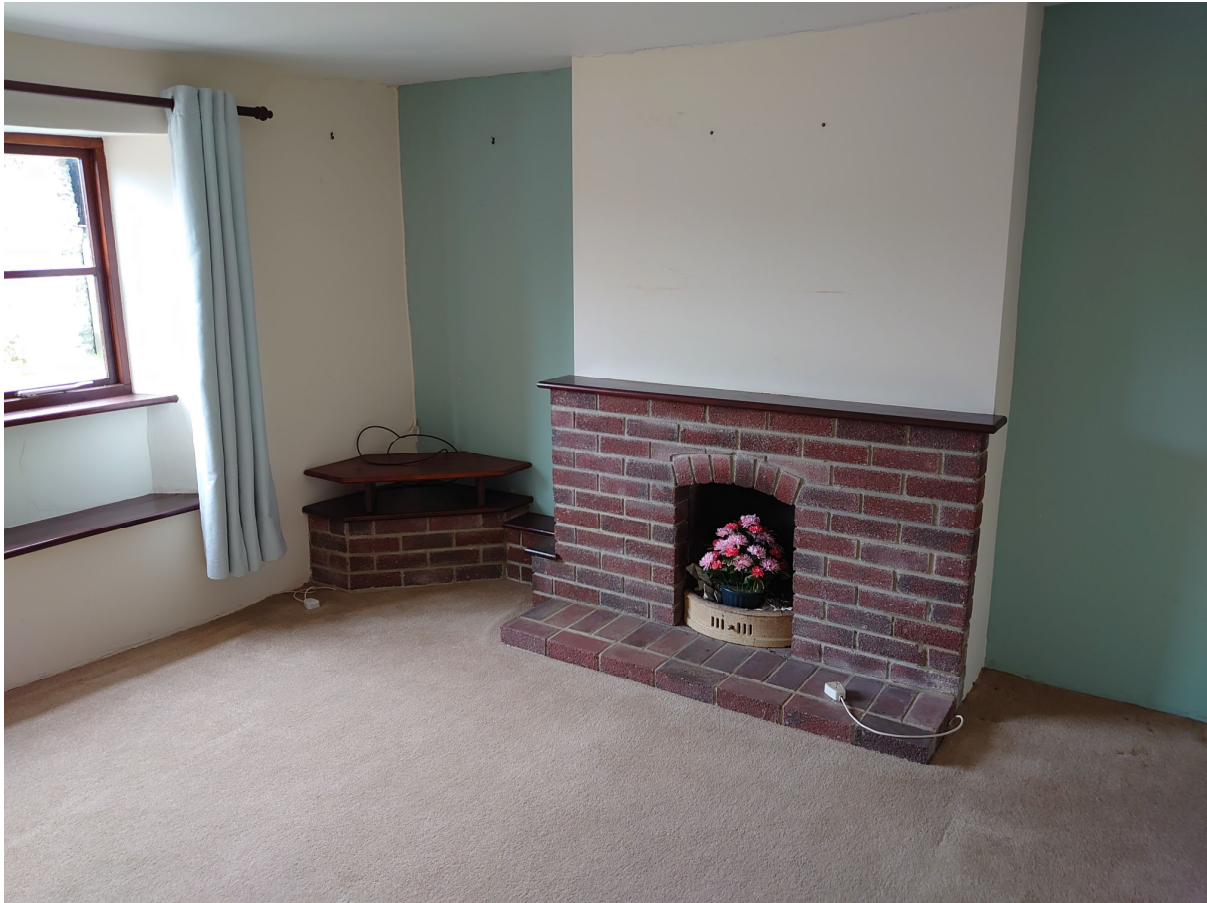
Fig 4 20th C brick fire surround feature.

Remove 20th C brick feature fire and shelving etc. and investigate fire opening currently concealed. Fit new fire back and surround as necessary. Carefully remove door and frame and raise lintel over. Extend bottom of existing door and frame to suit new height and refit in original position.

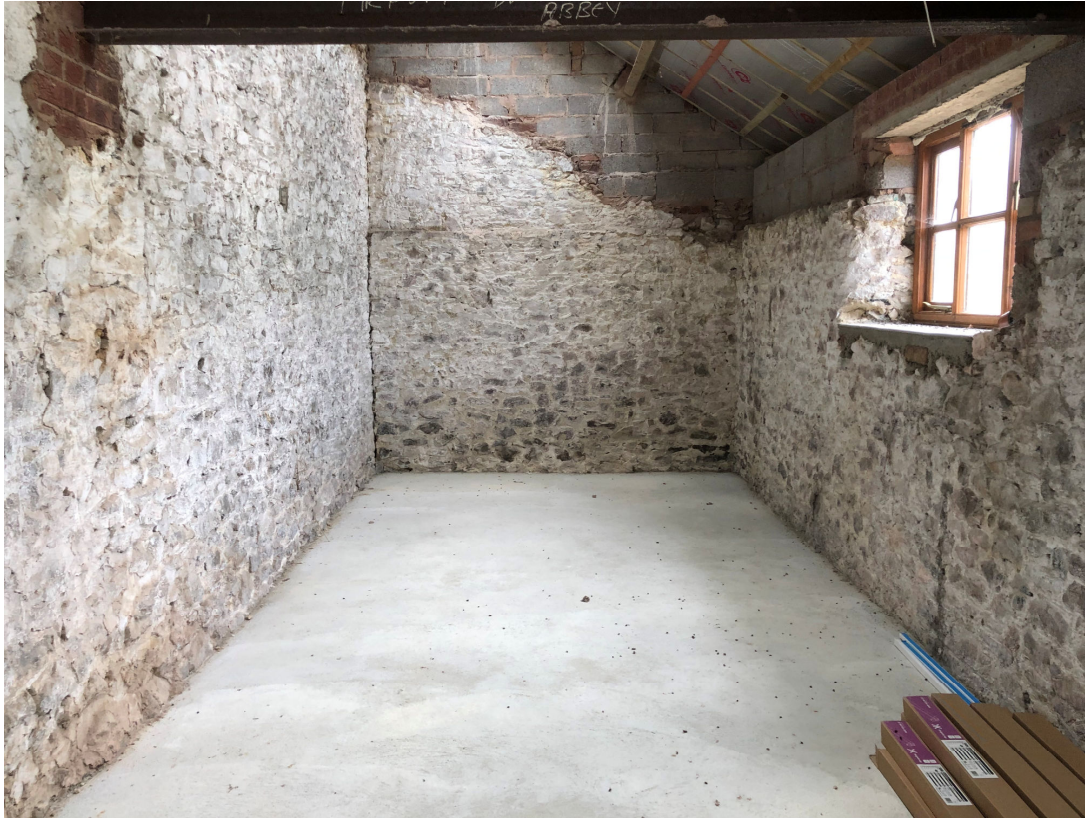
Fig 5 showing wall on left to have new opening in to room 4

Form new opening through wall into room 5 as shown on proposal plan such that room 5 can be used in conjunction with room 4. This is a 19th C wall and the new opening is to be restricted in width as shown so that the original line of the wall is expressed both sides of the new opening.

Construct new ceiling to form floor of new shower room over as proposal plans. There are no heritage features in this space.

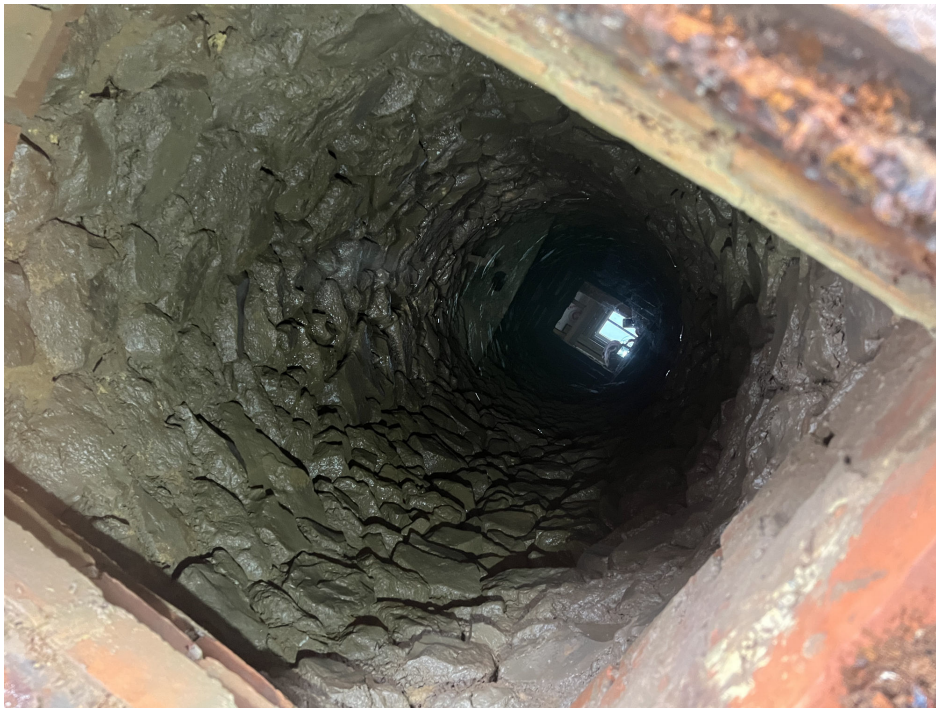
Fig 6 Well in room 6 showing brick encasing iron frame and cover.

Existing stone lined well to be cleaned and stonework raised to floor level and stonework joints flush pointed in lime and white sand 1:3. New floor laid as Room 1 with toughened glass circular cover.

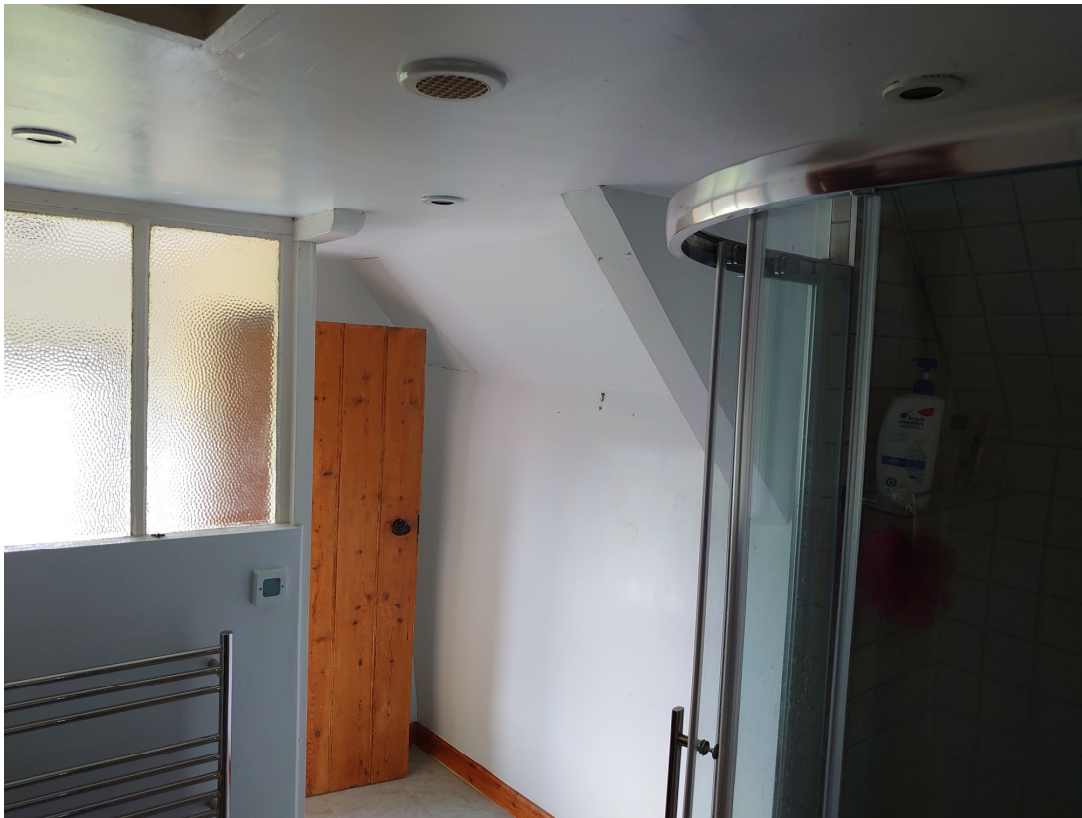
Fig 7 Showing 20th C glazed partition and shower etc. to be removed.

Remove 20th C studwork and timber partitions separating bathroom from shower and landing area, Fill in area of floor where 20th C stairs removed and return room to original proportion and size. Existing floor timbers to remain and matching boarding used to repair missing planks. Examine ceiling for stability and timber connections. (Some ceilings on the first floor have collapsed where metal fixings have rusted through) Fit new stainless steel screw fixings between ceiling joists and principals where possible. Where timbers have decayed beyond preservation, replace with new treated timber fixed with stainless steel screws.

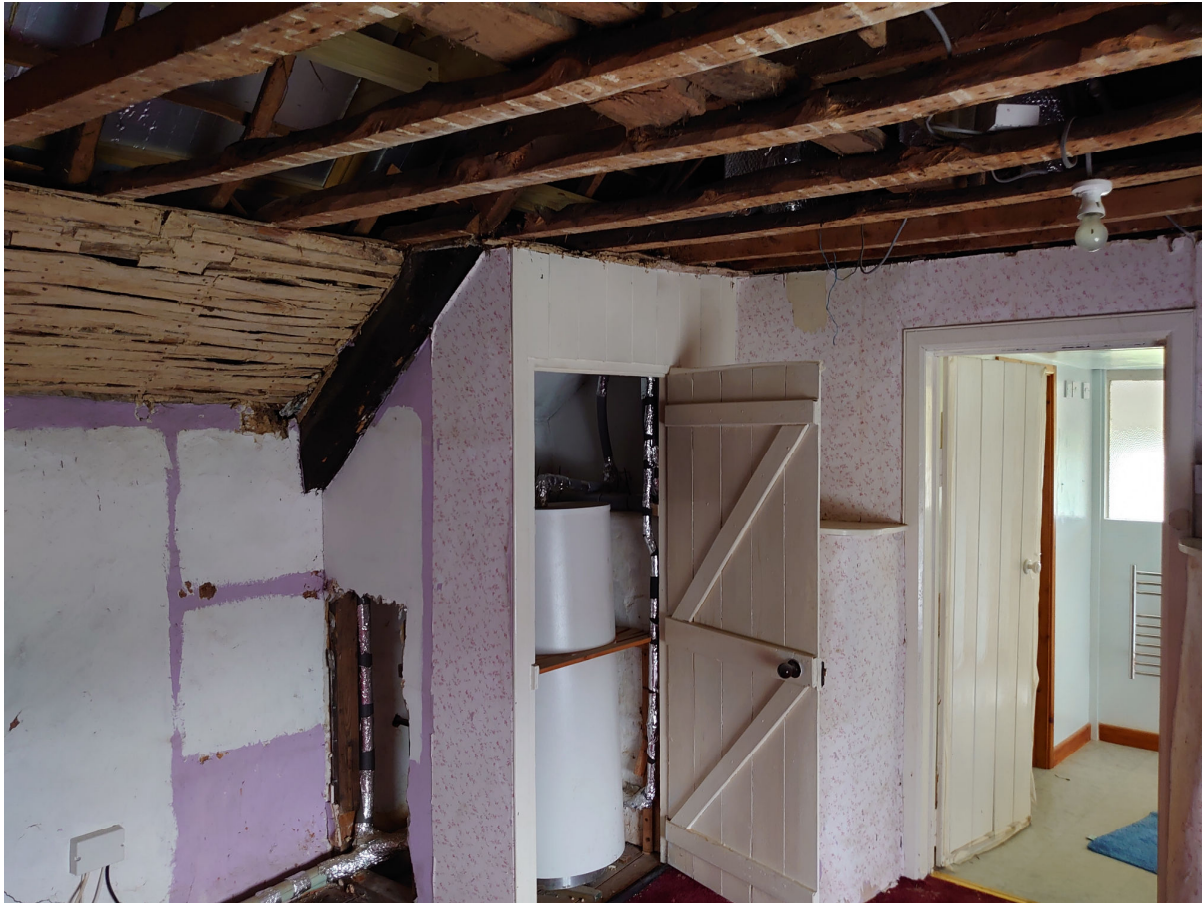
Fig 8 showing cylinder cupboard to be removed and collapsed ceiling.

- 5.4 To ceilings have collapsed and the ceiling over room 10 is sagging badly. These could and will collapse into the bedrooms in due time if not repaired now.

Remove partition forming hot water cylinder cupboard. Screw ceiling joists up into binder and purlins to strengthen ceiling and fit new plasterboard ceiling. All original ceiling joists and rafters to remain and additional timbers fitted where necessary. Carefully mark and lift floorboards and ensure that all joists are resting firmly on principal beam under and insert hardwood packing to prevent movement where necessary. Cut and scribe timber above each joist to accommodate shape of top of joist and provide flat top surface, and refit original floor boards in original position. Joist ends built into walls to have packing pieces inserted under to assist in levelling and firming floor. Remove water pipes and run in void on other side of wall above room 6.

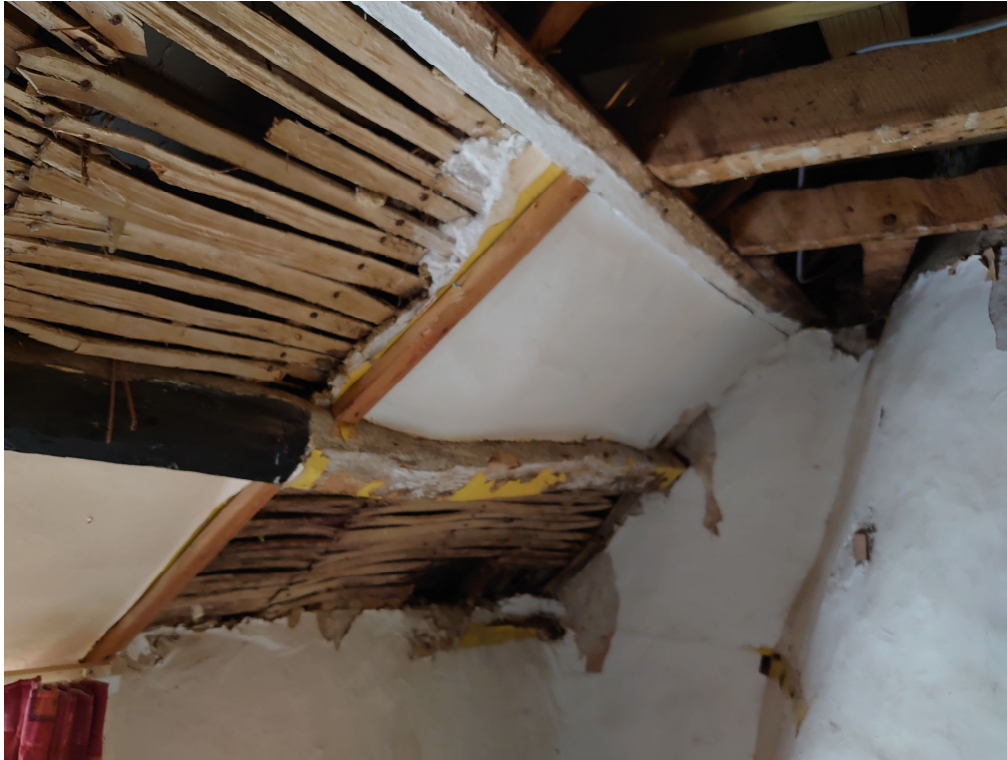
Fig 9 showing collapsed ceiling beside chimney gathering in room 9.

Repair collapsed ceiling as before. Provide additional framing to support ceiling around gathering of chimney. Repair floor as room 8. Ensure that joists are firmly supported on principal beam under and at ends supported by walls by inserting hardwood packing pieces and making good around joist ends in Lime mortar 1:3. Fit additional timbers either side of existing joists where necessary because of sever failure of joist. Bolt through joists where timber is not sound enough to accept stainless steel screws. Where 20thC studwork partitioning to stairs removed, erect timber baluster as guard to stair well.

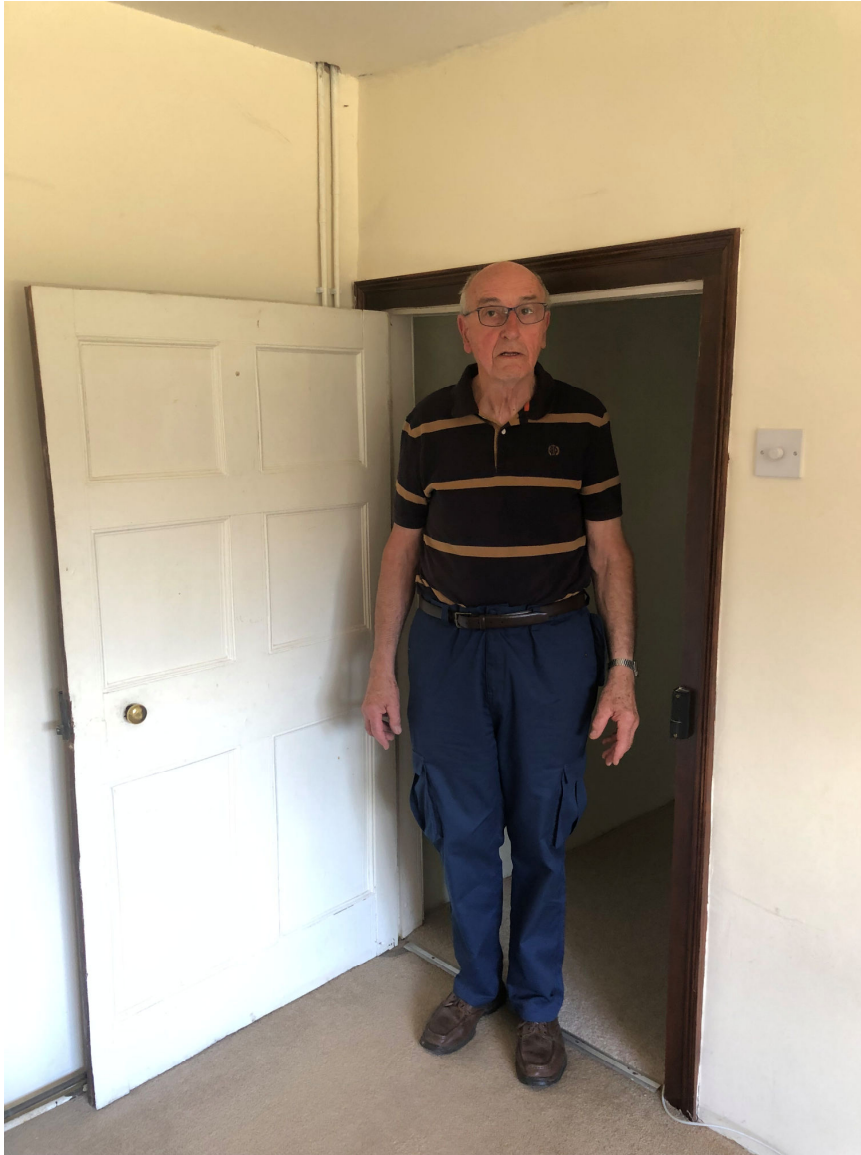
Form new opening through original internal wall into space above room 5. Raise lintel above door to landing and extend existing door and frame to suit new height. (NOTE: There is a step down under this low door and the stair well is immediately ahead presenting a great danger of falling).

Fig 10 showing low door from room 10 to head of stairs. Door frame to be raised and bottom of existing door and frame extended 150mm.

Bedroom door is c 1850 and is to be retained in existing position with an extension at the bottom screwed up into the underside of the door.

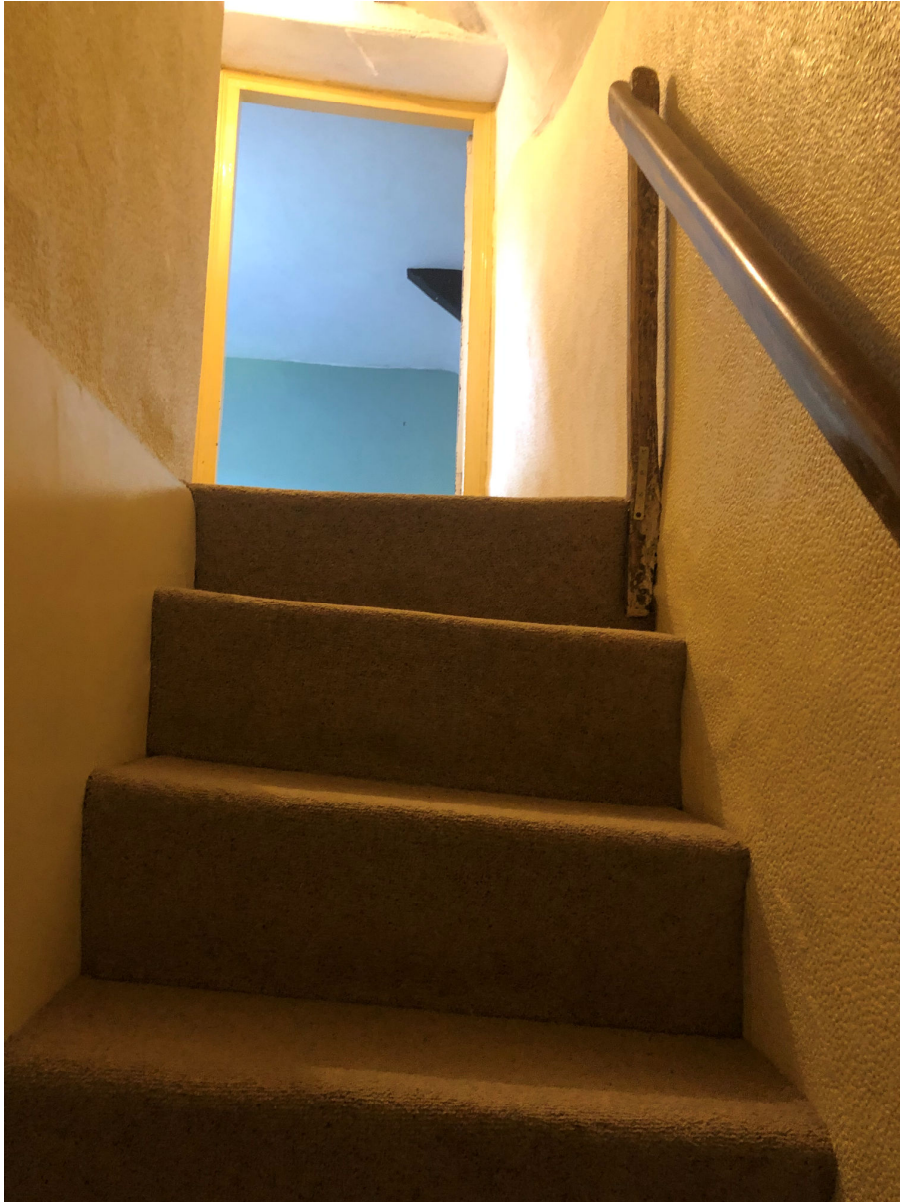
Fig 11 showing stairs with dangerous unequal treads and risers. Line of later partition on left visible at upper floor level.

Remove carpet and all coverings to expose stairs and stair construction. Treads vary in width and are narrow with high and unequal risers. Treads slope sideways in differing directions and are deformed. Before the building of the extension forming rooms 4 and 10 the stairs probably rose over a brick oven (demolished) at the right of the fireplace where the door to room 4 is now situated. The existing stairs to be repaired and extended and exposed with all the plaster work stripped away. Where possible all original timbers to be preserved as part of the refurbished stair, but it is accepted that some timbers will have to be replaced. Removal of the 20th C partitioning will provide better light and visibility. The handrail to be securely fixed to the wall and provide both sides of the stair.
