5.2022

BS5837 2012 Tree Information High Winds

High Winds
Tredunnoch
Monmouthshire
NP15 1PF

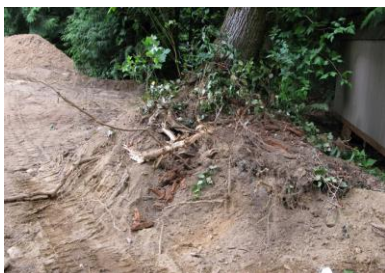
This photo shows a combination of damage. The roots have been severed or damaged in such a way that stability has been lost and this tree was felled. If the same damage had not led to an immediate tree failure the tree would have been sent into an irreversible spiral of decline.

The loss of roots will have caused a lack of structural support, loss of moisture take-up, loss of oxygen take-up and a means of the tree storing energy as starch within root structures. This type of root damage causes a slow decline in tree foliage known as crown die back.

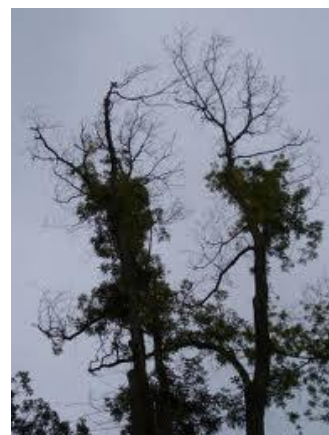
The picture to the right shows the die back of foliage several years after the completion of a development site. Machine operators will often mention how they have dug roots or driven over them. This is what happens once they leave site.

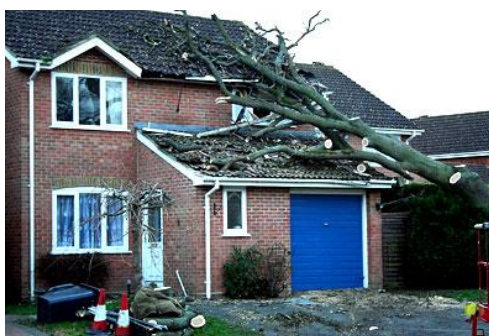
If adequate protection is not given the disaster below is not far behind!
