# PROPOSED DEVELOPMENT OF BARNES AT CHURCH FARM, FRING, NORFOLK

## ECOLOGICAL APPRAISAL

Report ref: P2019-27 R1 **FINAL**

Date: 25<sup>th</sup> November 2021

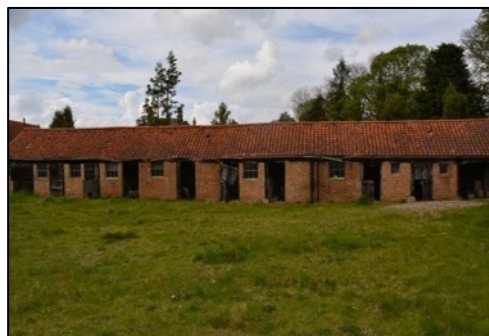
**Figure 19** – Southern view of Main Barn 4 Complex (section J), showing the damaged doors and windows

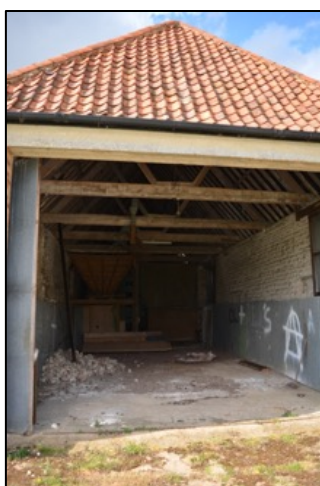
**Figure 22** – Southern view of Main Barn 4 Complex (section C), Barn Owl pellets were noted towards the entrance of the barn

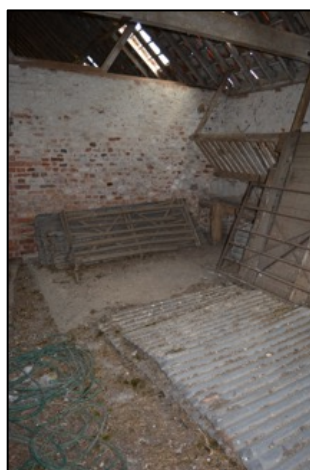
**Figure 25** – Internal view of Barn 4 Complex (section E), showing general use and the poor state of repair

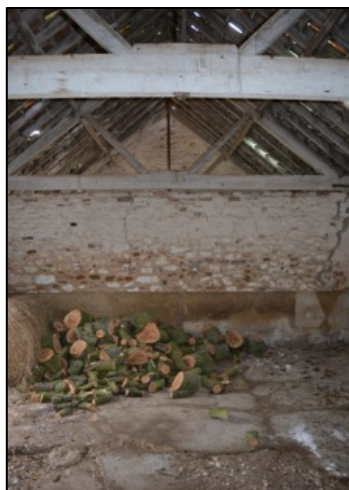
**Figure 26** – Internal view of Barn 4 Complex (section F), showing its poor state of repair

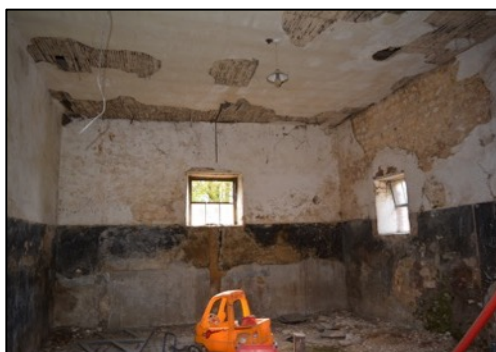
**Figure 28** – Internal view of Main Barn 4 Complex (Section I) showing the lath and plaster ceiling including gaps

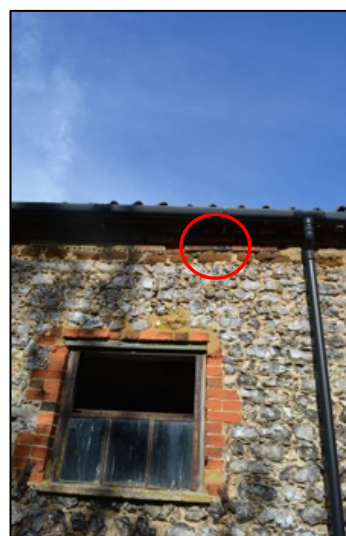
**Figure 31** – Features where a single common pipistrelle was found within a mortar cavity on Main Barn 4 Complex (Section I)

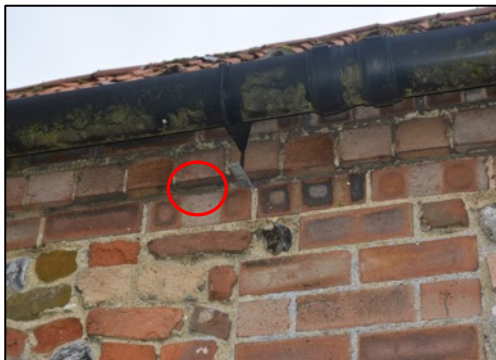
**Figure 32** – External feature northern view of main Barn 4 Complex (section E) where a single common pipistrelle was found

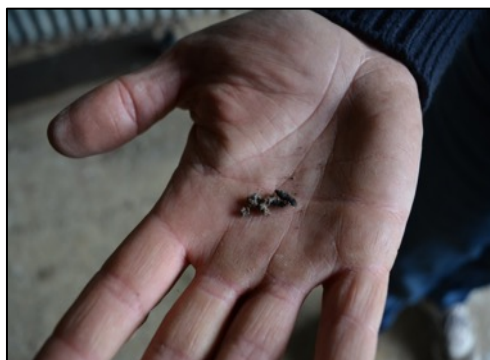
**Figure 33** – Natterers type droppings found in a cavity in the eastern wall of Barn C

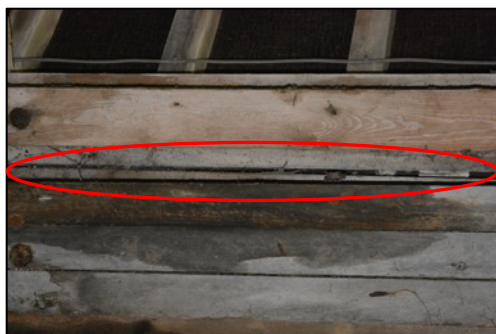
**Figure 34** – Feature between the lintel and door frame that a barbastelle was found on the eastern elevation of Barn C

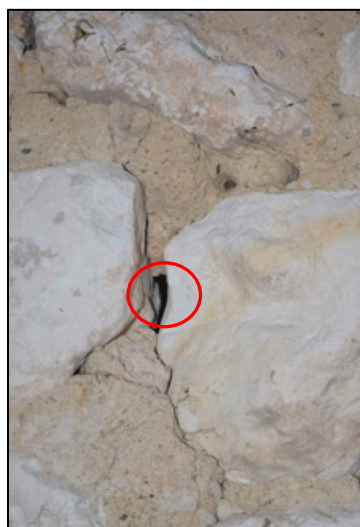
**Figure 35** – Internal cavity in Barn E – made smooth by bat activity

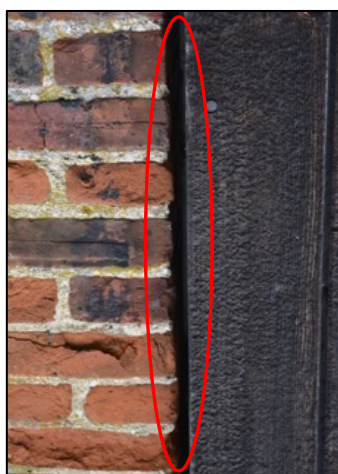
**Figure 36** – Feature between the door frame and wall where a common pipistrelle was noted roosting on the west elevation of Barn C – external

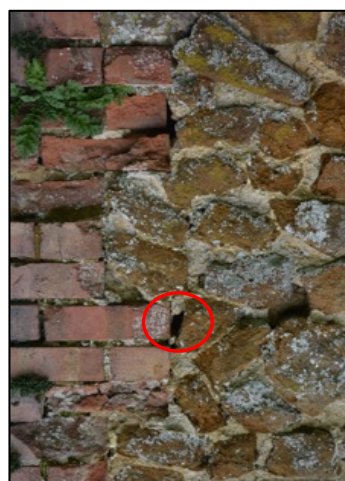
**Figure 37** – Lower cavity where a common pipistrelle was noted roosting on the south-western elevation of Barn E

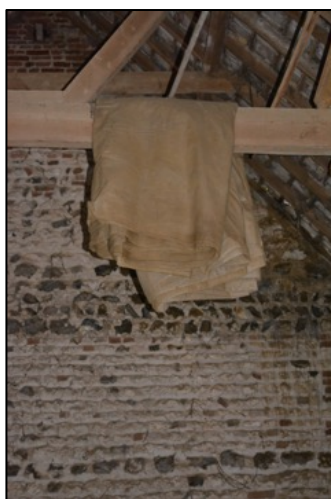
**Figure 40** – Hessian sack over the rafter where a brown long-eared was recorded roosting during the 2020 bat activity survey (20<sup>th</sup> August 2020)

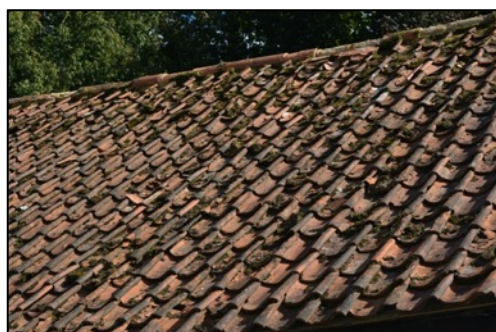
Figure 45 – Lightly mossed western elevation pantile roof, with gaps between the pantiles

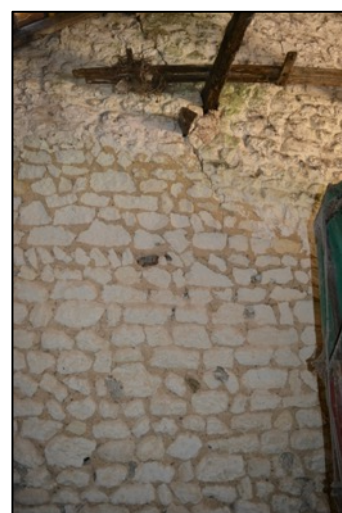
Figure 46 – Cavities in the chalk wall of the trailer store

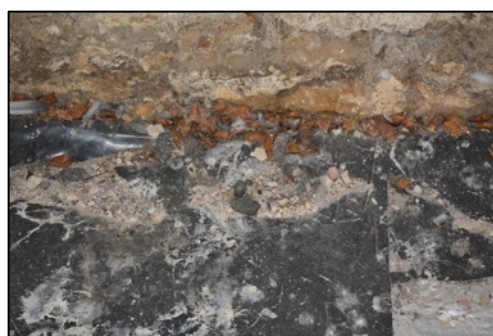
**Figure 48** – Barn owl pellets in Field Barn 2
