# **Tree Report for 55 Fieldgate Lane, Kenilworth, CV8 1BT**

**Cotswold Wildlife Surveys**

**July 2022**

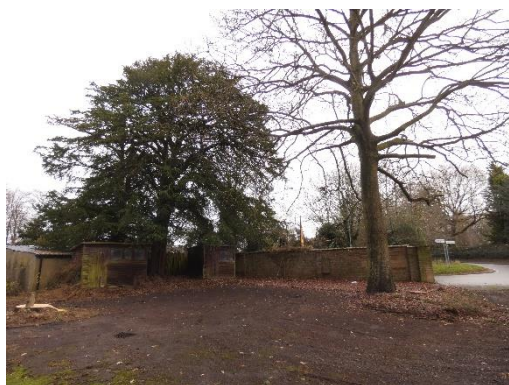
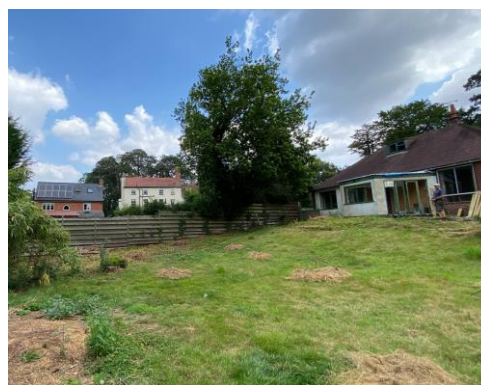
**Figs. 1 & 2 Mature trees in and around the grounds of 55 Fieldgate Lane**

The trees provide both an individual and collective contribution to the site, and their physiological condition is generally good, except for a conifer stump (T9), which is nearly dead.

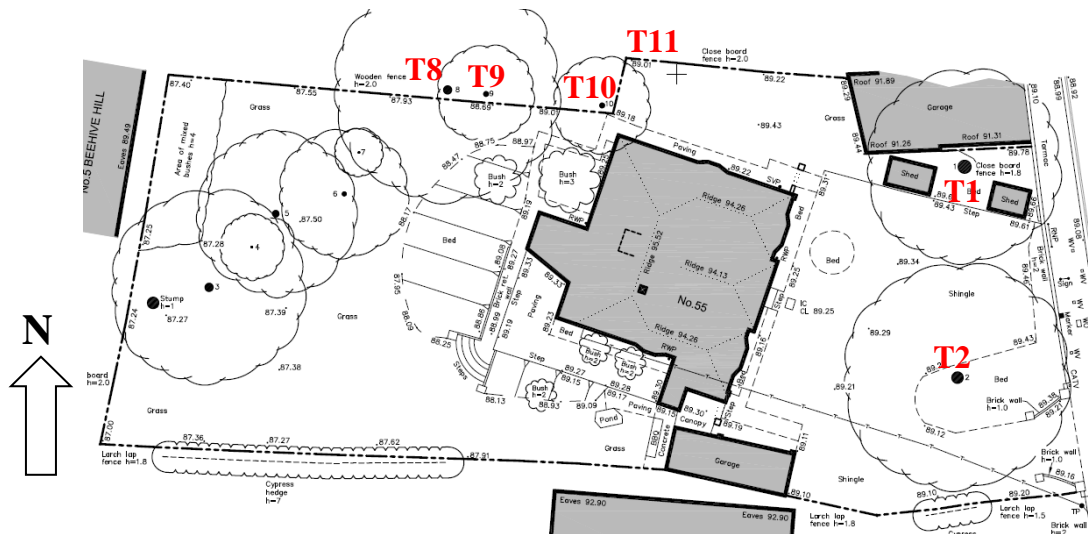
**Plan 1 Tree survey and existing site plan**

The survey focussed on five trees across the site. The locations of the trees are shown on the existing site layout plan below, and the numbers follow those on original drawings for the site. These include a stump (T9). Other trees were too far away to be impacted upon by the proposed works and have not been included as part of the survey. Numbers 3-7 referred to shrubs or previously removed trees and do not form part of a BS5837 survey.

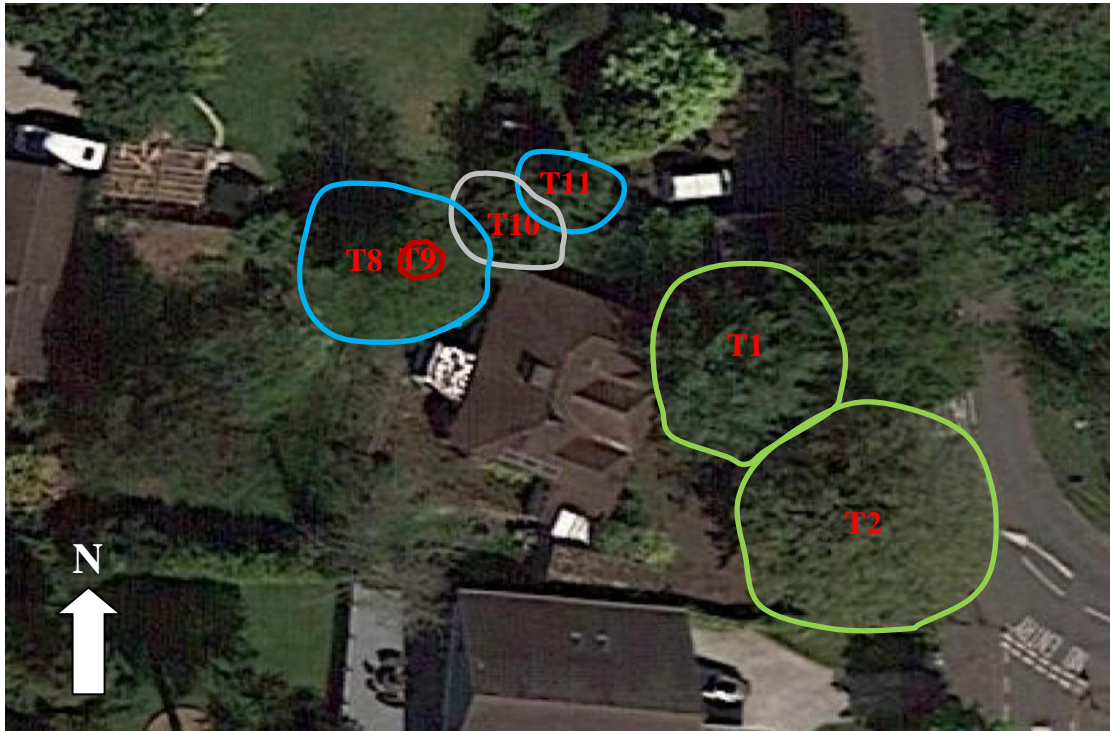
**Plan 2 Tree Quality Assessment & crown spreads (to scale)**

Tree No.	Species	Category
T1	Yew	A3
T2	Turkey Oak	A3
T8	Pedunculate Oak	B1
T9	Conifer stump	U
T10	Lawson's Cypress	C1
T11	Norway Spruce	B3

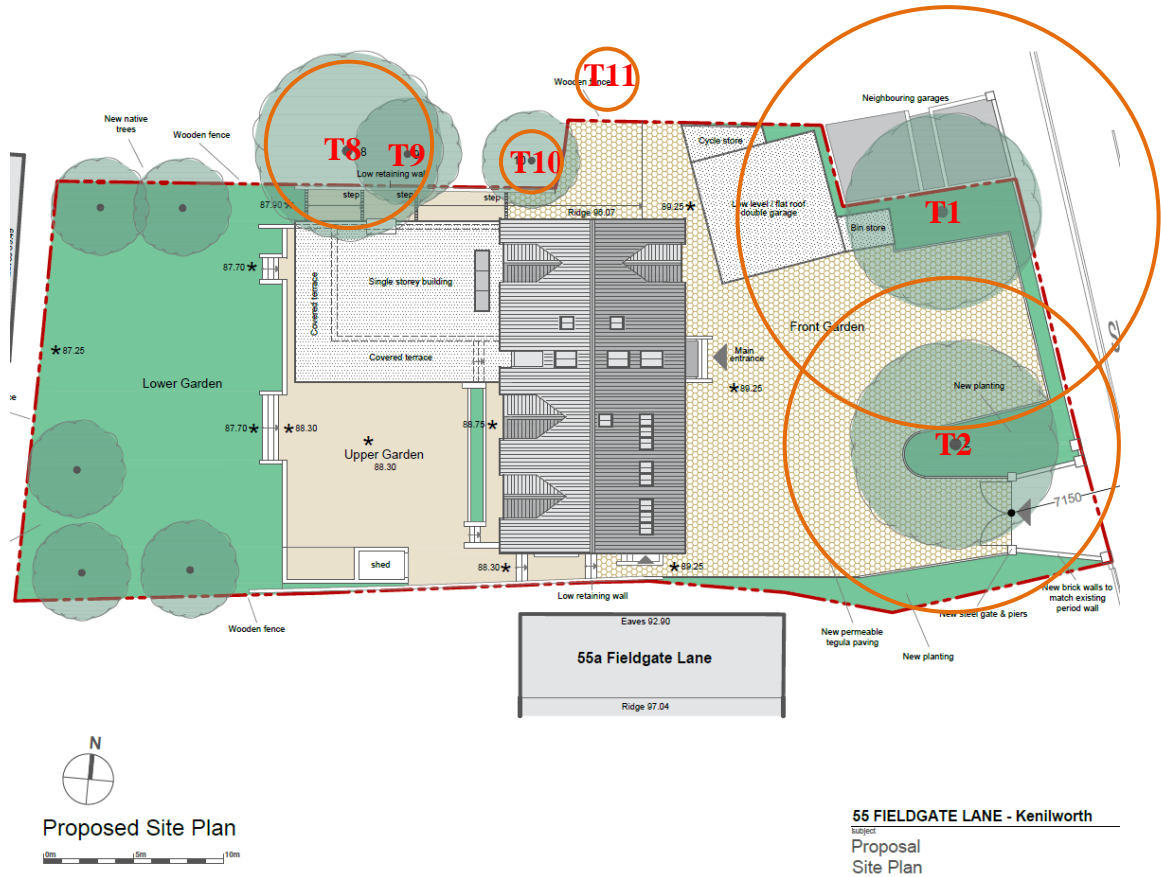
Site plan - RPAs shown to scale

The RPA of T8 will be incurred by less than 5% by the proposed single storey element of the dwelling, and there will also be incursion by the side path and steps. These will therefore be constructed using a fully permeable surface.

The existing sheds within the RPA of T1 are to be removed, but the RPA of T1 will be incurred by the proposed garage and bin store. This building will therefore be constructed using mini-pile foundations and a ring beam at ground level from which to build up from. Roof water run-off will be returned to the RPA through shallow shingle soakaways within the RPA.

The front garden parking areas incur the RPAs of both T1 and T2 as they do at present. These will be constructed using the special engineering solution detailed in section 5.5 to minimise the impacts on root systems.

Tree No	RPA radius m	Tree No	RPA radius m
1	11.7	9	-
2	9.3	10	1.8
8	4.6	11	1.8
