**LAND OPPOSITE THE OLD POST OFFICE,
NEWTOWN, NEWBURY, BERKSHIRE**

PROTECTED SPECIES SURVEY AND MITIGATION

Final Report

2nd August 2021

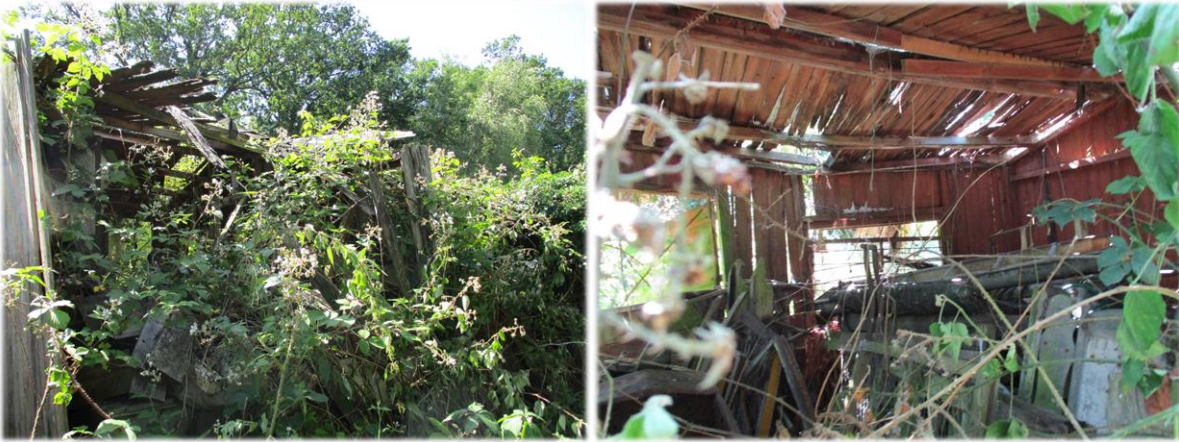
- ❖ A dilapidated timber shed, constructed from timber walls and a shallow pitched timber roof covered with bituminous roofing felt. The walls and roof are collapsing, with one side wall completely missing. The shed is now shrouded in bramble (*Rubus fruticosus* agg).
- ❖ A dilapidated waggon, constructed from corrugated metal. Two walls and the roof are completely missing, and the waggon is now shrouded in bramble.
- ❖ Two small greenhouses constructed from metal frames and glass, now both shrouded in bramble.

These outbuildings are totally unsuitable for supporting roosting bats.

Dilapidated wooden shed covered in bramble
