# CHESTNUT COTTAGE, IPSWICH

## Preliminary Roost Assessment Report

*July 2022*

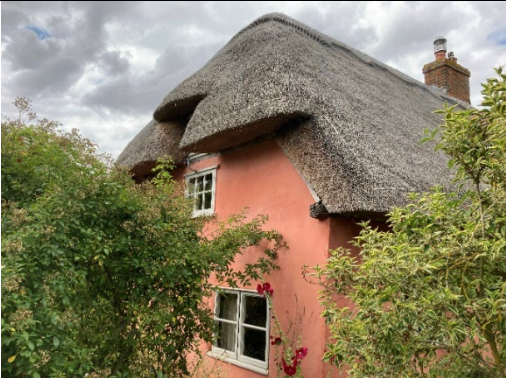
<b>Feature</b>	<b>Photograph</b>
<i>Southern aspect of the building</i>

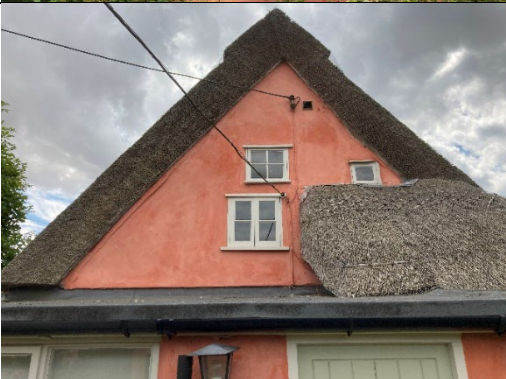
<i>Northern aspect of the building with porch type extension.</i>

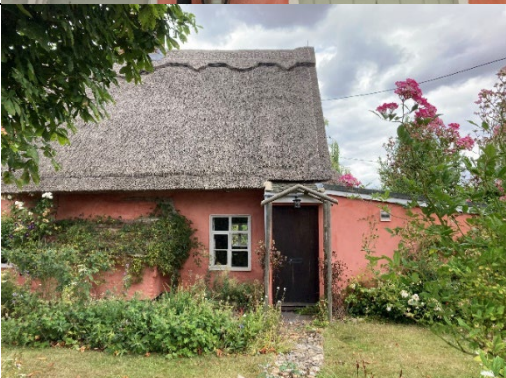
<i>Eastern aspect of the building with front door.</i>

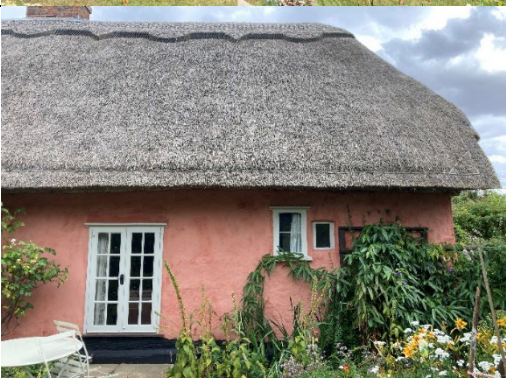
<i>Western aspect of the building</i>

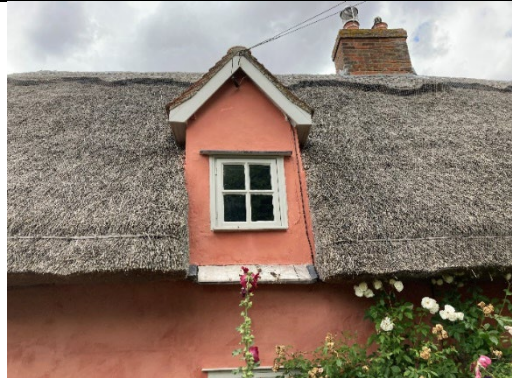
- 3.2.2. All windows and doors were in good condition and completely sealed into the external walls. There is a small outcrop for a window on the eastern aspect of the building with tiling. The mortar was present across its extent, with no PRFs or potential access points observed.

*Tiled outcrop on the eastern aspect of the building, wasps were seen entering below the lower window-ledge.*

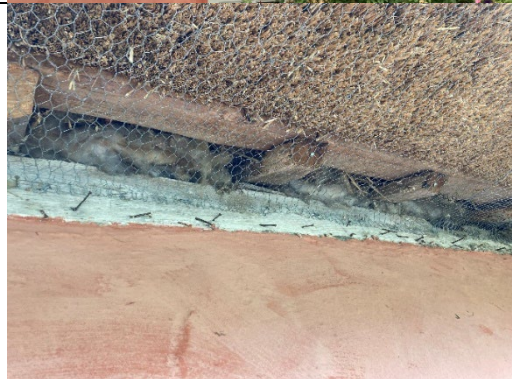
- 3.2.1. A two-storey building with rendered brick work and thatched roof. The external rendering was in good condition with no obvious crevices. The thatched roof was completely tight against the walls on all aspects of the building. Although small gaps were present in the straw, the nature of the thatching style meant that the gaps did not lead to anywhere or allow for internal access to the building. The roof is lined with fibreglass on the underside, providing unsuitable conditions for roosting bats.

*Underside of the thatched roof showing fiberglass lining blocking any potential crevices.*

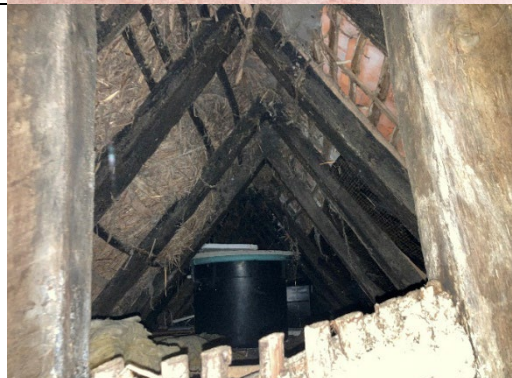
- 3.2.4. An internal inspection of the loft was completed, demonstrating the roof was supported by wooden beams, which may provide suitable roosting opportunities for bats. However, due to the thatched roof, no potential access points to the loft were identified, with no light gaps observed to indicate potential points. The remaining internal aspects comprised a used residential house, with plastered and painted walls with no PRFs observed, and no potential access points.

*Loft displaying brickwork and tight thatching.*

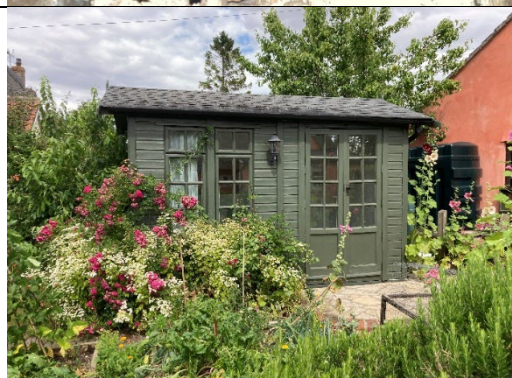
- 3.2.8. Wooden shed with a pitched roof, lined with roofing felt. No double layered materials were observed, to provide a suitable crevice or cavity. Whilst the extent of the building was well-sealed with no potential access points observed. As such, the building was assessed as having **negligible bat roosting potential**.

*Garden shed, all woodwork tight with no crevices.*

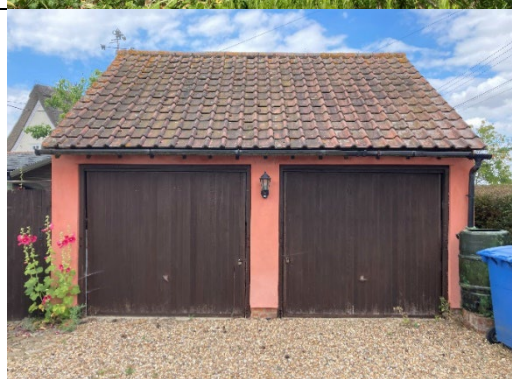
- 3.2.6. Two door garage comprising rendered walls and a pitched tile roof. The rendering was in good condition, with no PRFs observed, whilst the garage doors were tight to the walls, providing no access points. The roof was in good condition, with no missing or broken tiles, whilst all mortar was intact in relation to the walls and ridge tiles.
- 3.2.7. Based on the no potential access points being identified and no external PRFs, the building was assessed as having **negligible bat roosting potential**.

*Garage with good tile work and no cracks under the drainpipe or around the door.*

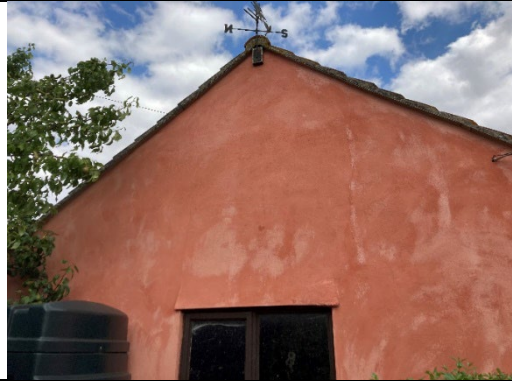
*Western aspect of the garage with a single window, tightly fitted to the building.*
