Proposed tree work
Related to
Gra-Mar Back Street South Clifton

Application Reference: - 22/01393/HOUSE

Arboriculture – Professional Tree Inspection (PTI)

24/07/2022

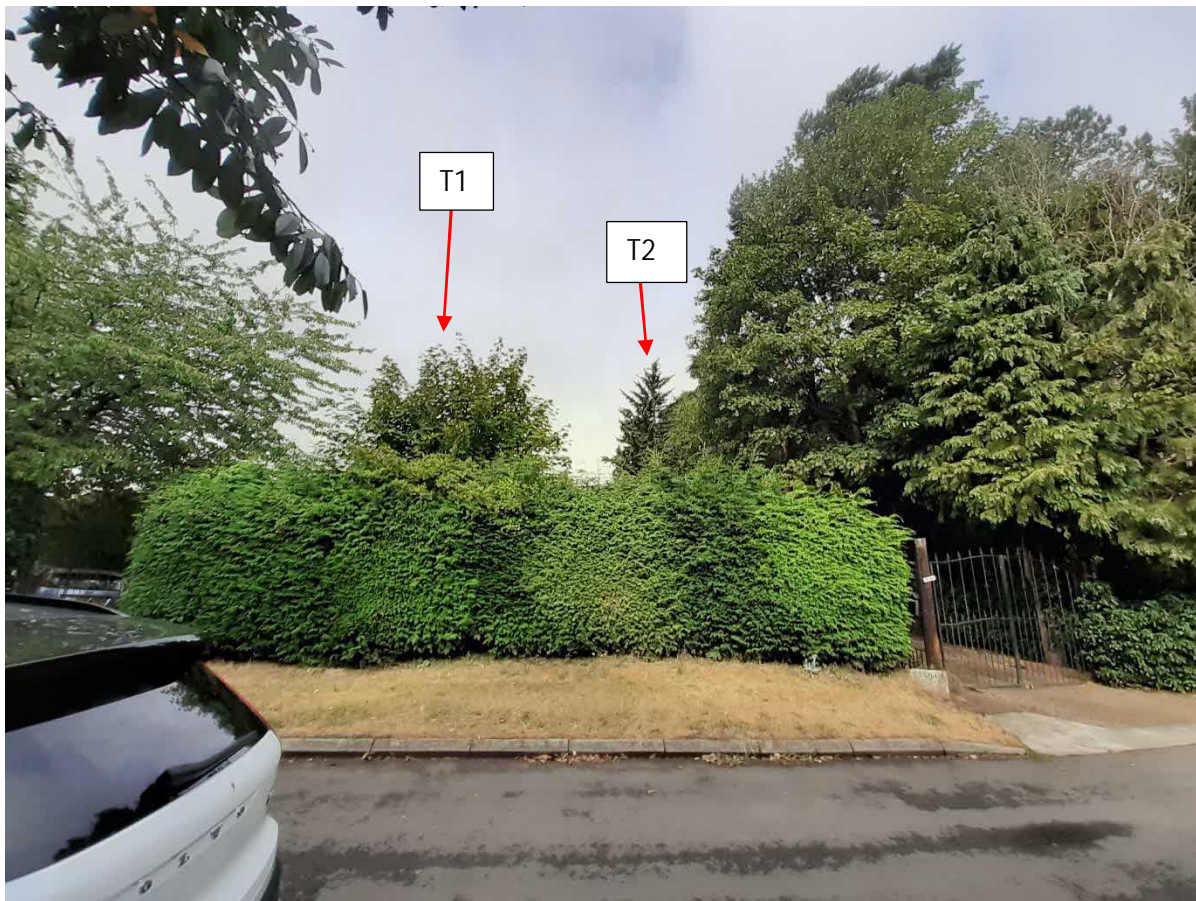
Photo 1

Visual amenity is often assessed using The Helliwell System, which takes in to consideration subjectivity and different opinions of those valuing trees and woodlands. The image below (Photo 1) illustrates the view from the public highway via Back Street. In my opinion the T1 and T2 have very low visual amenity and are much subservient to the adjacent more mature trees.

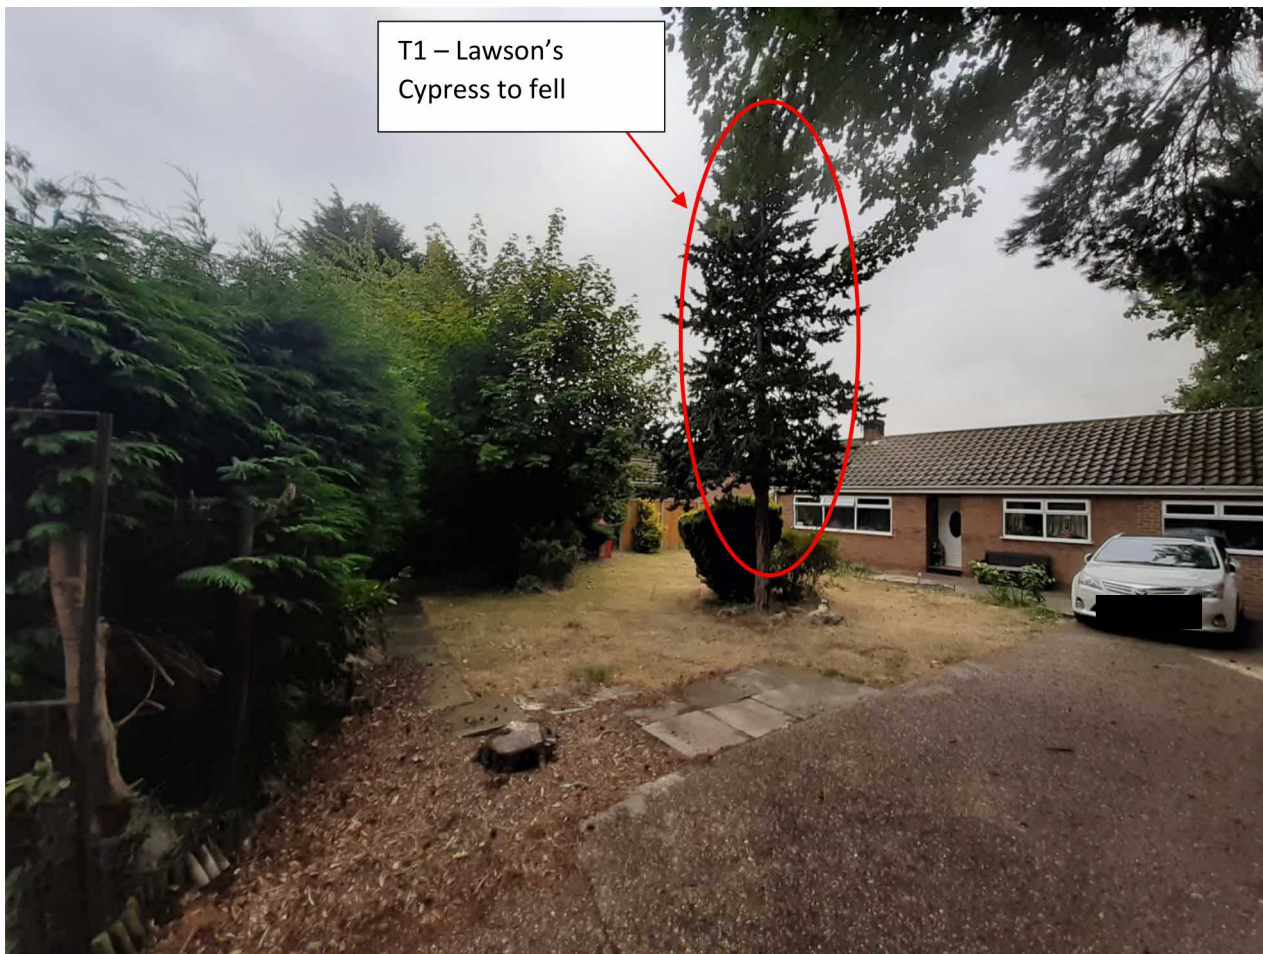
T1 – Fell

T1 – Lawson's Cypress is in normal good condition. However, wires (maybe old washing lines) have been tied around the stem causing bark inclusion, which could allow pathogens leading to decay/disease.

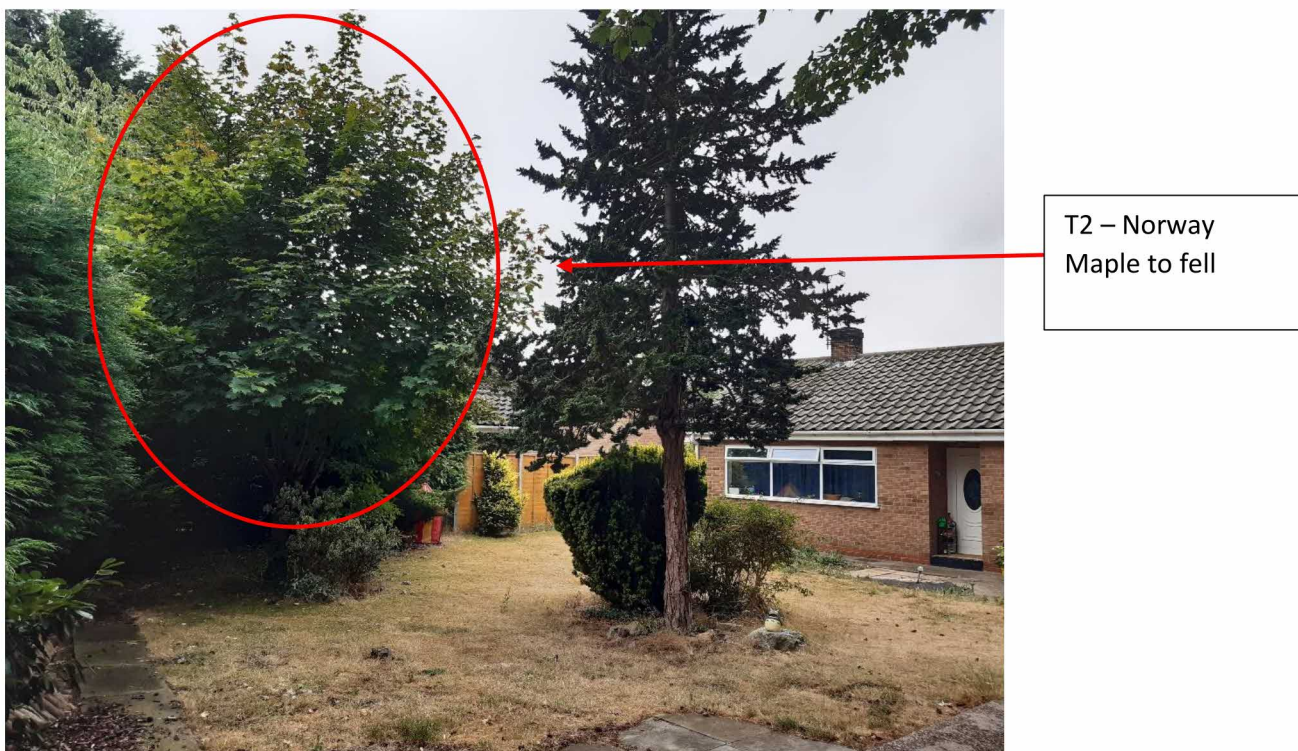
T2 – Fell

T2 – Norway Maple has been continuously, heavily pollarded in the past resulting in weak epicormic regrowth. These multi-stems are susceptible to shedding. The tree is in poor health and recommendation is to be felled.

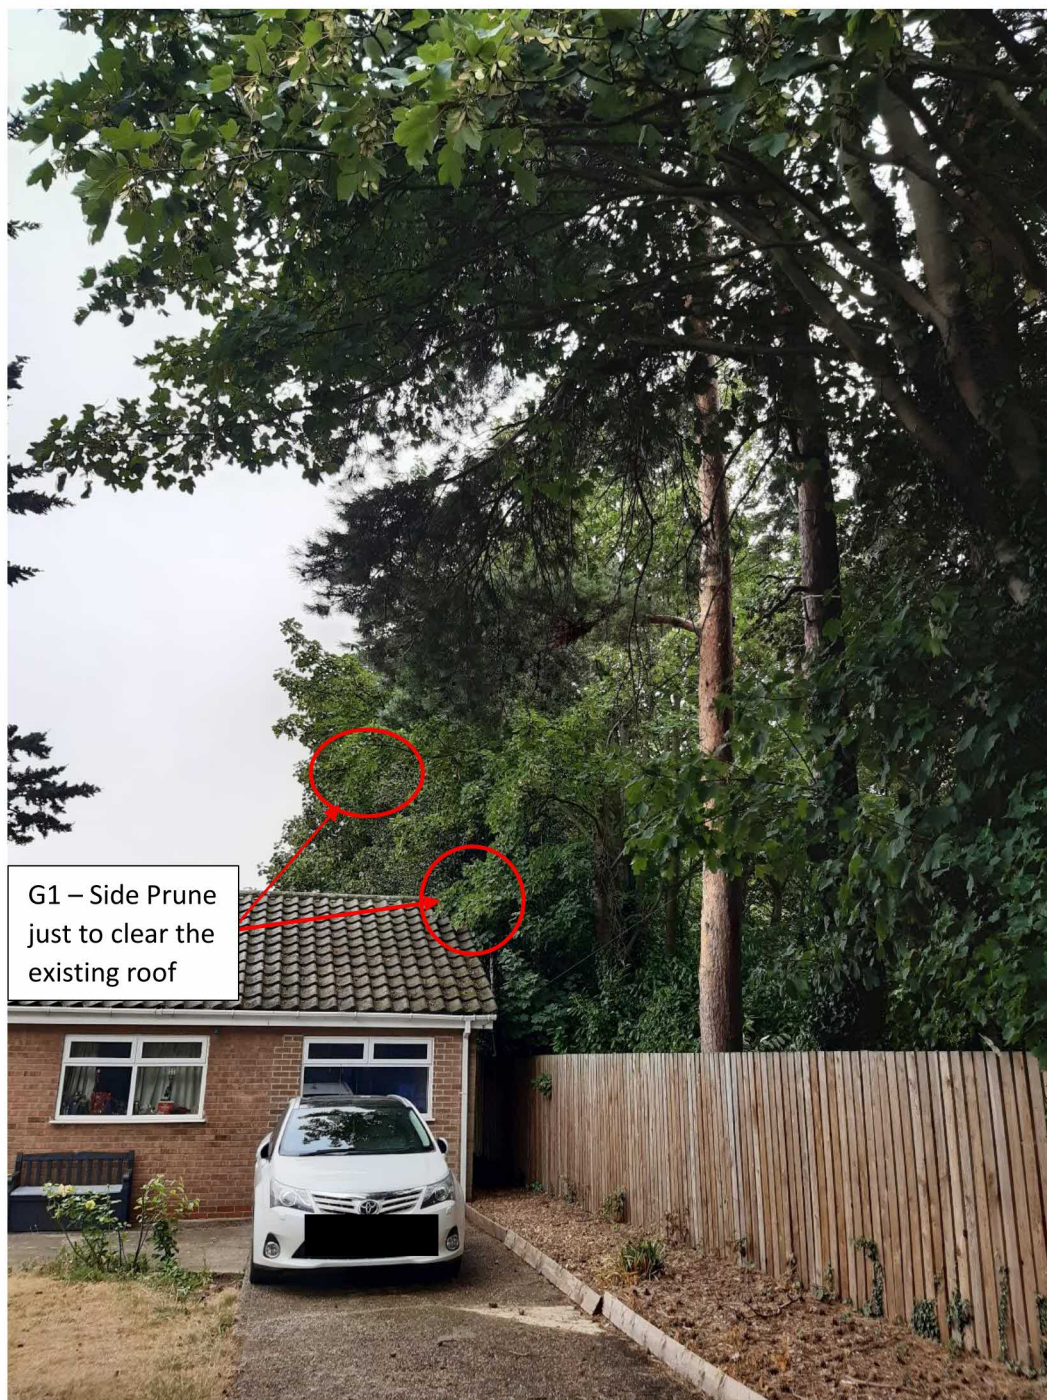
G1 – Minimal side pruning

G1 – Various species listed in the table above are in the neighbouring property overhanging this property. Lateral branches may need to be side pruned in order to gain easier access to the roof.

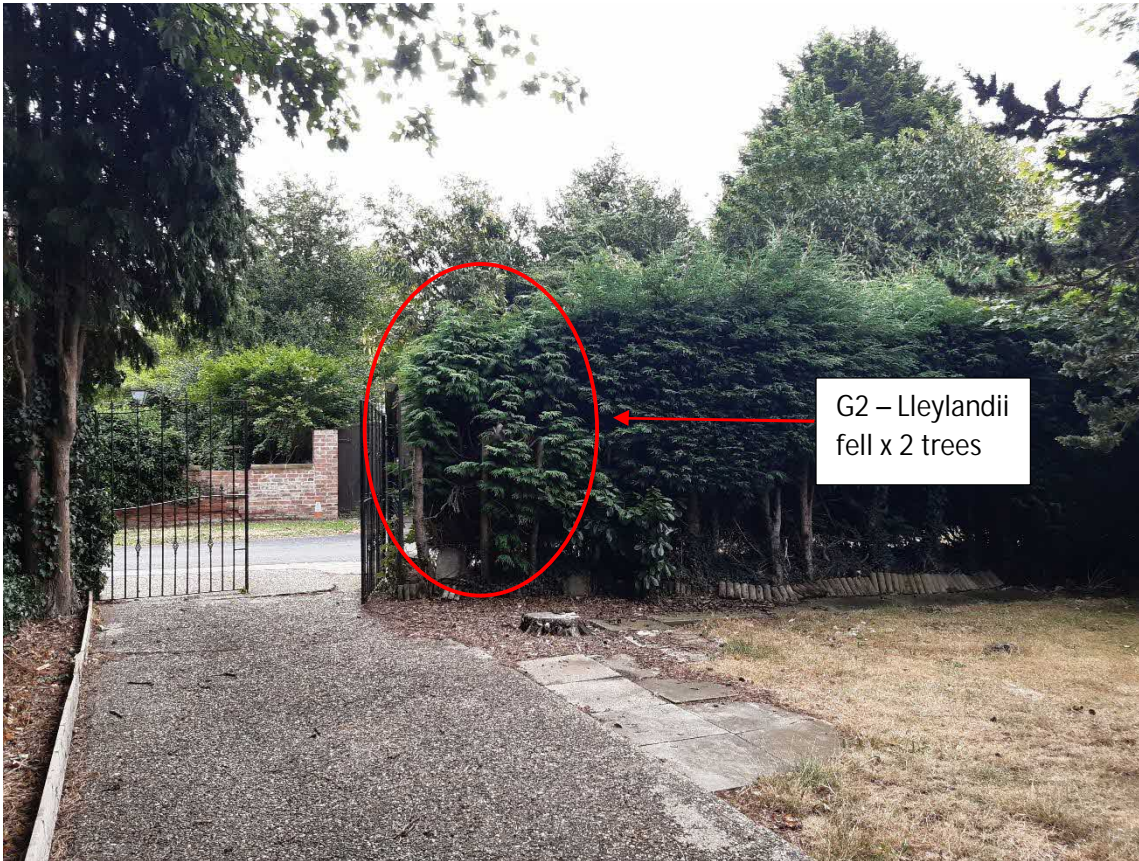
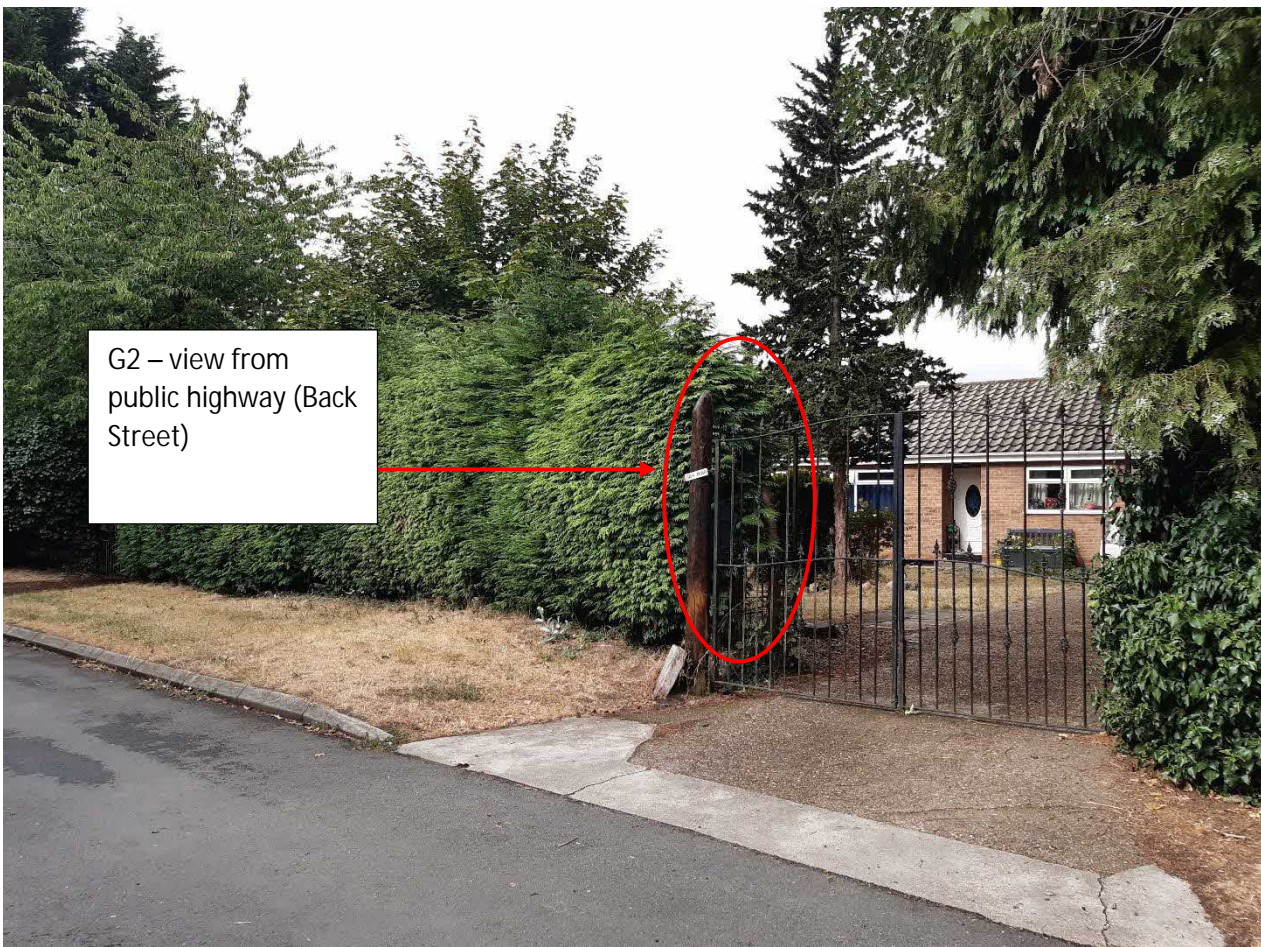
G2 – Fell

G2 – Leylandii hedge forms the front screen acting as privacy to the property from the public highway. Removal of 1 to 2 stems maybe required to widen the front access gate during the development and for future access for parking
