# Arboricultural Report

**Conversion of house into five flats  
17 Victoria Grove  
Stockport  
SK4 5BU**

22 June 2022

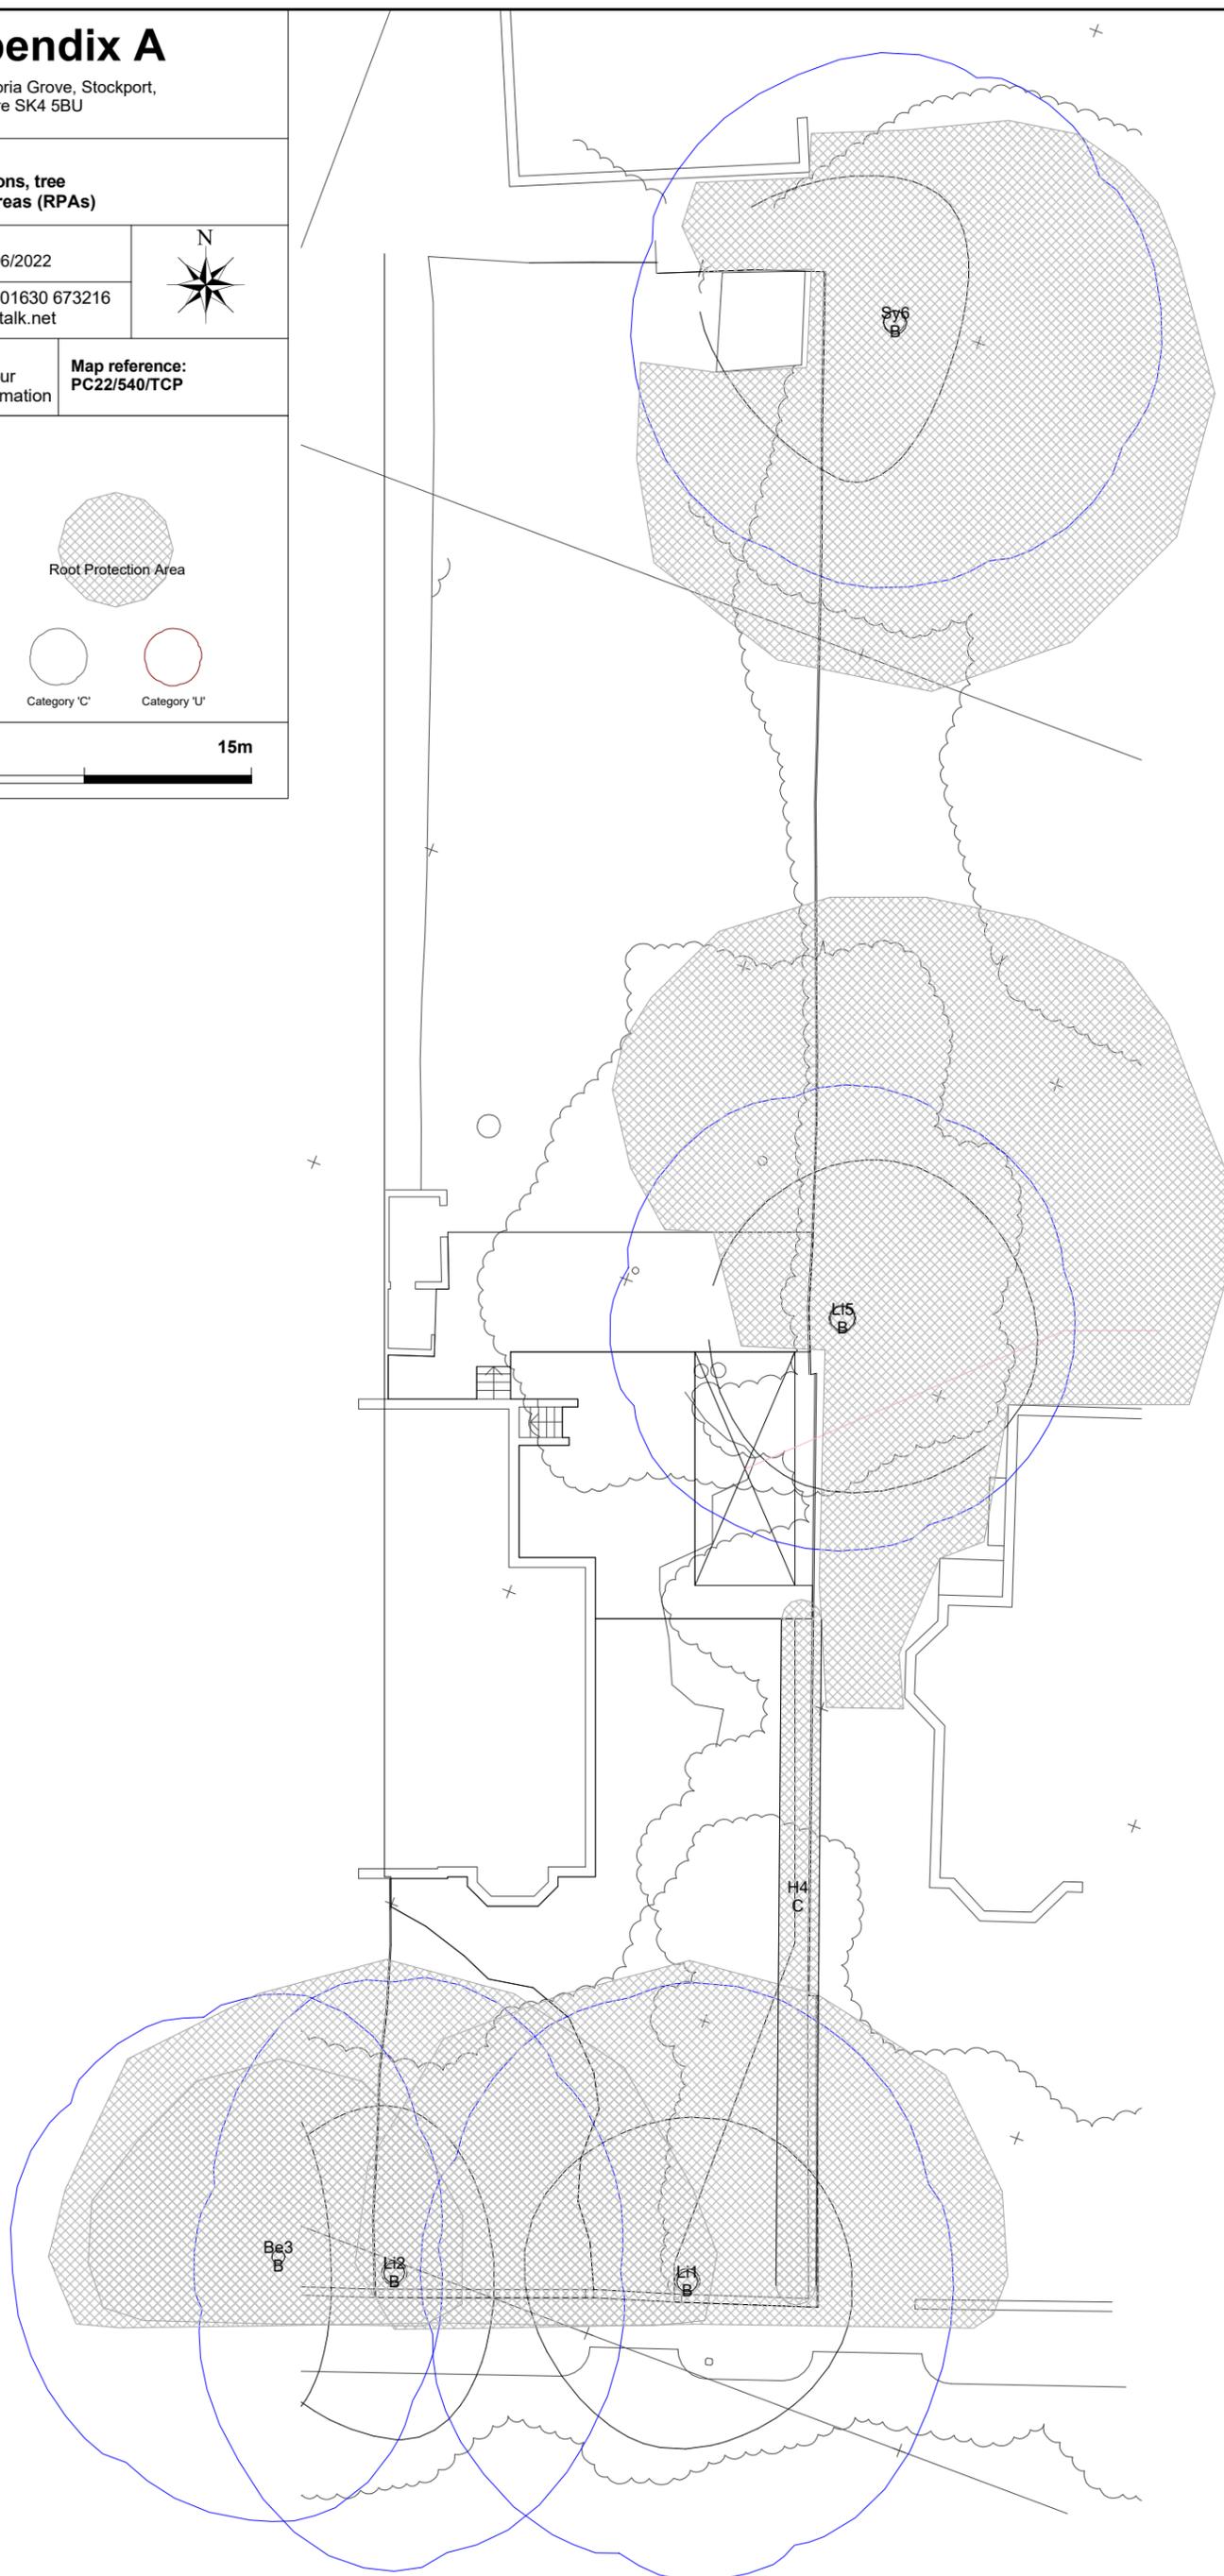
Map reference:  
PC22/540/TCP

**Tree Constraints Plan**  
Showing all trees, crown dimensions, tree  
categories and root protection areas (RPAs)

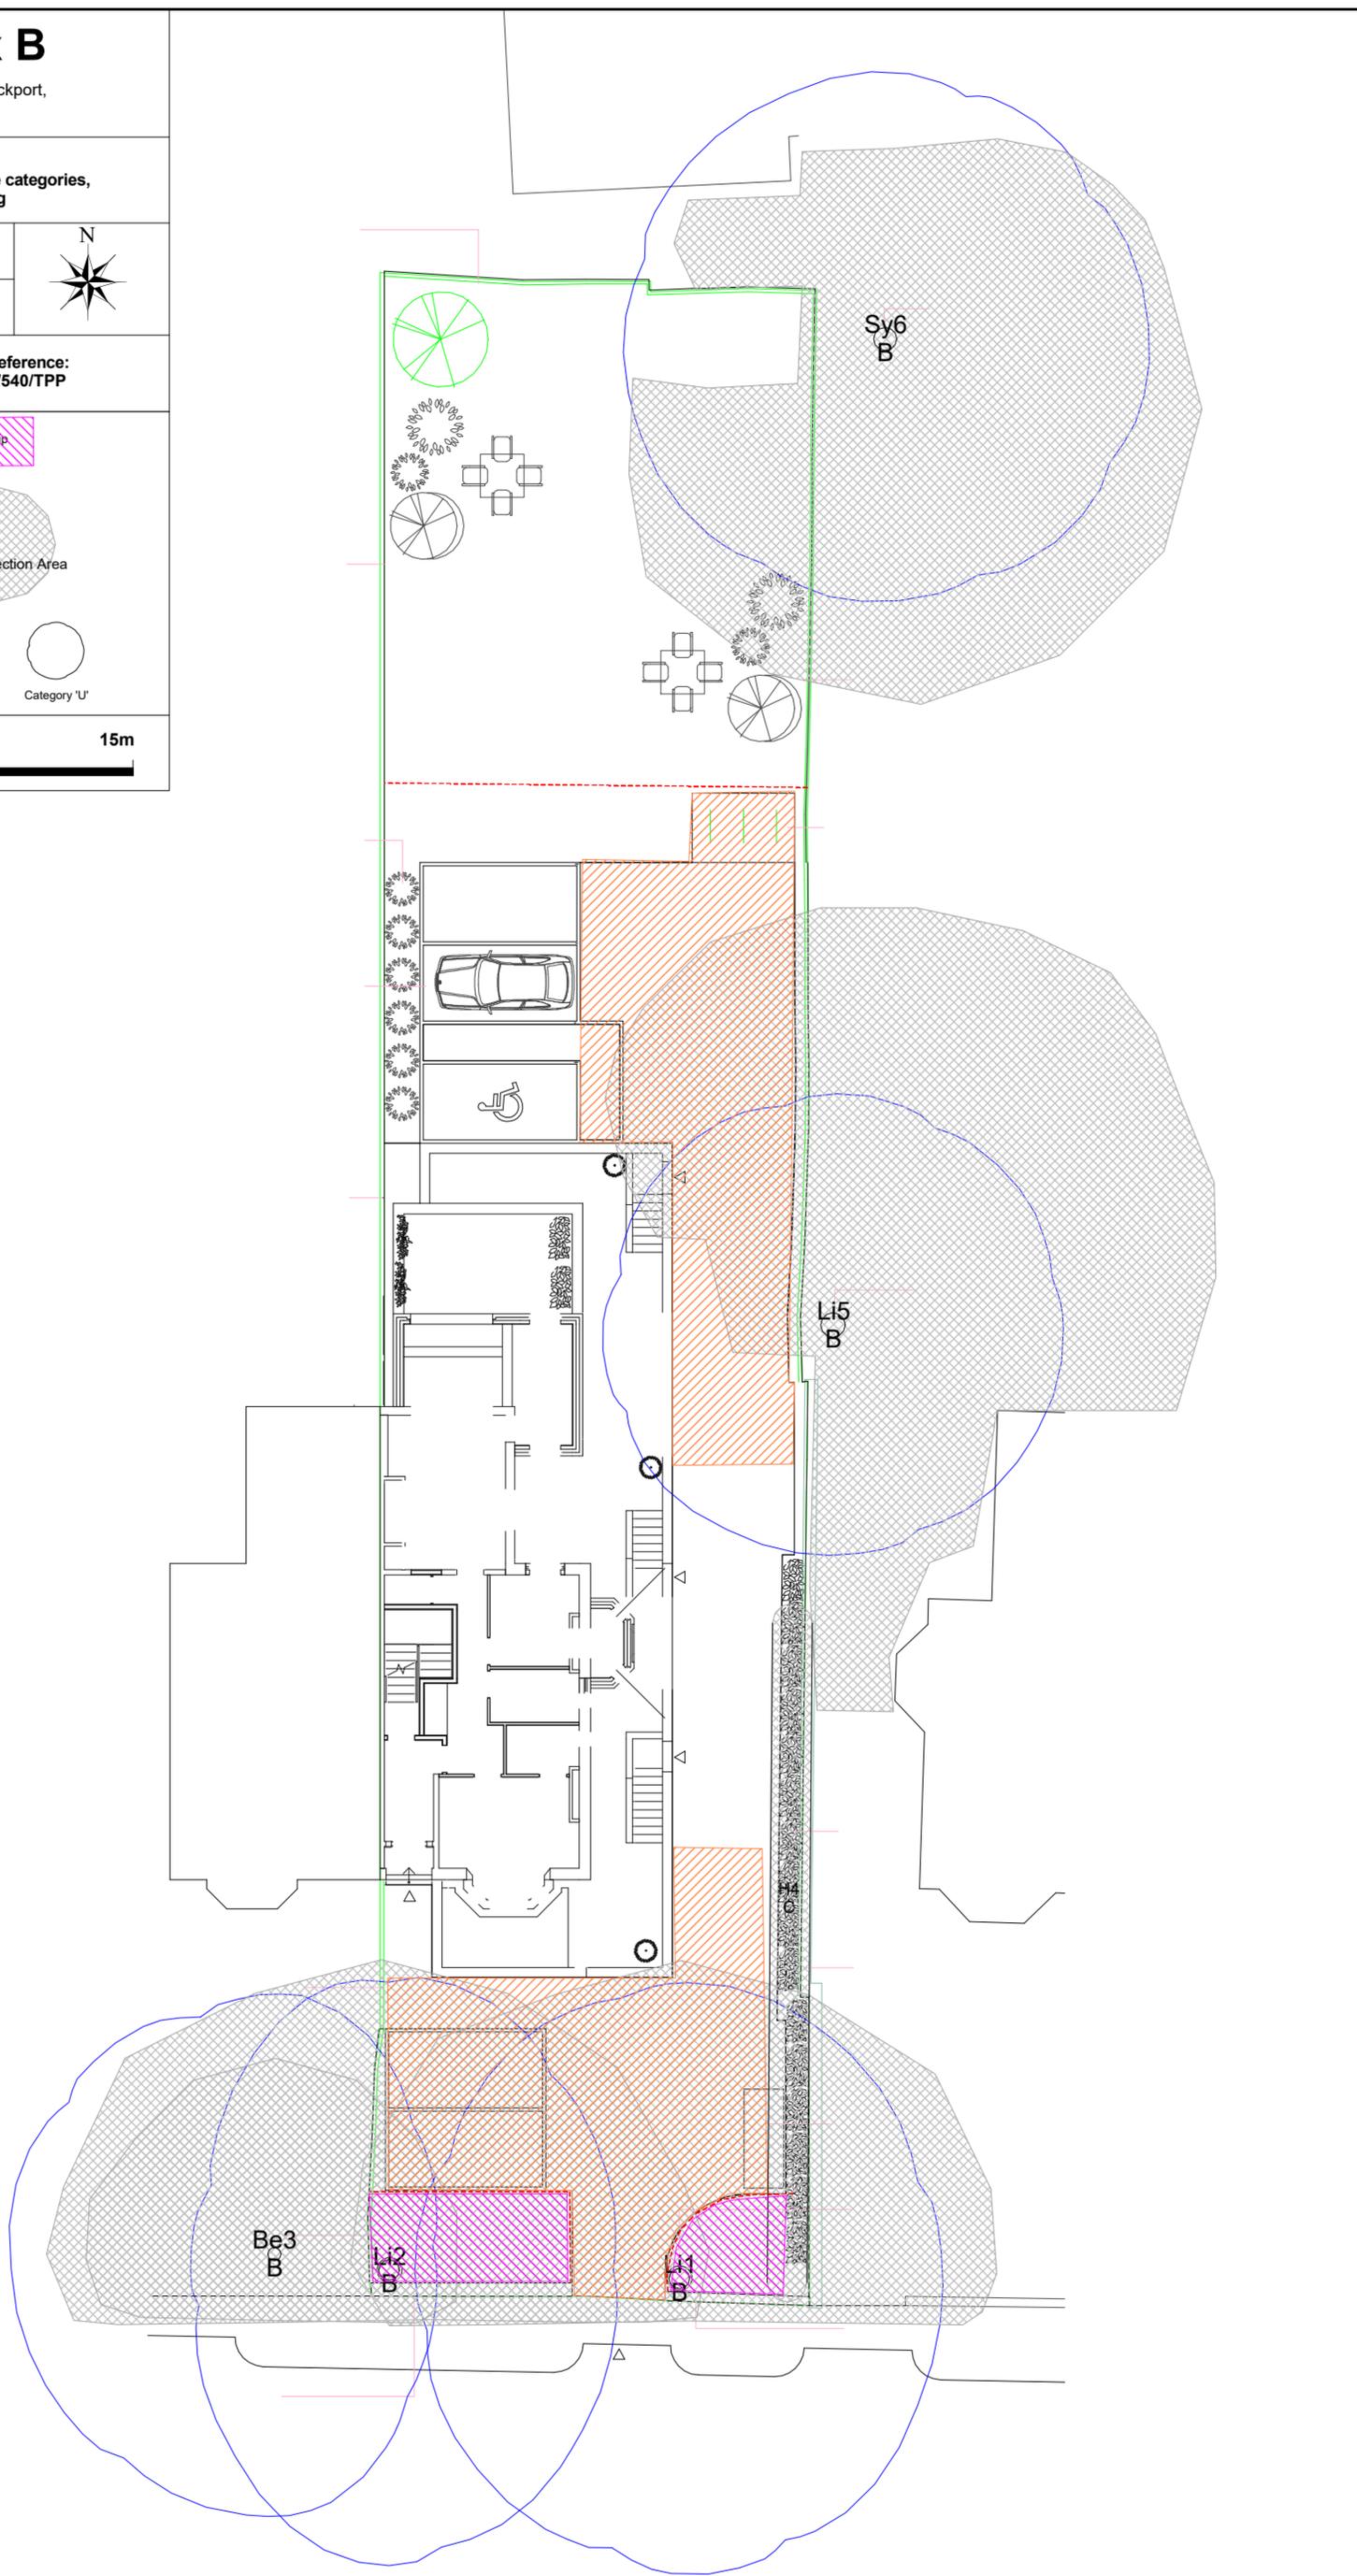
Map reference:  
**PC22/540/TPP**

**Tree Protection Plan**  
Showing all retained trees, crown dimensions, tree categories,  
RPAs, protective fencing and special engineering

- 8.5 Protective fencing similar to that shown in BS5837, shown in Appendix D, is to be used to protect RPAs from vehicular and foot access. The fencing is to be securely joined and attached to immovable objects to prevent it from being moved. Fencing should be firmly attached into the ground and will require tools to move it. The positioning of fencing is shown in appendix B.
