Design, Access and Heritage Statement

Chimney Repair

The Grange, Norwich Road

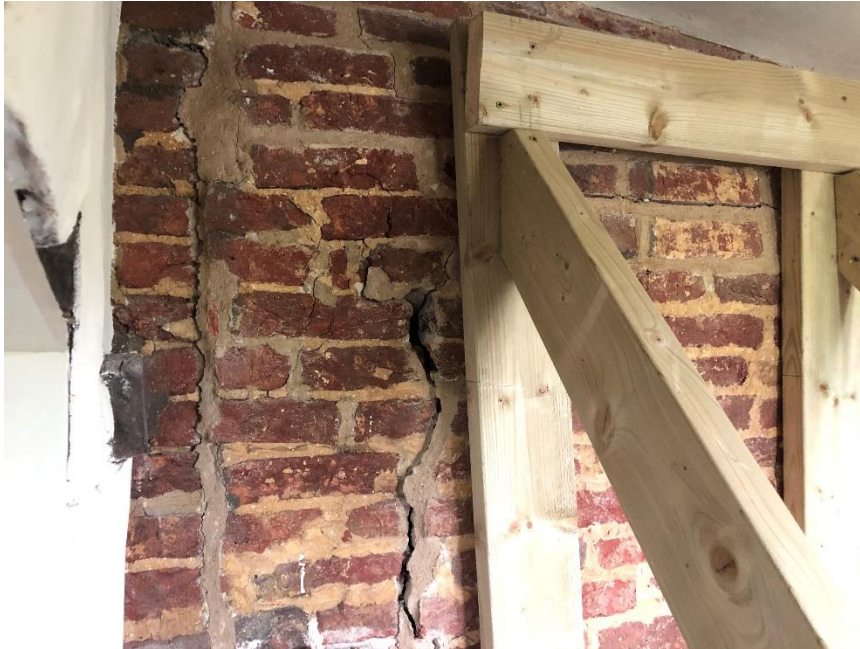
The chimney (and thus house) was in serious danger of collapse due to settlement, most likely caused by increased wet/dry weather (sitting on clay), exaggerated by water run off (from the tarmac road), traffic vibration (close to the road). There was no option but to carry out the works and all works were carried out in accordance with the structural engineers recommendations to prevent collapse.

This application is a follow on from the screw piling, underpinning application submitted in July 2022. These applications deal with an emergency repair that has been carried out to prevent the structural collapse of the chimney.

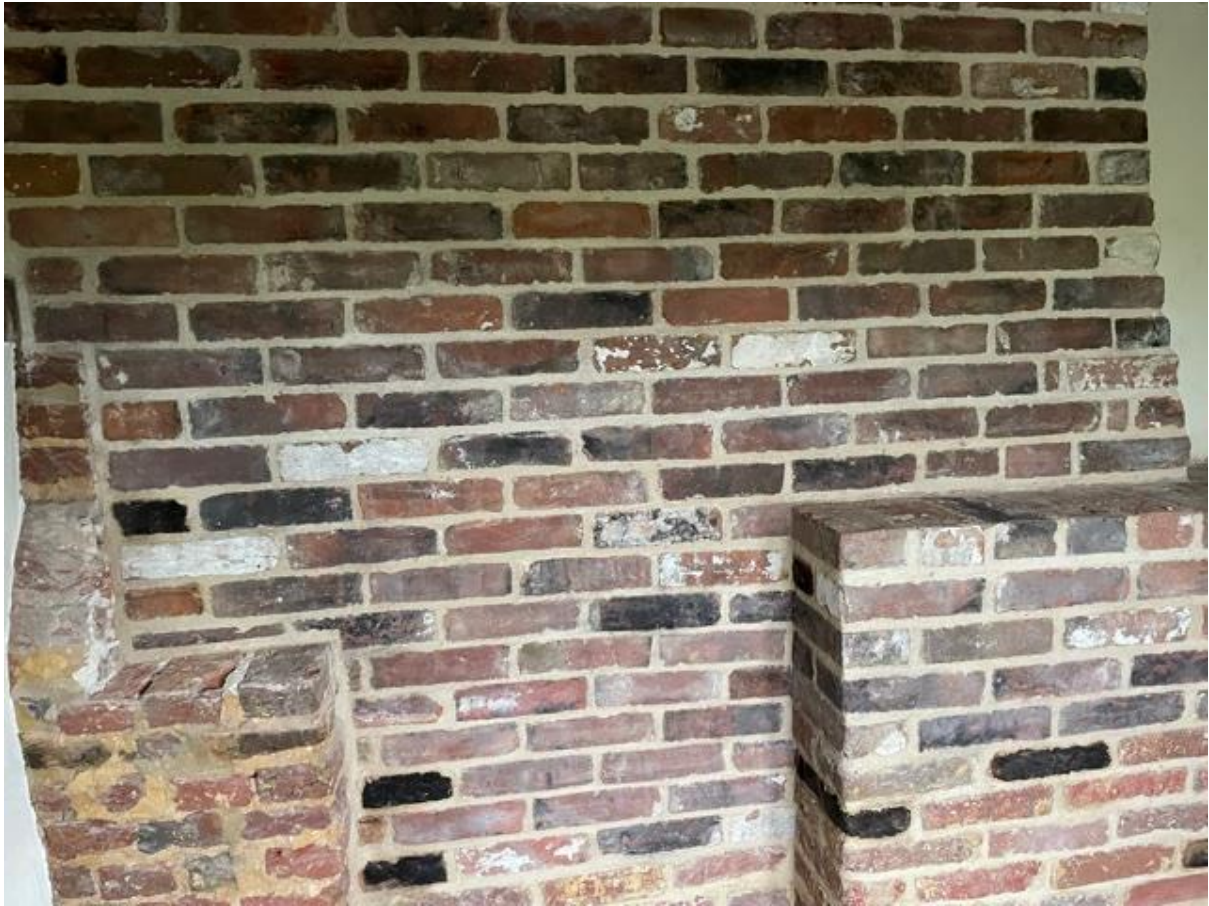
Note that the appearance (particularly noticeable on the left hand side pillar (the colour)) we have been advised is likely as a result of a previous owner covering the brick work with unibond.

The first floor bedroom wall has been rebuilt using inkeeping/period brickwork with bricks of the same size, sourced from a reclamation yard.
