1.0 Introduction

ST 20 SW STOCKLAND MILLHAYES
4/556
Higher Seavington Farm
House

Planning Support Statement - 14/0526/LBC

SUMMARY HISTORICAL DEVELOPMENT - 26/02/2014

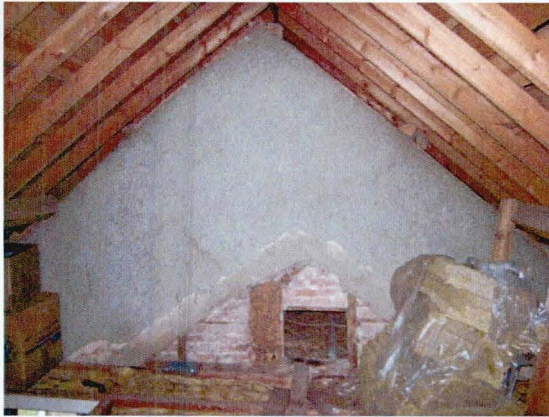
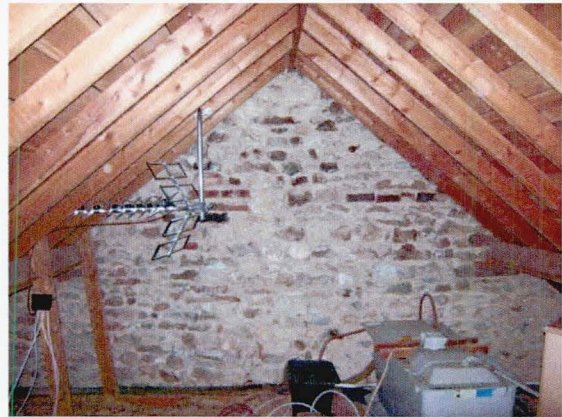
Above the line of the bedroom north-south wall is a brick nogged and pebble-dashed (rendered) truss, suggesting this was once an external wall. This coincides with a reduction in wall thickness of the main north and south walls of the house, all suggesting a possible different construction phase.

A triangular pattern of render absent from the lower part of this truss is suggestive of a low roof line, prior to reconstruction of the roof.

Above: Roofspace over main bedroom and bathroom, showing former external gable (?) and roof scar at low level, against brick-nogged king post truss

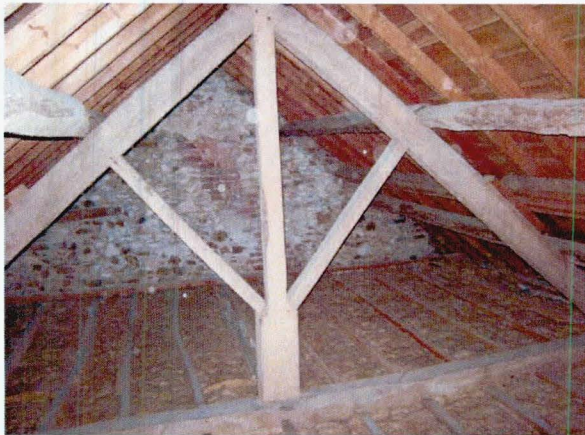
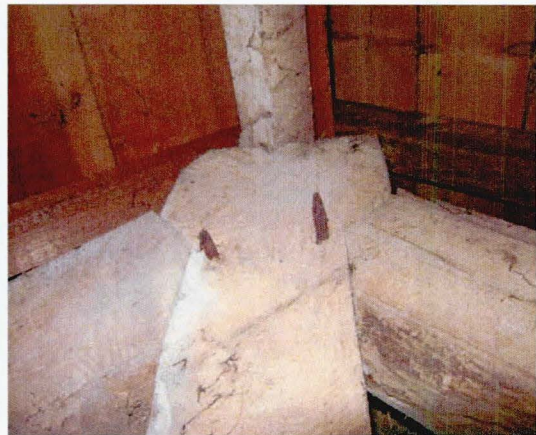
Brickwork within the east gable (roof space) shows a chimney flue is present; this runs diagonally away toward the south side of the house; a fireplace may have therefore existed within the garage area.

Above: the eastern roofspace, showing the C18/early C19 trusses and purlins. Note brickwork to far gable, evidence of a lost chimney and fireplace

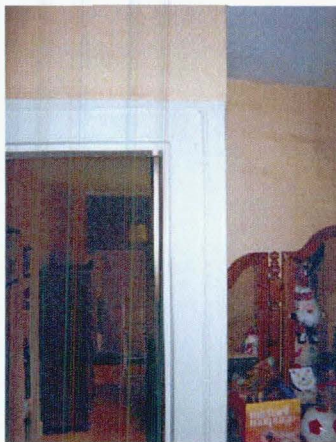
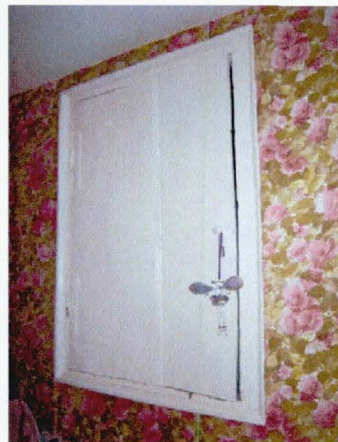
Left: C18 or early C19 joinery in the east end of the first floor. Note HL pattern hinges to cupboard.

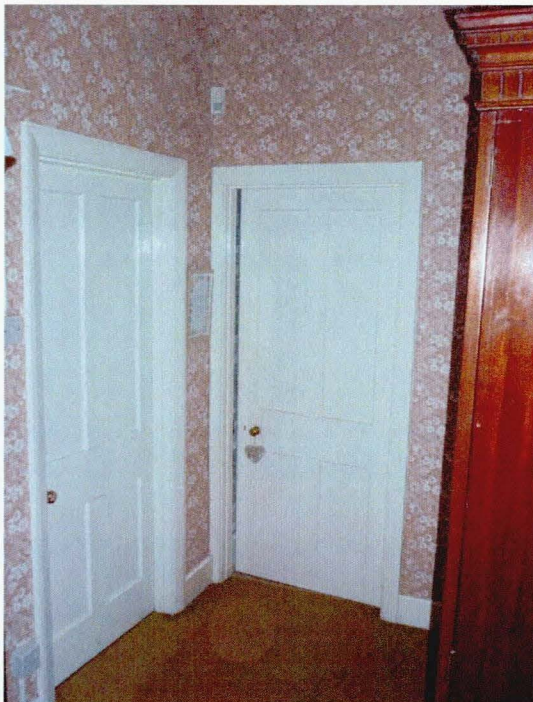
Left: the two 1920's doors, serving master bedroom and family bathroom, to the west end of the first floor.

Very high ceilings to this end of the house may suggest a lower roofline than that now present once existed.

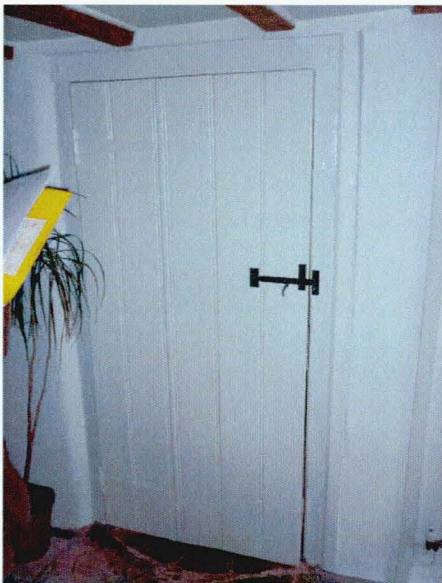
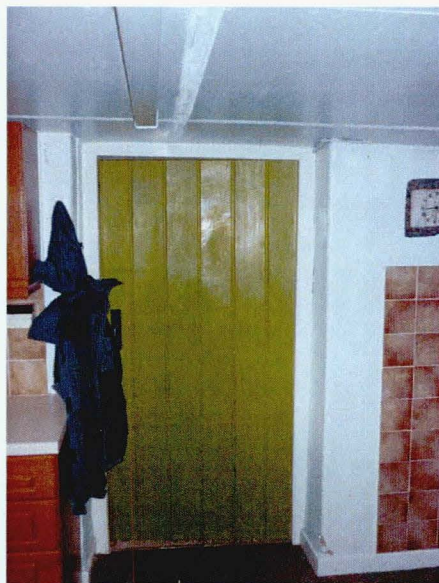
Below: C19 doors to dining room (left) and from kitchen (right)

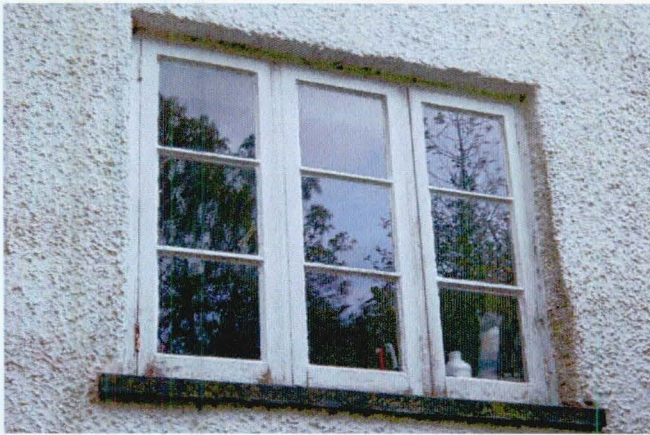
Left: 1920's window to family bathroom

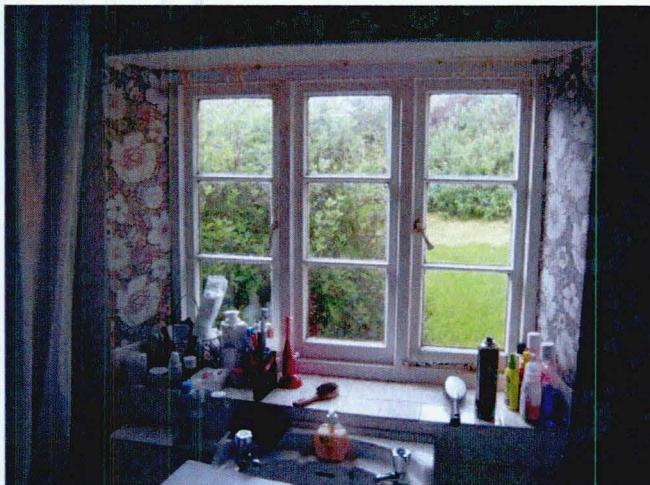
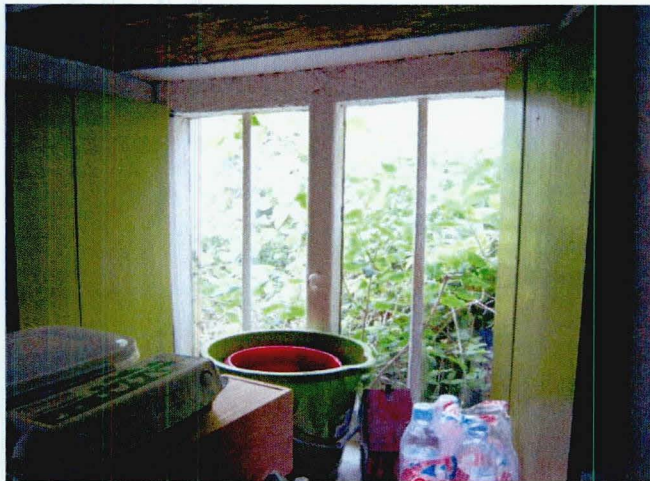
Below left: bathroom window: internal view

Left: C17 window to pantry, with C19 shutters. Iron bars may be original to the window.

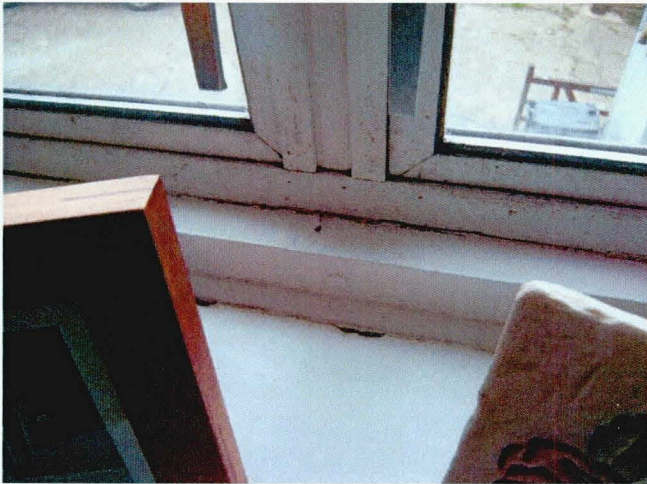
Detail of double glazing sub frame at first floor level. Note peg in timber by window board, evidence of mullion position in lost 1920's window.

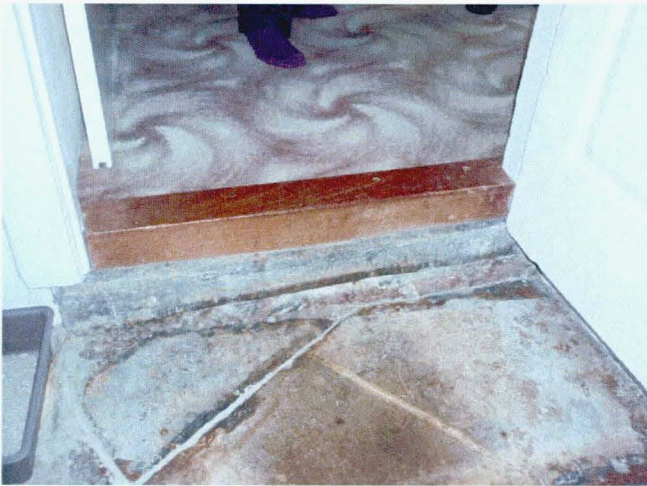
The presence of running water alongside the house, and associated dampness may have destroyed the lower flight, and may account for the concrete over-floor within the sitting room, now also covering part of the lower step of this flight.

Bottom Left: built up floor levels within sitting room. In foreground paving is possibly historic: checking substrate will prove age of finish. Note timber threshold in front of concrete over – floor. Under this the stone threshold of an earlier possibly C18 floor. Below this stone can be seen a possibly earlier floor level, which matches the brick finish of the sitting room hearth. Note doorcase rests on the threshold stone.

Older floor levels are evidenced by the stone threshold to the sitting room. Adjacent stone random paving may be historic; careful lifting of a couple of stones will quickly reveal whether they are laid on a lime/earth bed or on concrete.
