PROPERTY ADDRESS, LOCATION

July 2022
MS/6830

1.0 Introduction

This statement has been prepared in support of a Listed Building Application for repairs to 2 no. outbuildings at White House Farm. This is a retrospective application for works undertaken by the applicant in 2017.

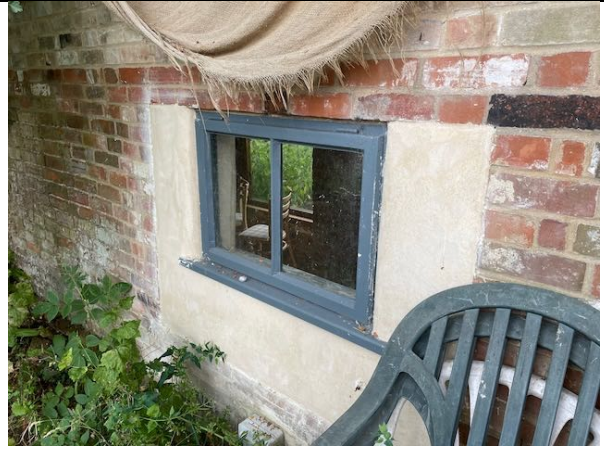
i

<p>North Wall – a clay lump section of the north wall around the window had collapsed, This was re built using the original clay lump laid in lime mortar with a lime render finish. The window was replaced in softwood to match the original design.</p>
		<p>North wall – The upper section of the wall had collapsed following the storm and has been re built in re claimed bricks</p>
		<p>Roof – This had collapsed following storm damage and the rafters were decayed. New oak rafters were installed. The corrugated iron roof covering was disposed of and a Double roman clay tile roof re instated with a mix of the original tiles found within the building made up with re claimed tiles to match.</p>
