DESIGN STATEMENT INCORPORATING ASSESSMENT OF  
SIGNIFICANCE

FOR  
REPLACEMENT WINDOWS AND REDUCTION OF CHIMNEY HEIGHT

AT  
CRAMMER BARTON, BROADHEMBURY, HONITON. EX14 3LN

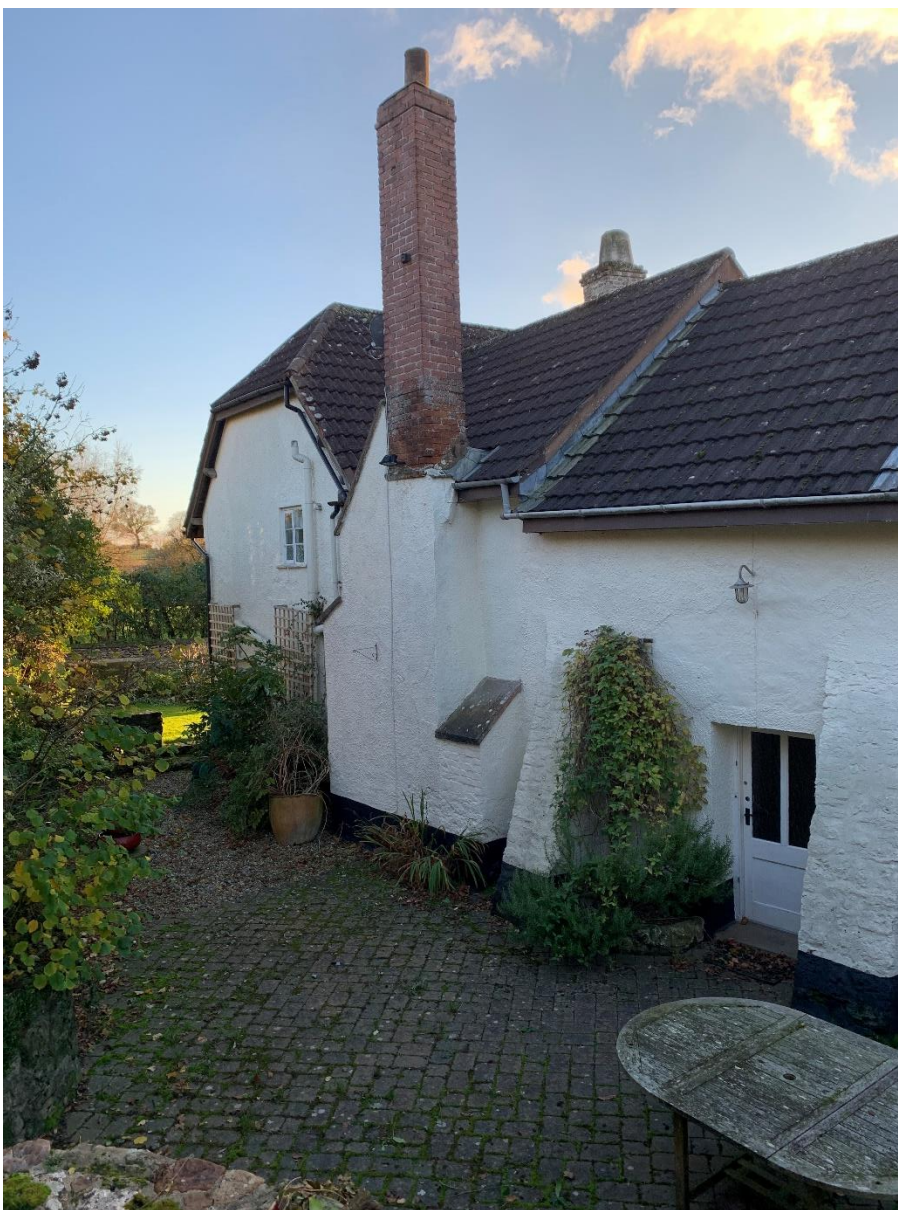
Figure 1: chimney to be reduced in height

- **Reduction in height of damaged Chimney** In the dining room a 1950's fireplace conceals an earlier fireplace. The 1950's fireplace has been sealed-off for many years and has suffered from water ingress. The chimney, which stands at ~3500mm above pitched roof height, (shown in figure 1 below) has been confirmed by experienced builders as being an unsafe structure and is highly likely to collapse under a high-wind load. It is proposed that the chimney stack height is reduced to the height shown in the below picture, the chimney is sealed at the top with a concrete plinth and the chimney pot reset. Given the dimensions of the chimney (470mm x 690mm) it would not be possible to rebuild the chimney safely using existing materials, hence the proposal to reduce the overall height.

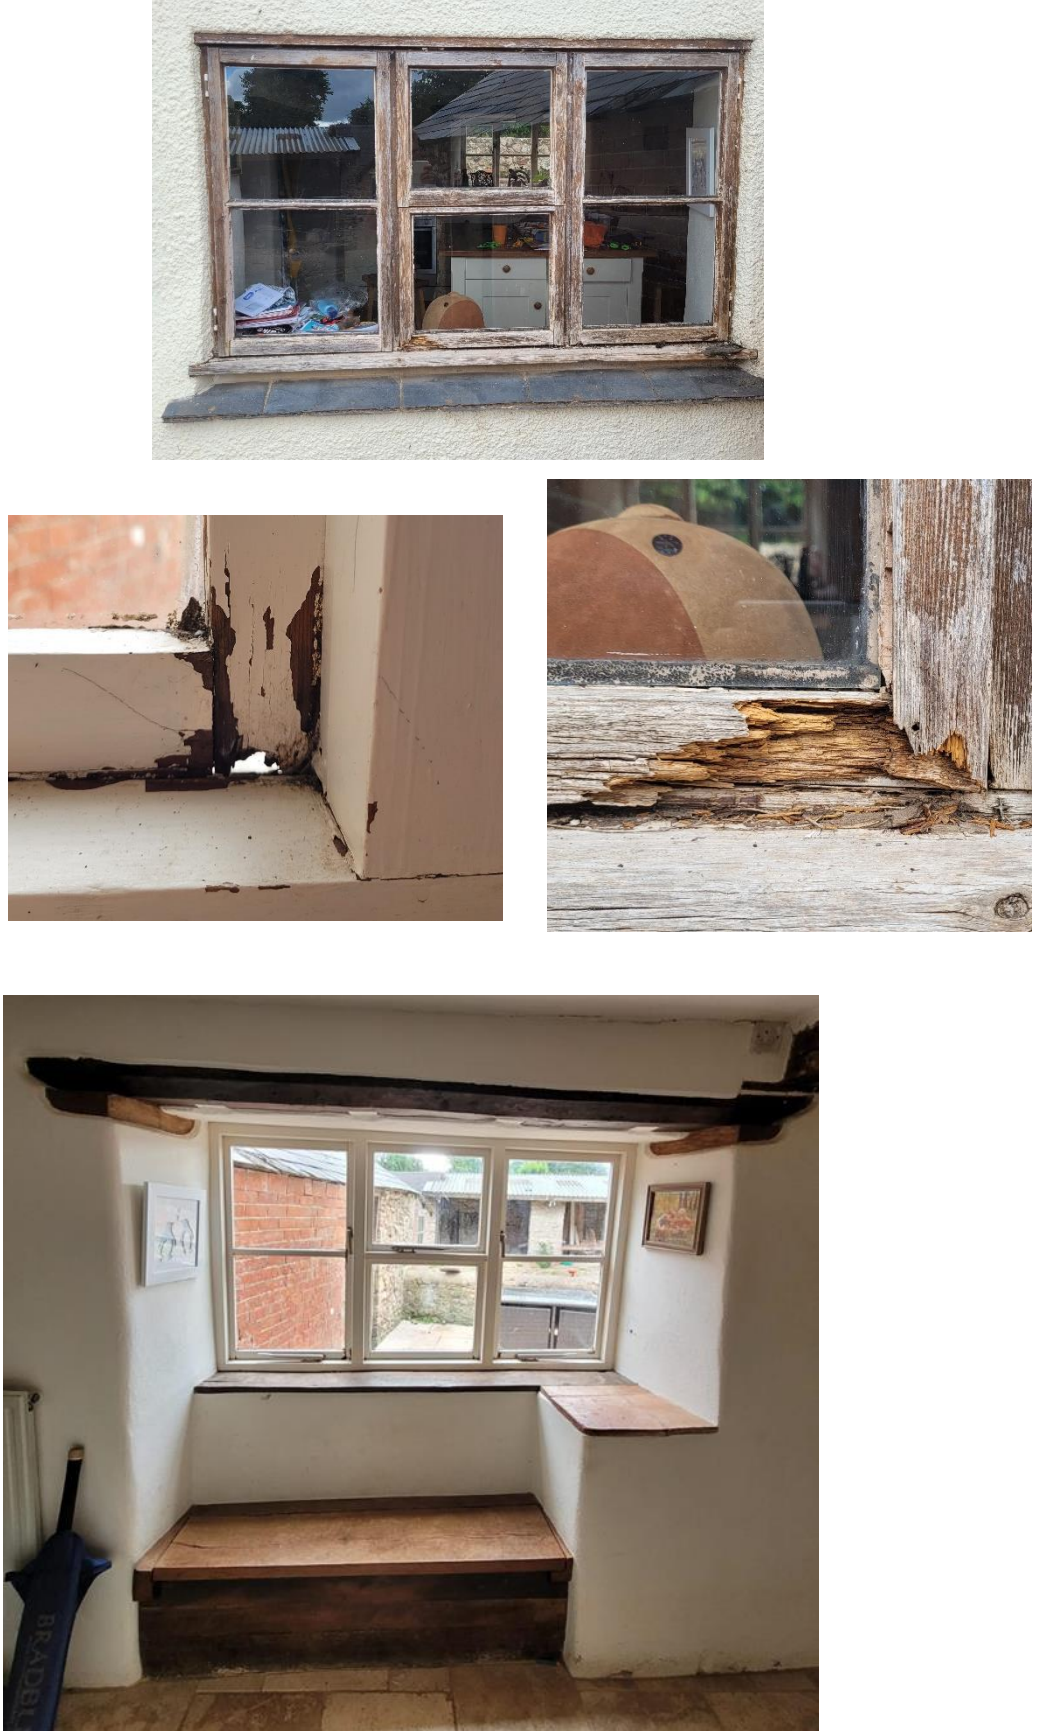
- **Replacing Kitchen Casement with Hardwood Double Doors:** the westerly facing kitchen Window (Window A schedule 1) is set on what is believed to be plastered early C20 single brick as well as a small section of thicker cob. The current casement is in a dismal state with a large finger sized hole in the frame. To improve the natural light and thermal efficiency of the kitchen the wall below the window shall be removed as well as the integrated bench and replaced with hardwood double doors with a consistent design to the replacement windows. No structural changes are required.

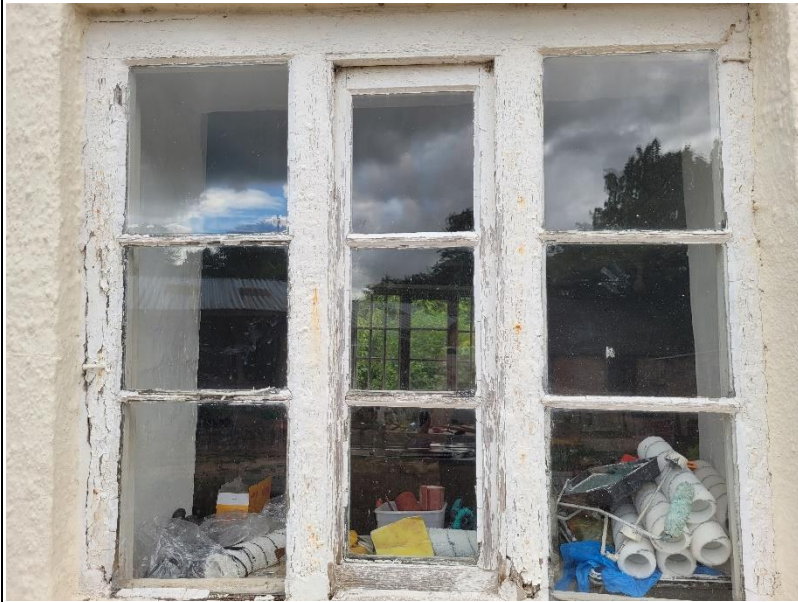
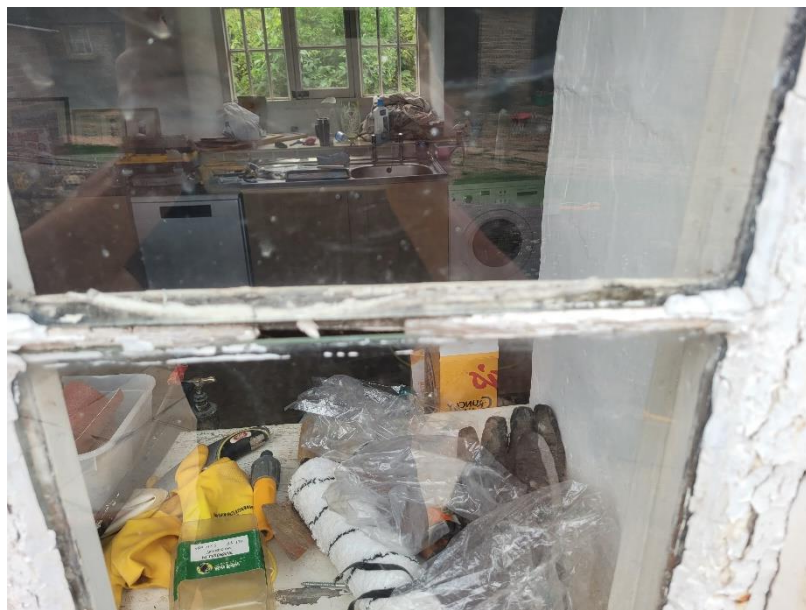
B

- **Window replacement (Wood Casements) | Type 1 & 2:** the casement windows throughout the property are in poor condition with extensive rot damage to frames (see examples in Schedule 1). The current windows provide little to no thermal efficiency and unhealthy levels of water ingress – several with missing sections to frames. The units are beyond repair and/or repair is not cost effective. It is proposed these casements are replaced with locally made handcrafted hardwood casement windows with slim-line doubleglazed units (alike in design to the current older casements). Where applicable the hardware will be black painted, metal, monkey tail, stays and latches that match that of the existing replacements windows.

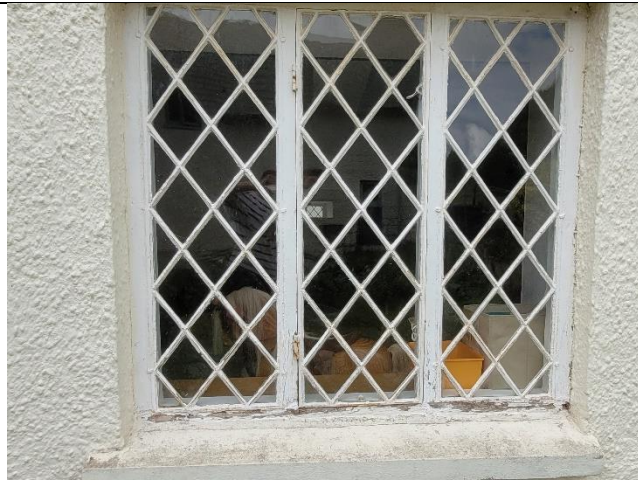
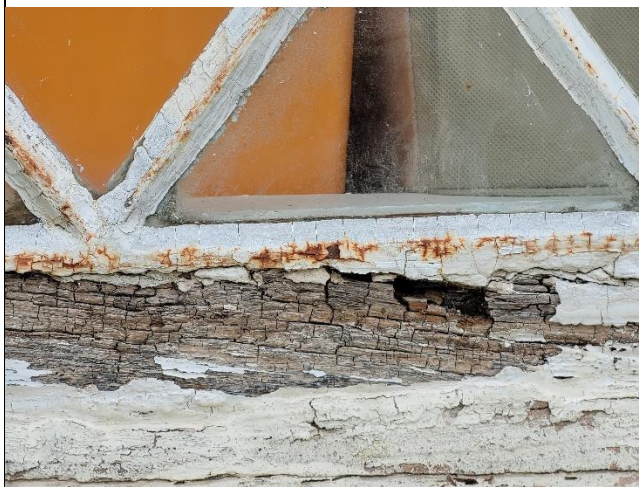
- **Window replacement (Iron Diamond Casements):** as outlined in the listing description above, there are 3 south facing C19 diamond paned windows. The casements are in general poor condition, with extensive rot, broken hinges, and many cracked panes (see Window E in schedule 1 as an example). After speaking with both a local ironmonger as well as a local joiner it was evident the cost of replacement with a like-for-like replacement would be unattainable. In consideration of this, and the desire to achieve greater thermal efficiency, the owners are

seeking to replace with the same design as the Hardwood Casement windows, creating consistency in design throughout the property.
