Full Bat Survey Report

Orchard Cottage

Radnage Common Road
Radnage
High Wycombe
Buckinghamshire
HP14 4DH

Dr Stacey Dawn Waring
21-024-FBSR
March 2022

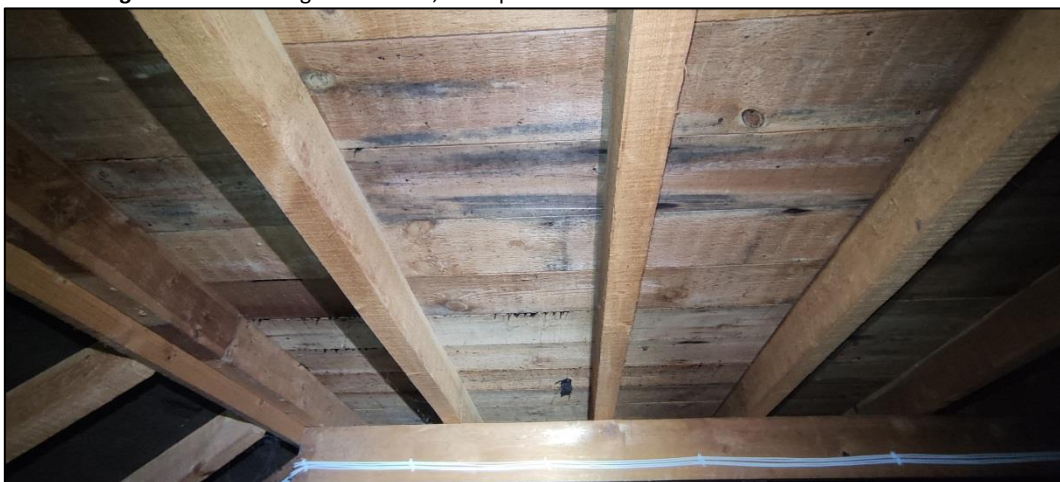
Figure 16 – showing underside of the flat roof section with sarking boards and pitch sealant

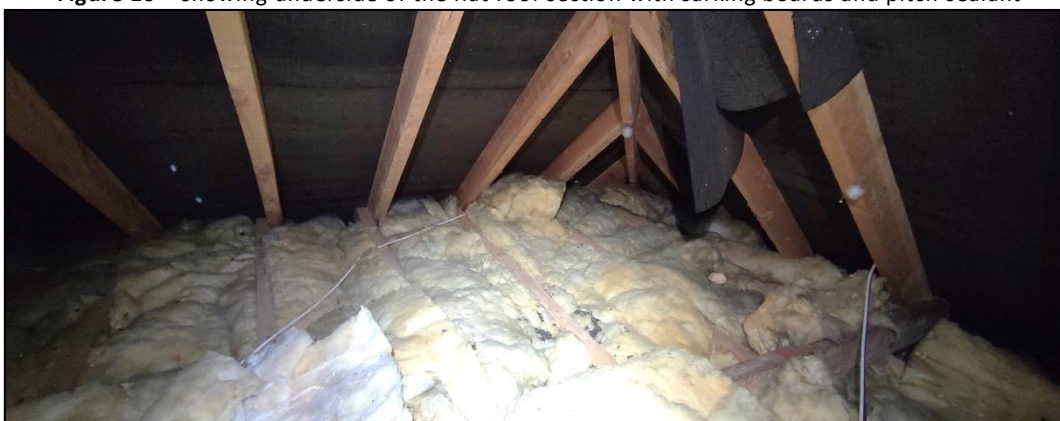
The modern timber rafters and trusses were in good condition, with no gaps or joints that could be utilised by bats (Figures 14 and 15). The underlay beneath the primary roof covering (Figures 15 and 17) consisted of a Type 1F bitumen felt, which was in fair condition. However, there were some areas where the overlaps were sagging (Figure 17) and light could be seen entering around parts of the eaves.

Figure 17 – showing sagging areas of bitumen felt underlay

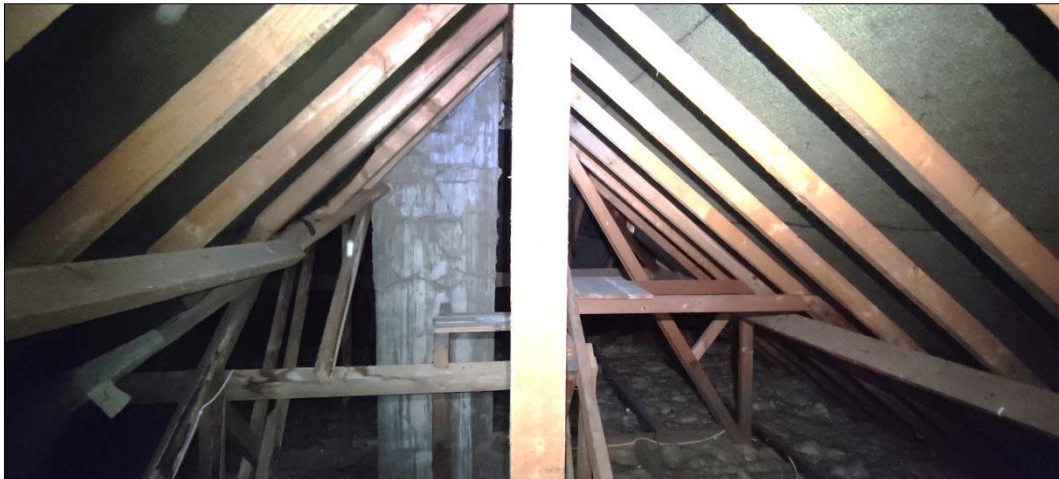
Continuing through the roof, the second section was approximately 2m high at the ridge (Figure 20). The chimney in this section had been rendered; however, this was in poor condition with the render peeling in many areas (Figure 21). There were also signs of water ingress suggestions gaps around where the chimney passed through the roof.

Figure 20 – showing one of the extended sections with rendered chimney in poor condition

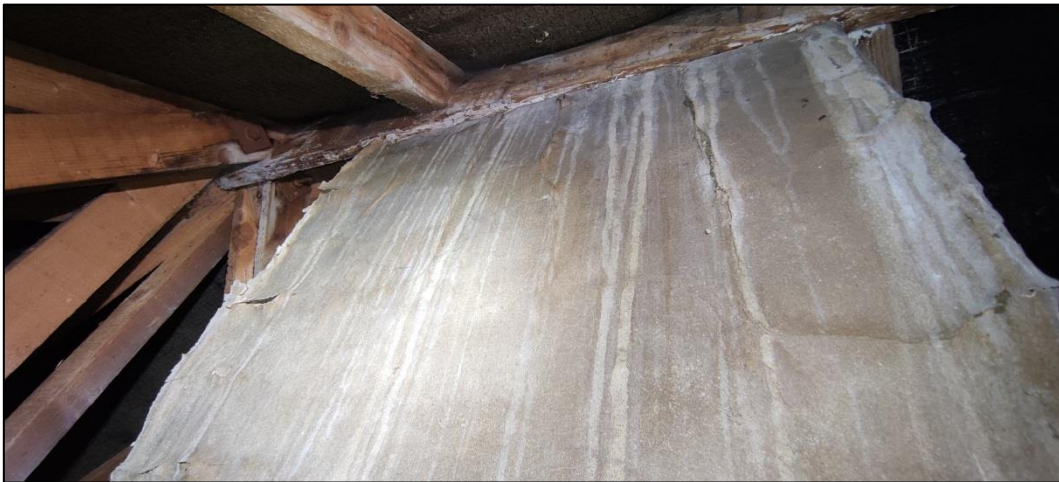
Figure 21 – Close up of flaking render on chimney stack and signs of water damage

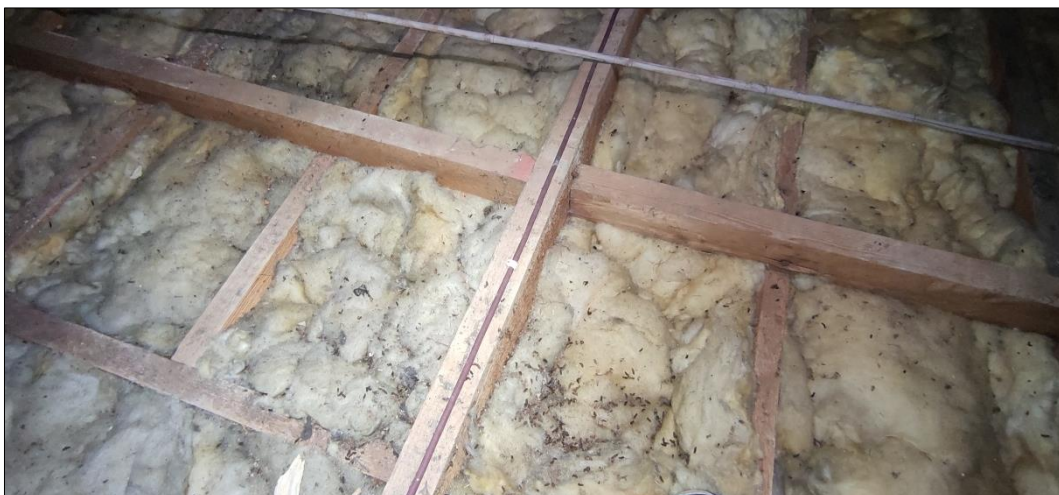
Scattered droppings consistent in size and shape with brown long-eared bat were observed across all sections of void 2 (Figures 24 and 25), with some areas of concentrated droppings under the ridge board (>100 droppings in total). Whilst no heavy concentrations were found to suggest large numbers of bats, the appearance of the droppings found (estimated age and deposition), would suggest that low numbers of bats have been using the property for a prolonged period of time.

Figure 24 – scattered bat droppings throughout roof void 2

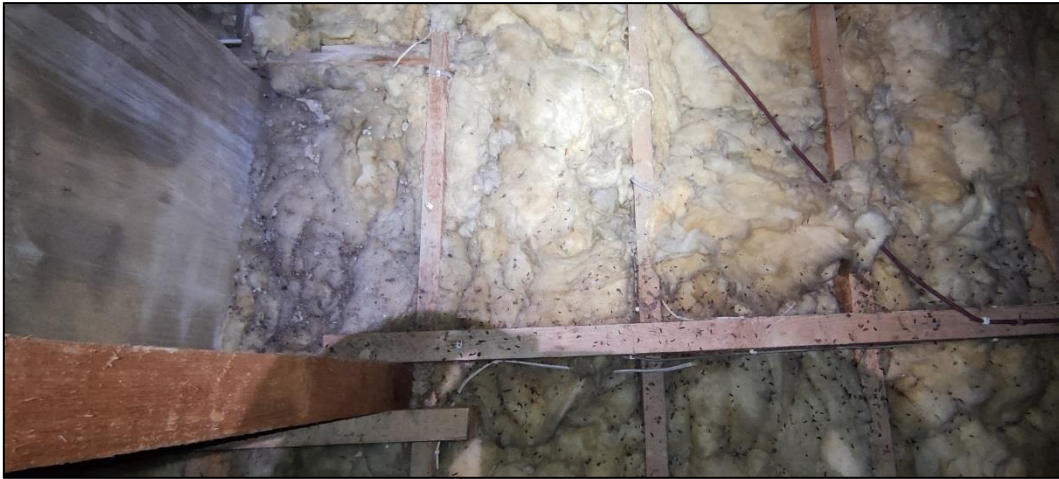
Figure 25 – more concentrated area of bat droppings close to a chimney stack

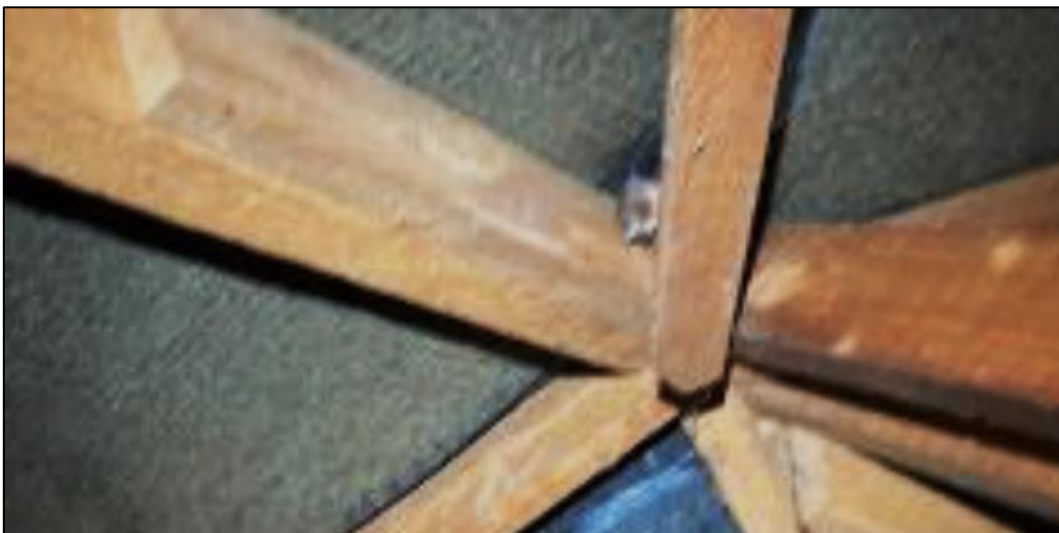
A single brown long-eared bat was observed roosting at the far western end of void 2 (Figure 26), where the rafters and hip beams meet the ridge board. During the preliminary roost assessment by Bernwood Ecology, this bat was determined to be an adult male in breeding condition.

Figure 26 – brown long-eared bat roosting at a hipped section of roof trusses

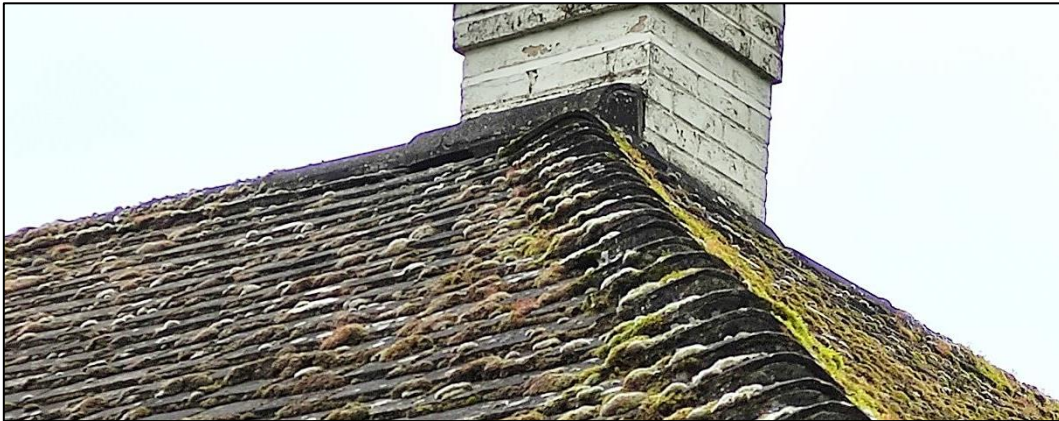
The ridge consisted of half round tiles (Figures 27 and 28) which were all present, although the mortar along the ridges was missing in several areas (Figure 29), which could provide bats access to both the internal roof voids. The chimneys were in good condition with no visible gaps in the brick-work or mortar that could be utilised by bats. The lead flashing around the bases of the chimneys was in good condition although lifted in some areas (Figure 30).

Figure 29 – image showing missing mortar and gap between ridge and chimney

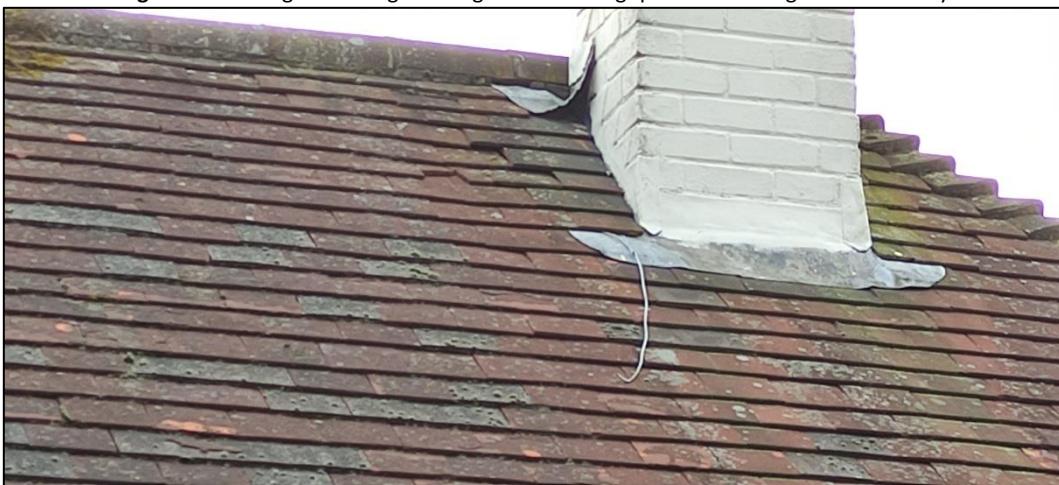
Figure 30 – image showing lifted tiles and lead flashing missing around chimney stack

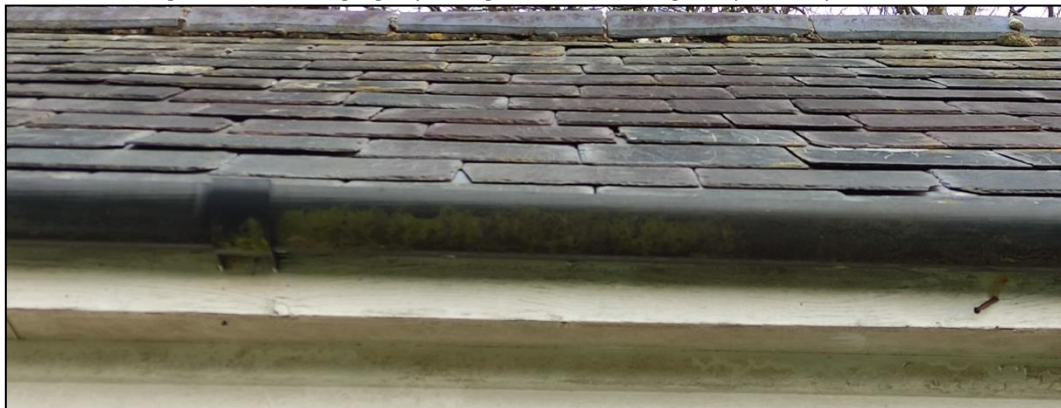
Figure 37– gap at the ridge only extends 5cm so is exposed to external environment

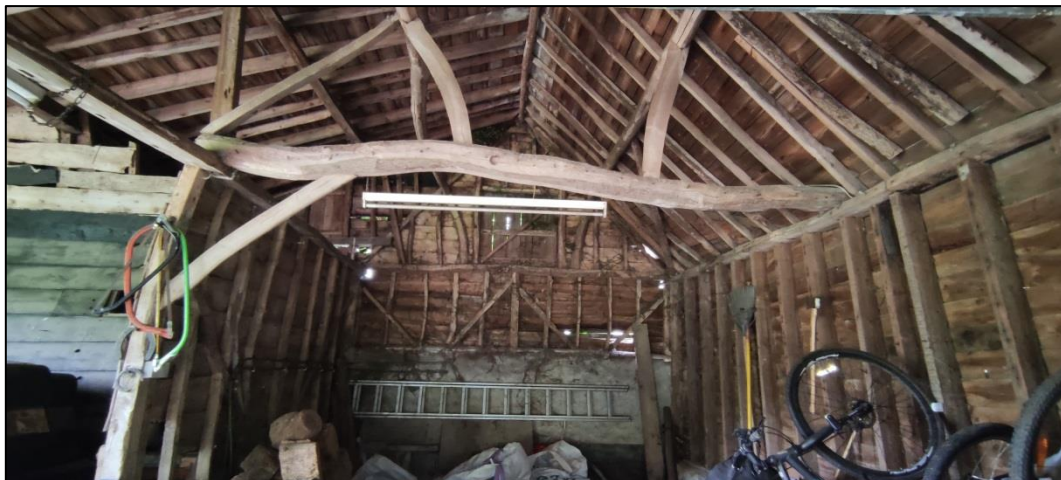
Figure 38 – showing hand-hewn timbers and holes in weatherboarding

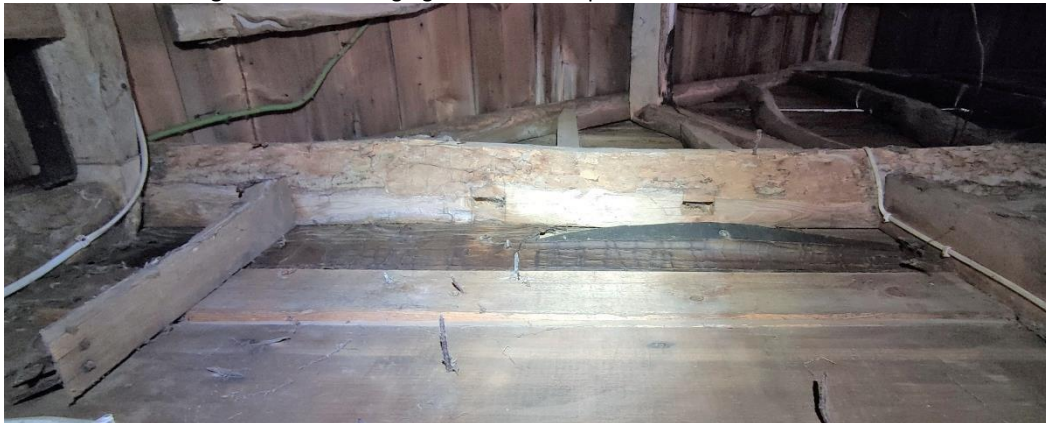
Figure 40 – showing notches in the hand-hewn timbers that could be utilised by bats

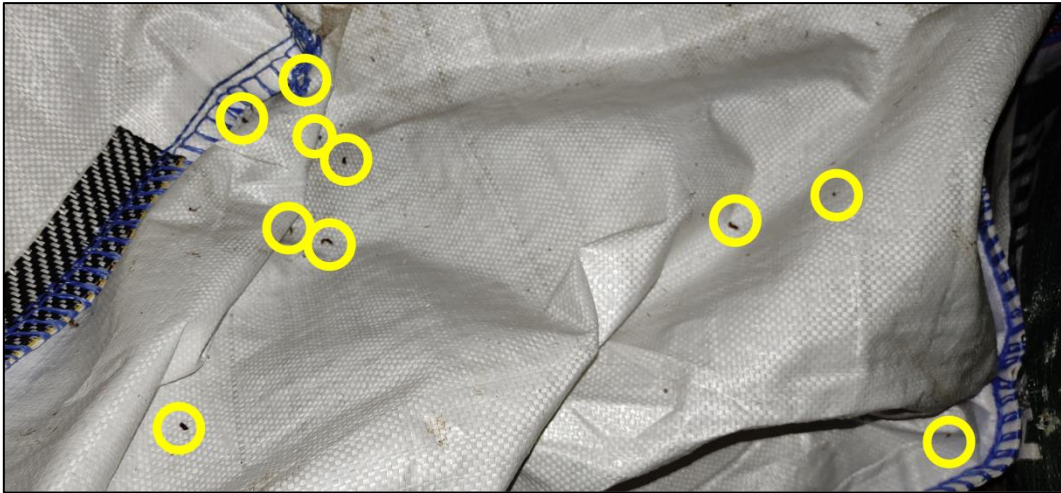
During the internal inspection of the Building 7 a small number of bat droppings (30>20) and feeding remains were found. The majority of the bat droppings were found under the ridge at the northern-most end of the barn (Figure 41) alongside scattered feeding remains, consisting of large moth and butterfly wings (Figures 42 and 43). There were also a smaller number of scattered droppings in the modern extension at the southern end of the barn. These were located on the vehicles parked under the garage roof (Figure 44).

Figure 41 – showing bat droppings (circled) at the northern end of the barn

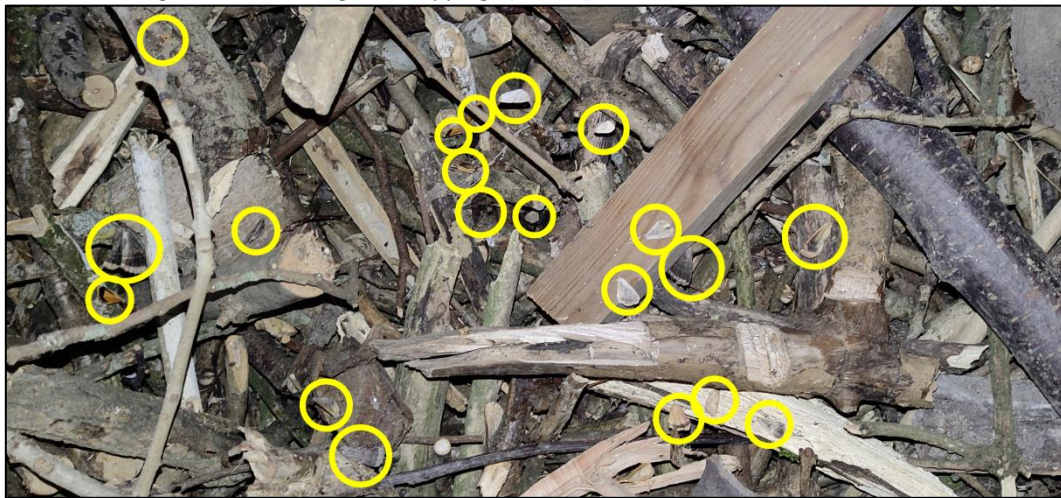
Figure 42 – showing feeding remains (circled) from butterflies and moths

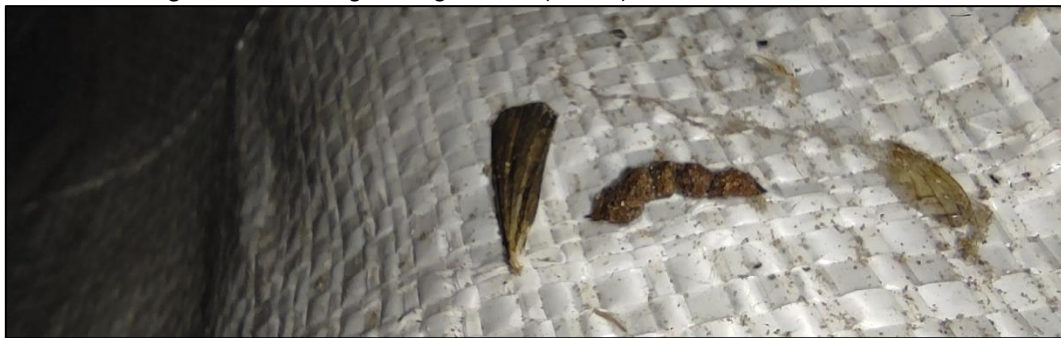
Figure 43 – close-up of a bat dropping and feeding remains

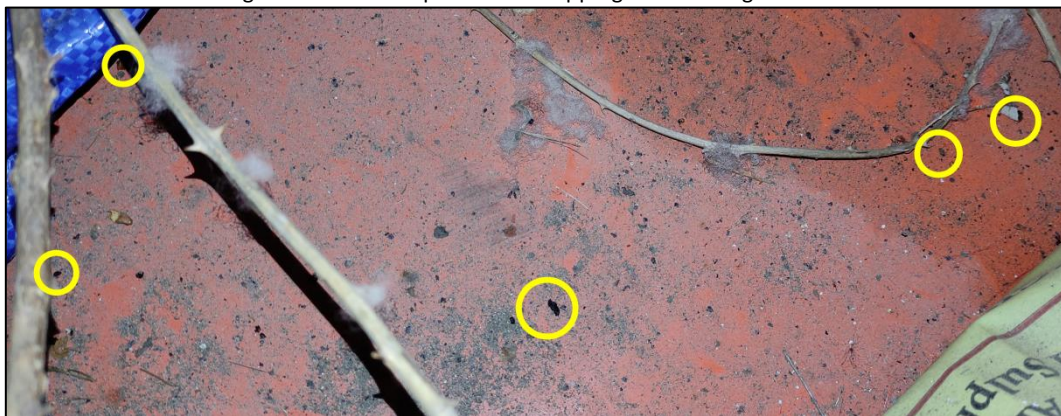
Figure 44 – bat droppings found at the southern end of the barn

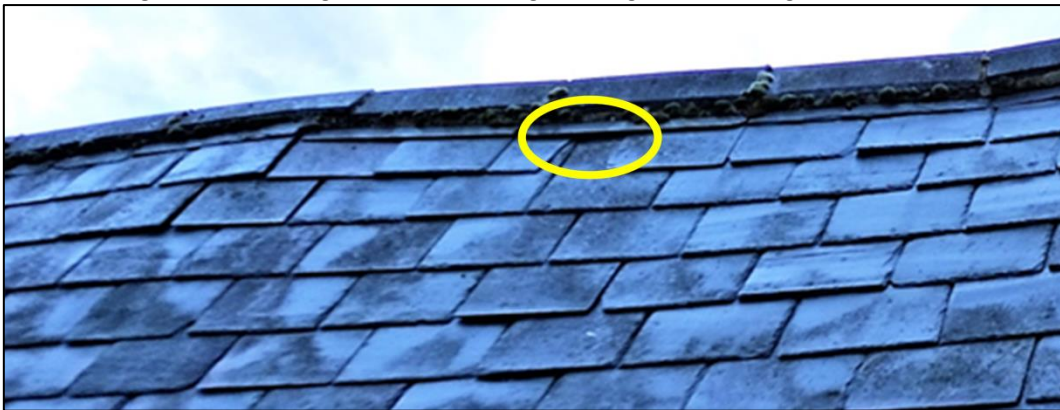
Externally, the original section of the barn at the northern end has an asymmetrical pitched (gabled) roof, with a slate covering (Figures 45 – 47). The smaller section of roof crosses into the neighbouring garden (Figures 47 and 48); which sits at a higher level and gives a clear view of the roofs condition. Externally, the slates appear to be fixed directly onto the sarking boards below, meaning there is no batten space that could be utilised by crevice-dwelling bats. There was only one gap across the pitched section of the roof, which provided some roosting potential for bats. This was located close to the ridge, on the eastern elevation; where a missing slate resulted in a gap providing access under the ridge tiles (Figure 48). There were also numerous gaps along the verges of the pitched roof, where the weatherboarding and slates did not meet. However, as the weatherboarding was a single layer, these gaps led directly into the internal void.

Figure 48 – gap where missing slate meets the ridge tiles

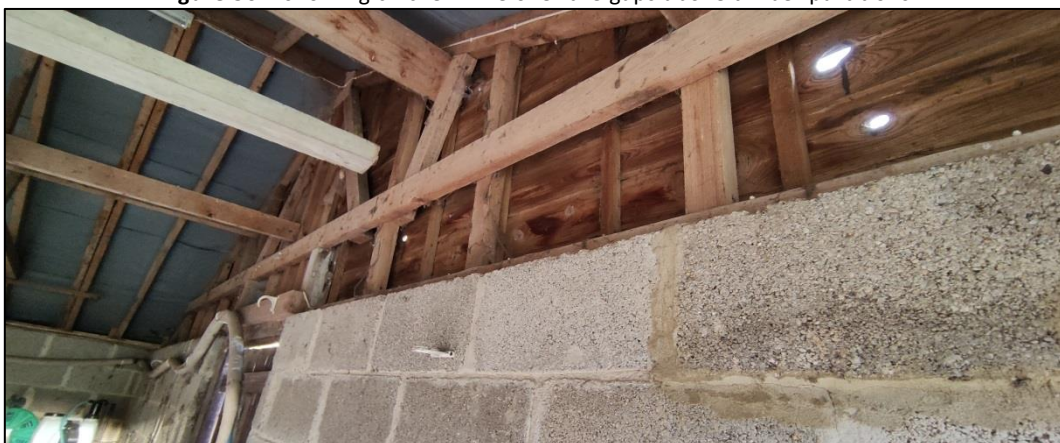
Figure 50 – showing breeze-block walls with timber weatherboarding with gaps throughout

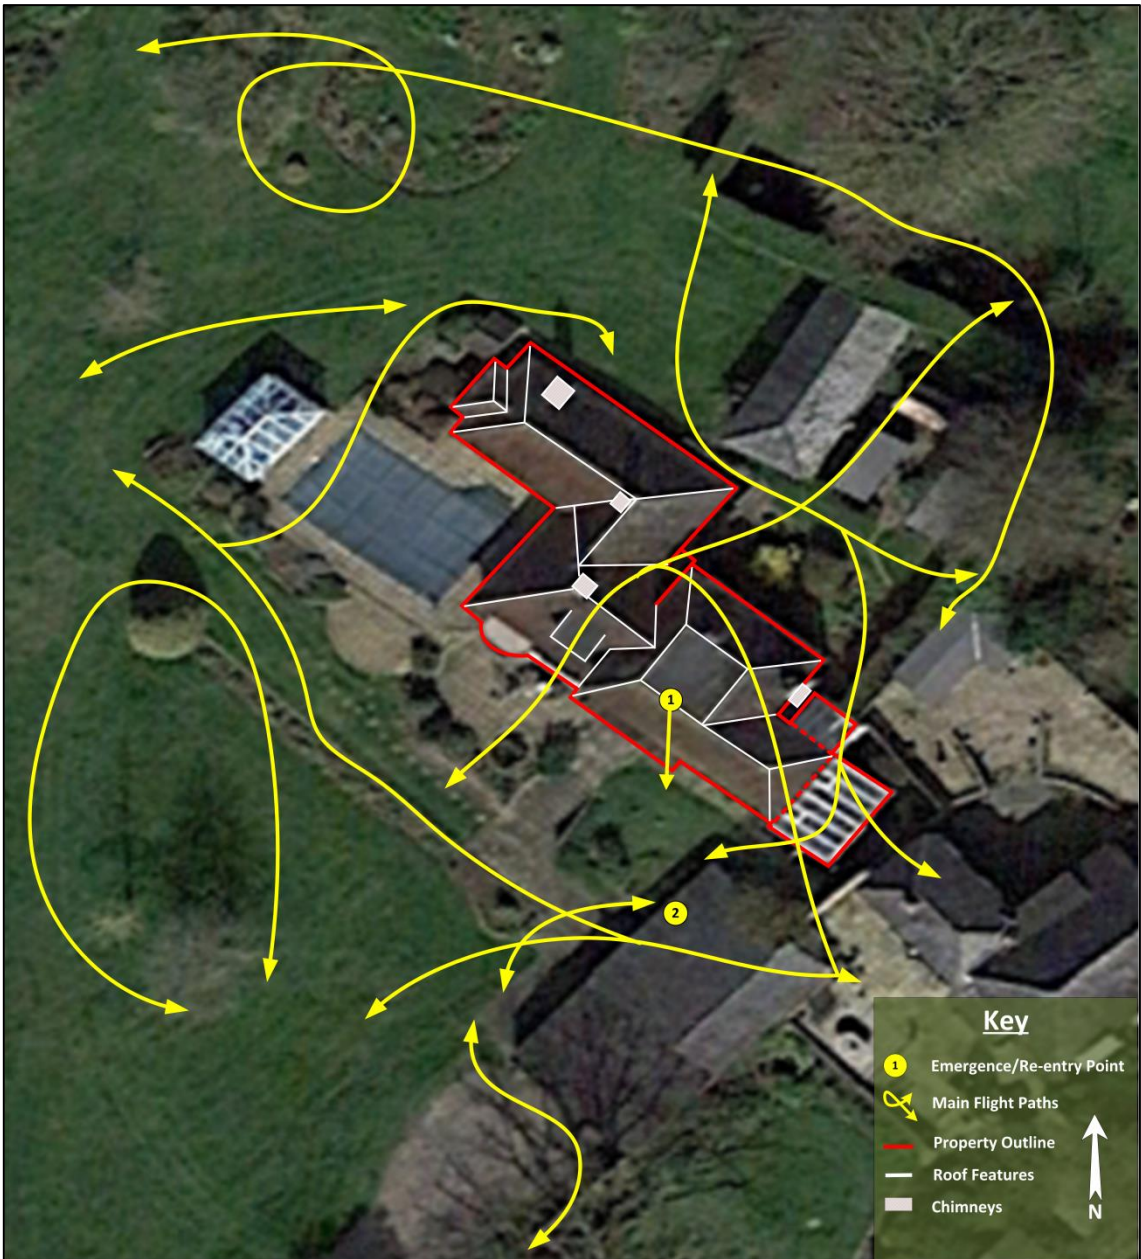
Figure 56– Emergence points (circled) mentioned in Table 3 and Main flight paths used by bats observed during the three activity surveys on Building 1 – Main House

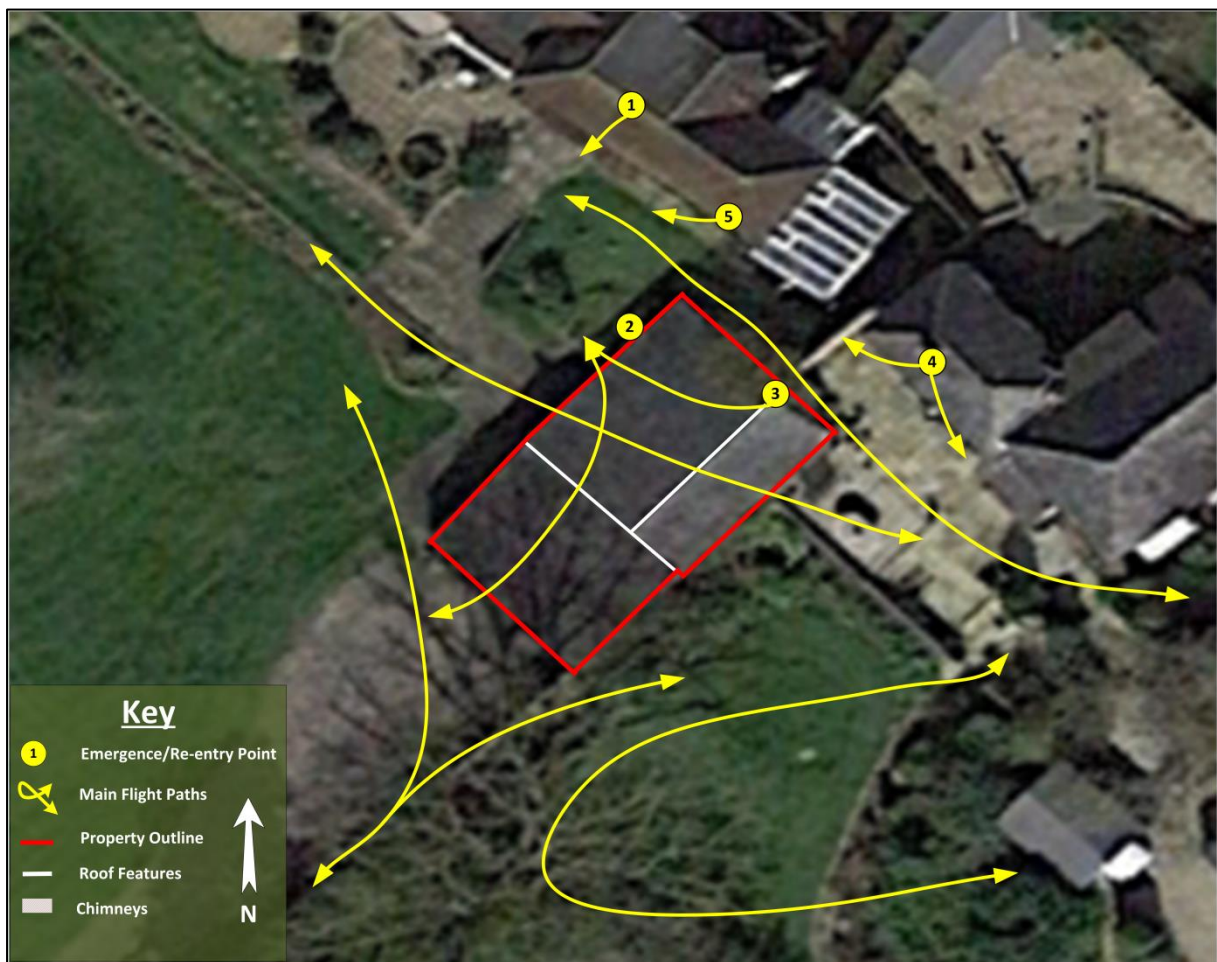
Figure 58– Emergence points (circled) mentioned in Table 4 and Main flight paths used by bats observed during the three activity surveys on the Building 7 - Garage/Barn

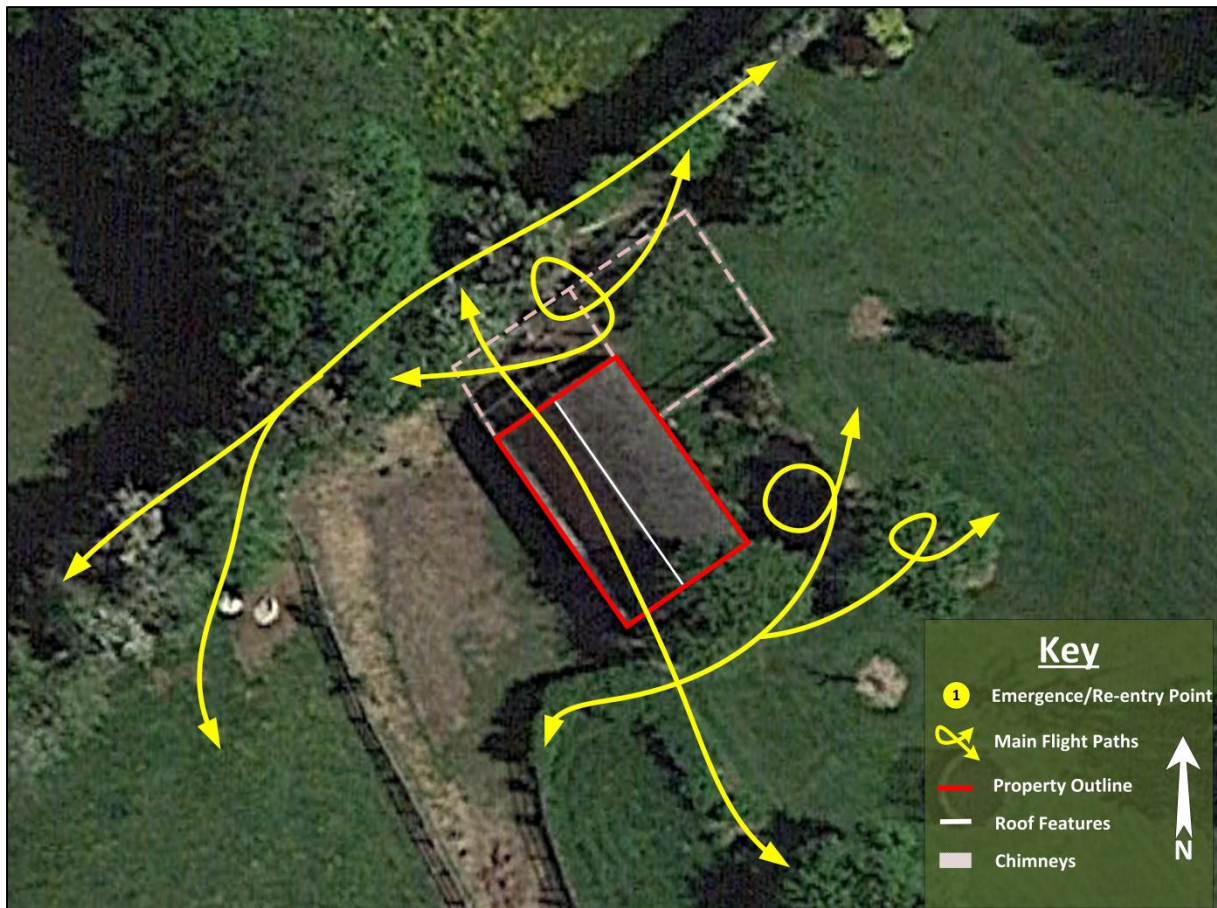
Figure 60– Emergence points (circled) mentioned in Table 5 and Main flight paths used by bats observed during the three activity surveys on Building 8- Stables at Orchard Cottage

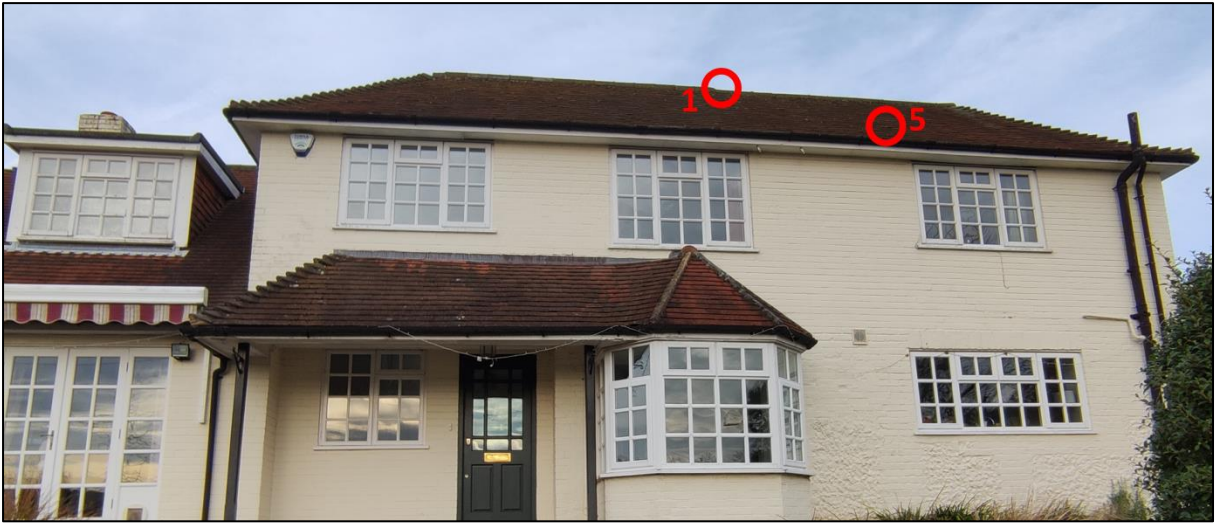
Figure 61– Building 1 - Main House access points (circled) used by bats during the activity surveys at Orchard Cottage

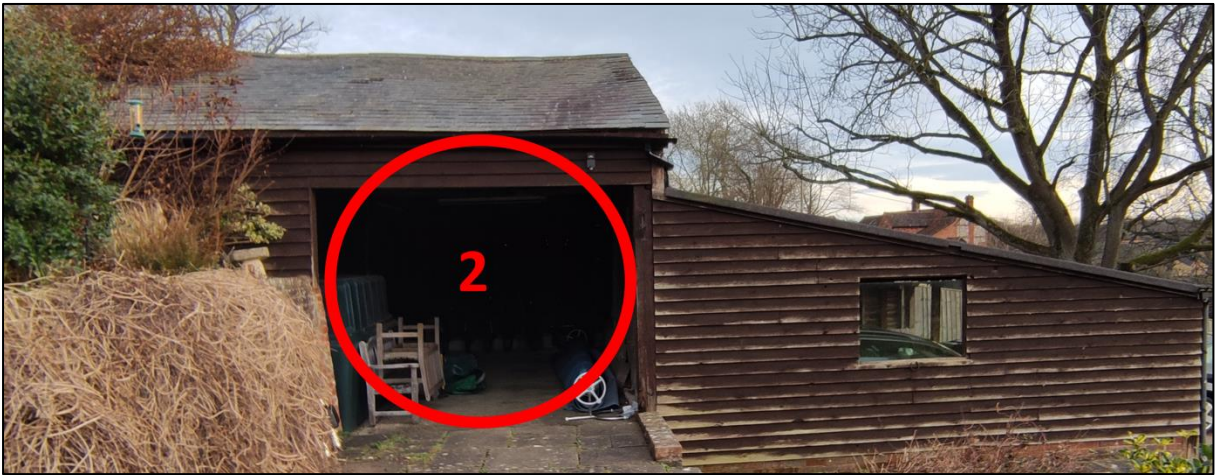
Figure 62 – Door access to Building 7 – Garage/Barn (circled) used by bats during the activity surveys at Orchard Cottage

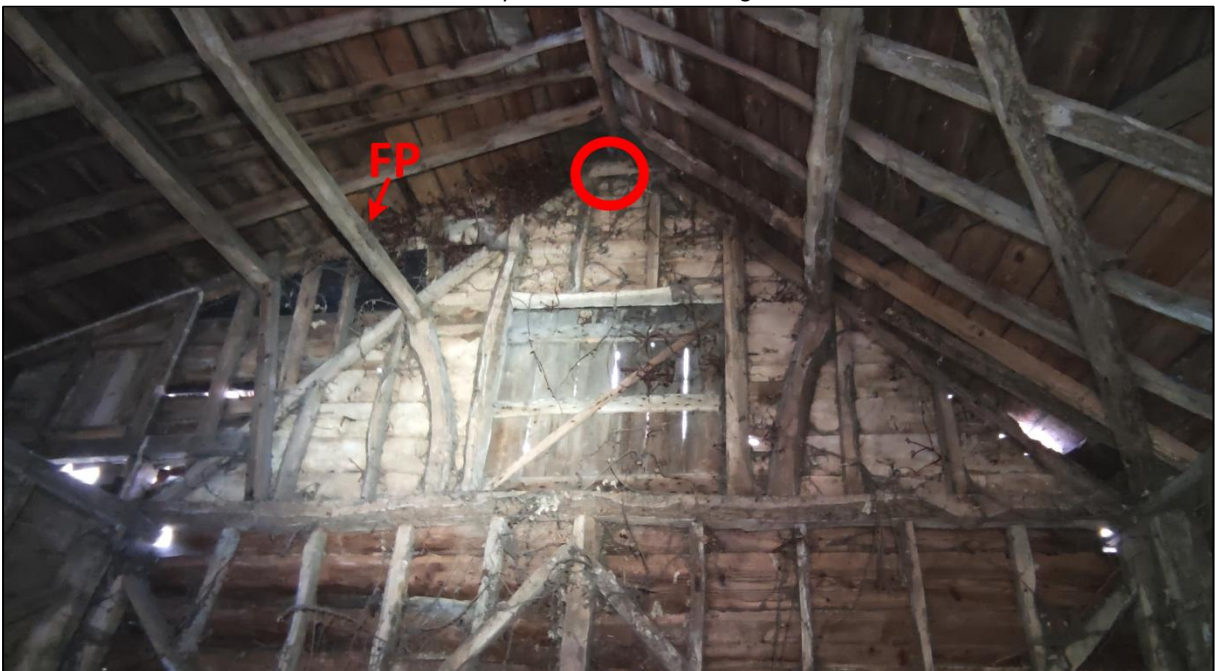
Figure 63 – Roost access and feeding perch in Building 7 – Garage/Barn (circled) used by bats during the activity surveys at Orchard Cottage
