Design and Access/Heritage Statement

Mr James House, 15 The Green, Felbrigg, Norwich, NR11 8PN
Tracy Tomlinson & Rodger Brown - [REDACTED]

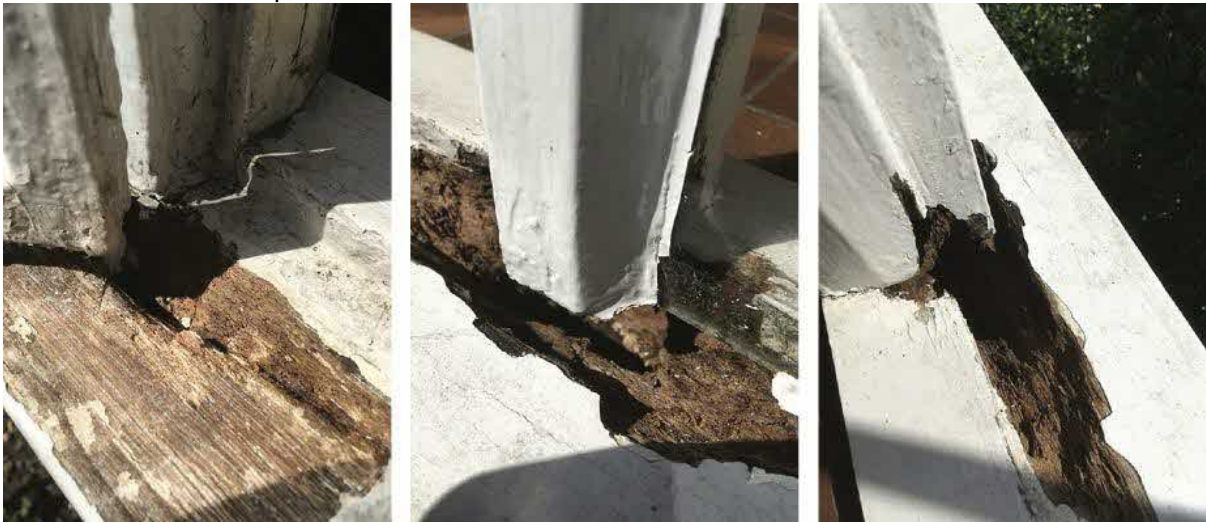
Ground floor – right hand window

The window is old but not original to the house, given the wood and other materials including the casement which is metal. We estimate it may be approximately 50 years old. This window has deep seated wood rot and metal corrosion to the casement, frame and sill.

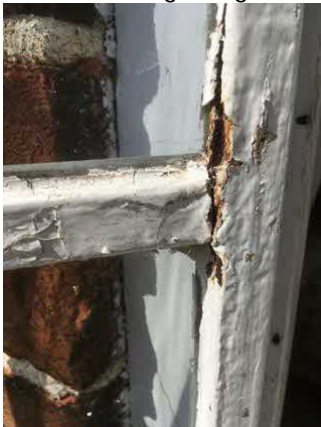
The following image details the metal casement corrosion

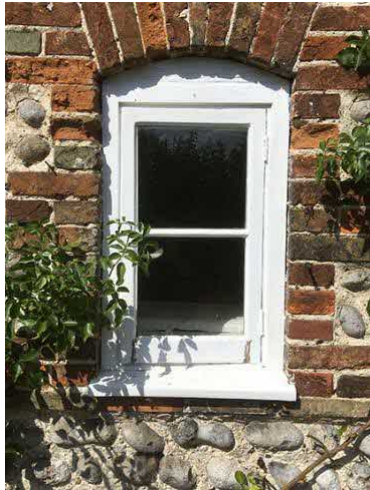
Ground floor – central window (between the doors)

The window does not appear to be as old as the others and does not have significant or unreparable wood rot.

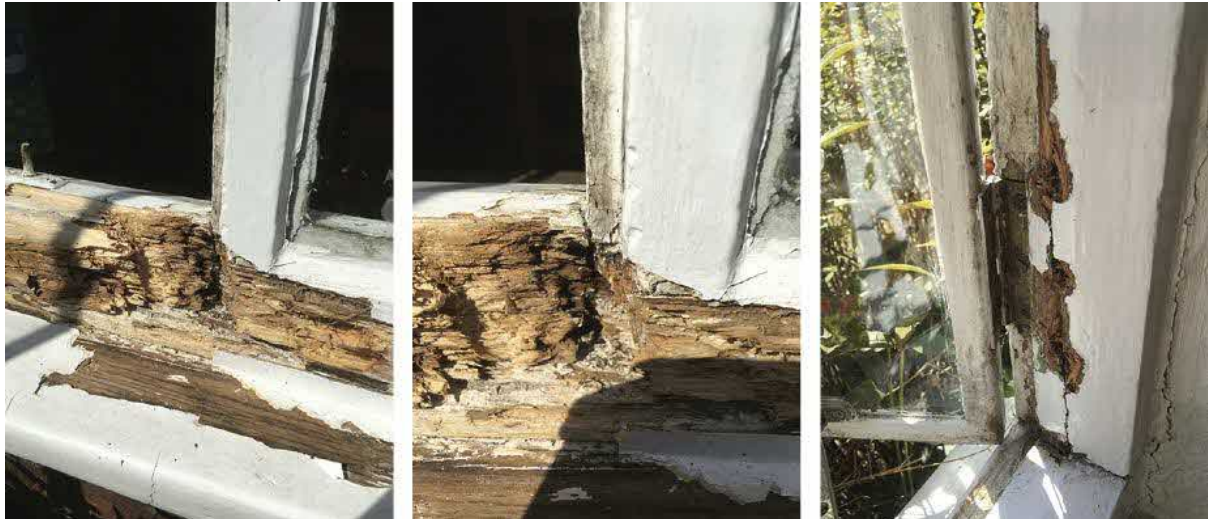
Ground floor – left hand window

The window is old but not original to the house, given the wood and other materials including metal glazing bars we estimate they may be approximately 50 years old.

This window has deep seated wood rot and metal corrosion to the casement, frame and sill.

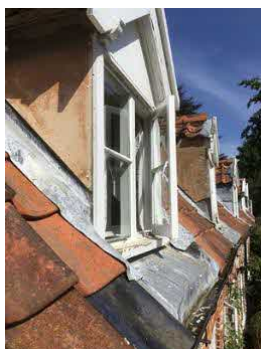
Dormer windows

The dormer windows are all more recent insertions than the ground floor front elevation windows, we estimate they may be 30 years old. The three windows are each differently constructed and set within the roof. They are not entirely in keeping with the cottage in their existing form and rotten beyond repair in several places.

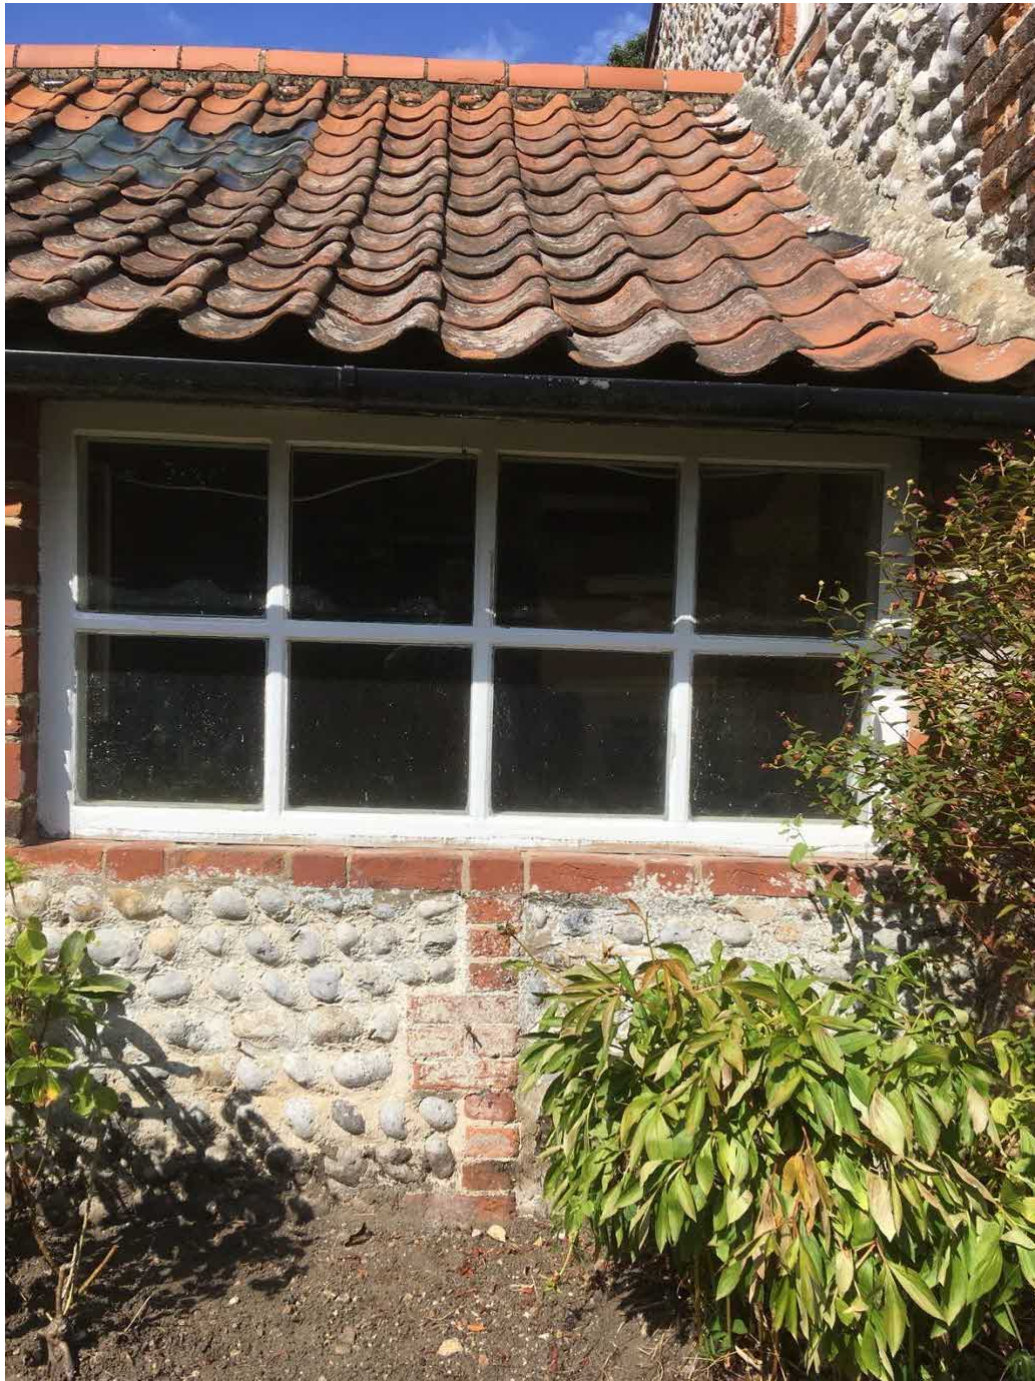
Outbuilding/Workshop windows front and rear

The outbuilding/workshop windows both front and rear do not appear to be as old as the others and do not have significant or unrepairable wood rot. The windows do not have opening casements.

As stated above the outbuilding/workshop windows front and rear will be restored rather than replaced as they lie outside of the main house and are not rotten.

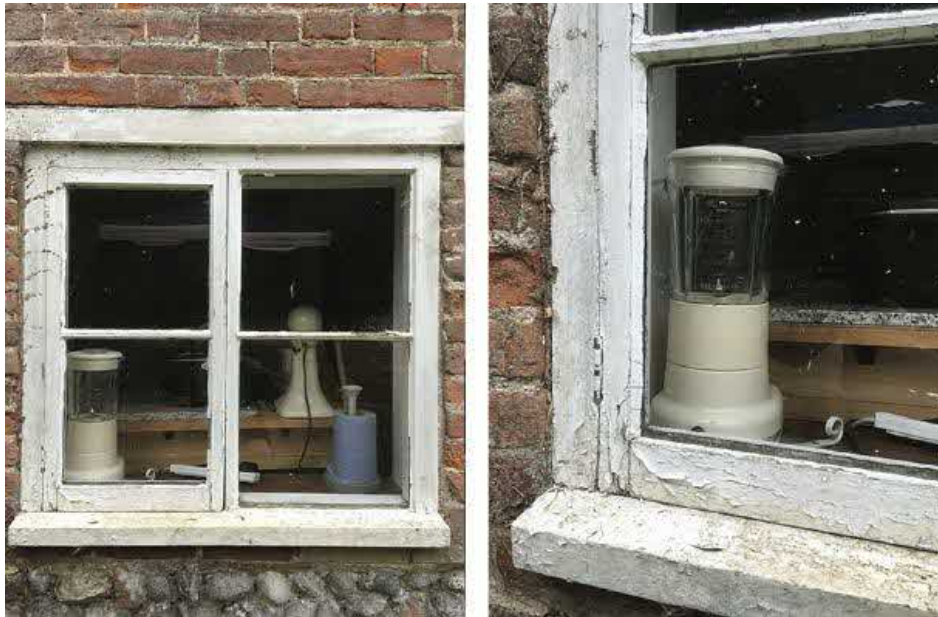
Ground floor - first window from left

The rear windows are all more recent insertions than the front elevation, we estimate they may be 30 years old. The approach to style was very varied and mostly unsympathetic to the character and architecture of the house.

The rear windows also have deep seated wood rot and metal corrosion where there are metal glazing bars.

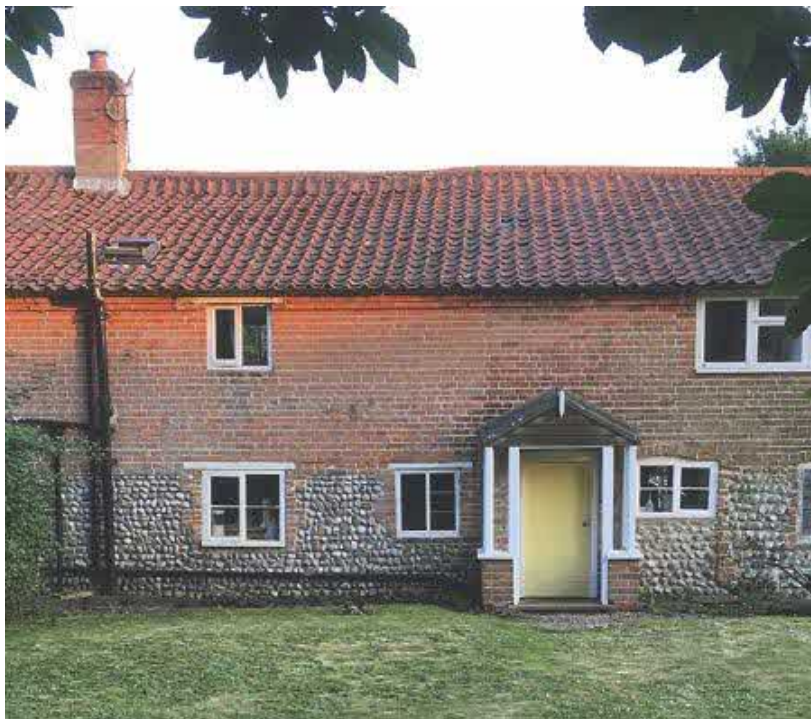
Replacement roof light

We understand that the roof light is circa 1980. It is leaking very badly into the roof space. We propose a conservation roof light of matching size, fitted flush in the plane of the roof featuring a central glazing bar which this has the potential to offer localised enhancement.

We propose to replace the existing roof light with a conservation roof light of matching size, fitted flush in the plane of the roof, featuring a central glazing bar which has the potential to offer localised enhancement to this roof plane
