# **Bat Assessment at Woodlands Farm, Ringshall, Stowmarket, Suffolk. IP14 2LY**

**Ashton Design Company Ltd.**

**June 2022**

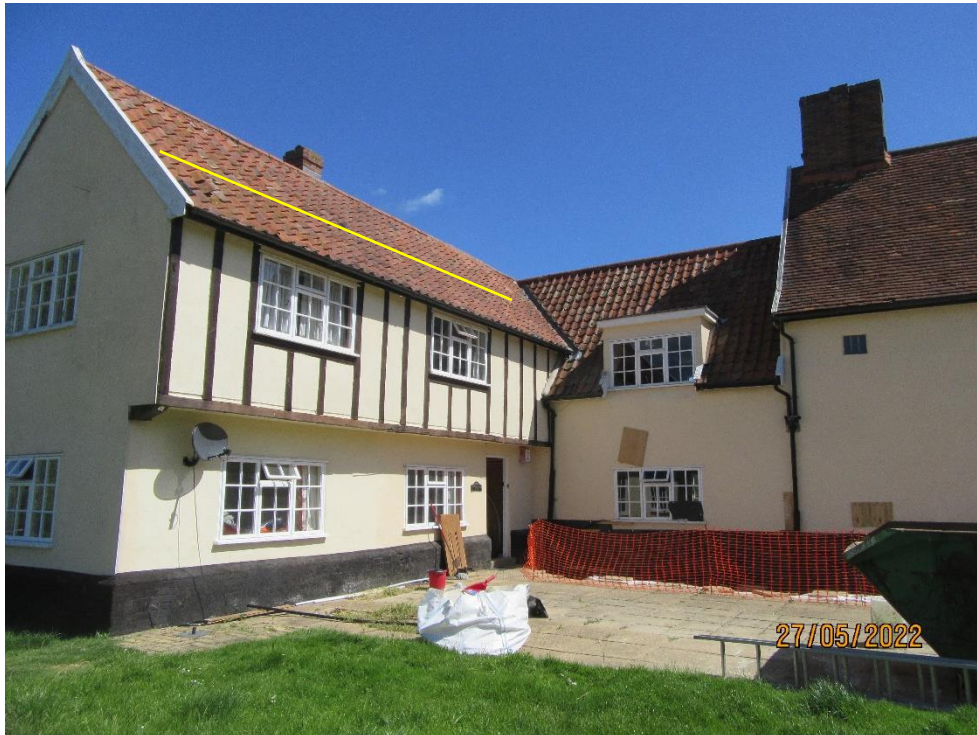
- 0.3 The building is a detached, period farmhouse. The north western section of the roof requires re-roofing as part of broader refurbishment works which have already commenced. The roof is pitched and tiled with peg tiles. A modern breathable membrane is present in places and it is understood that the roof was refurbished approximately 15 years ago.

**Photograph 1: Woodlands Farm house. Yellow line indicating section of roof requiring works.**

- Works to the roof should be undertaken by hand with hand movement of tiles etc. If at any stage bats or evidence of bat activity (droppings) are discovered, works should stop and an ecologist called for advice;
- If future external lighting is installed it should be warm white LED, directed downward and ideally set on sensors sensitive to large moving objects only to prevent passing bats from switching the lights on.

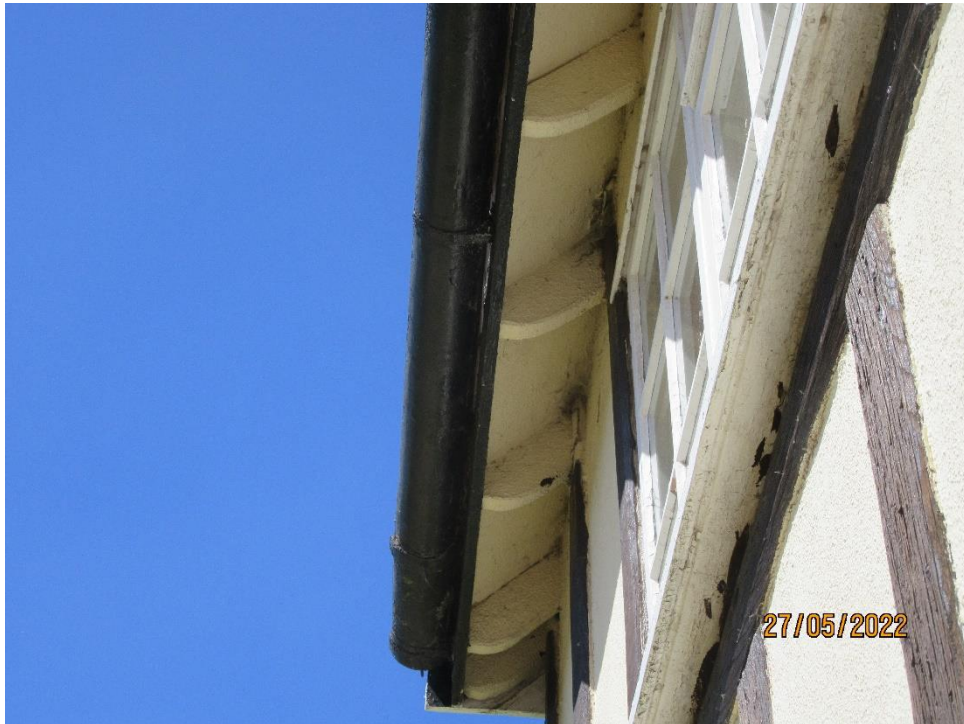
- 3.3.1 The building was closely inspected internally and externally for bats, signs and evidence of bat activity, potential for roosting and access opportunities.
- 3.3.2 Externally, the roof was considered negligible for roosting bats with negligible opportunities for roosting. Gaps around the few tiles that were damaged/lifted were considered too small for roosting bats.
- 3.3.3 Internally, the space appeared dusty and dirty toward the roof and along the ridge beam indicating that bats had not been roosting along the ridge beam recently.
- 3.3.4 No internal or external signs or evidence of bats were found.

**Photograph 3: Blocked eaves – no access for bats into loft at Woodlands Farm house.**

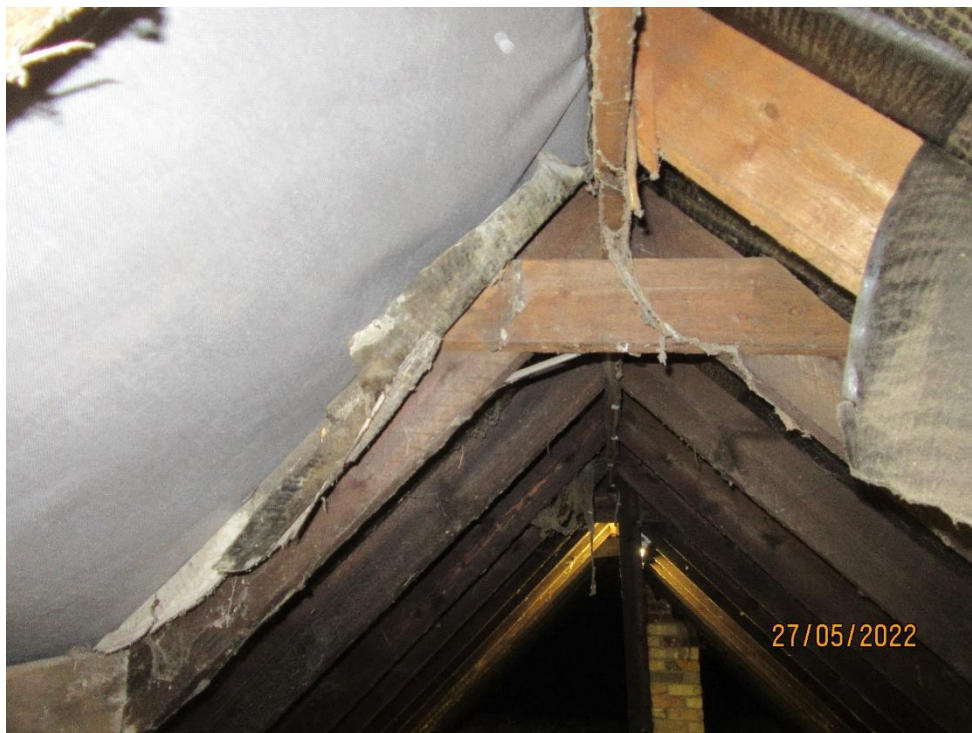
**Photograph 4: Loft space inside Woodlands Farm house. Note part breathable membrane indicating some recent roof works.**
