## Moor Farm 1

Talaton

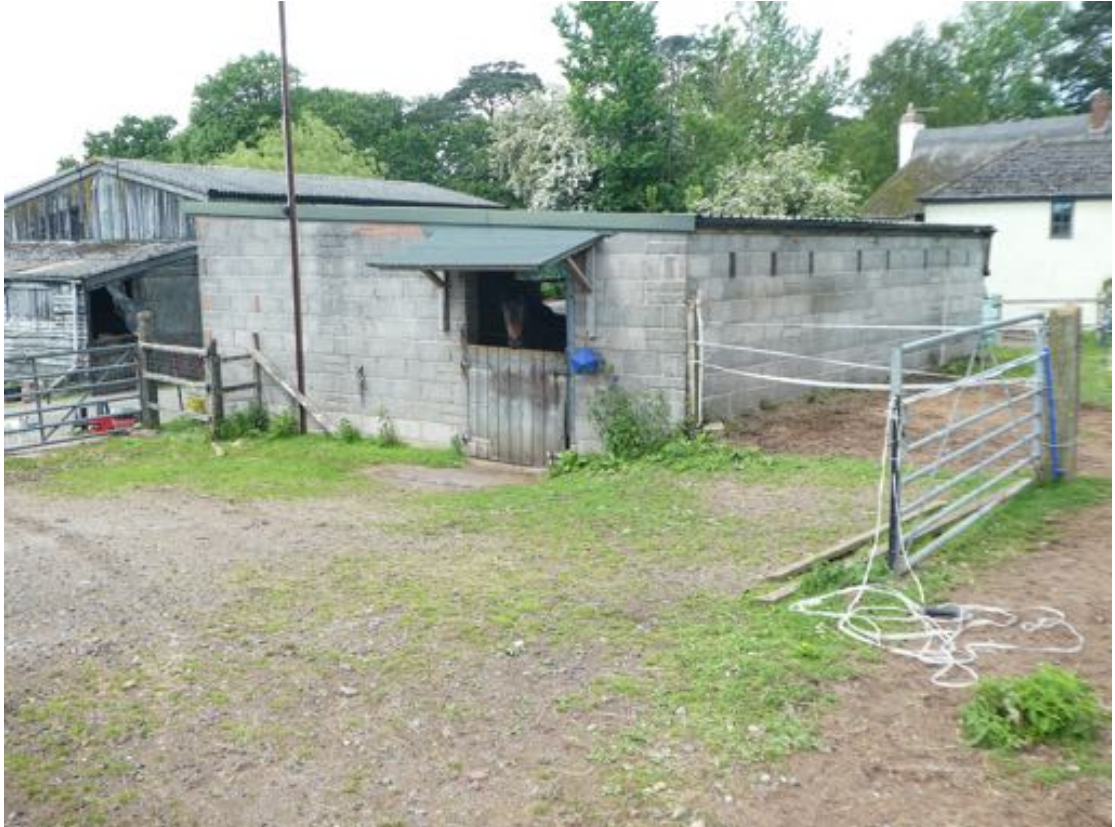
0604

This image shows the southern and eastern sides of the stable cum barn, which the applicant proposes to convert to provide a dwelling for herself, together with the addition of an extension in part of the yardage that surrounds the building

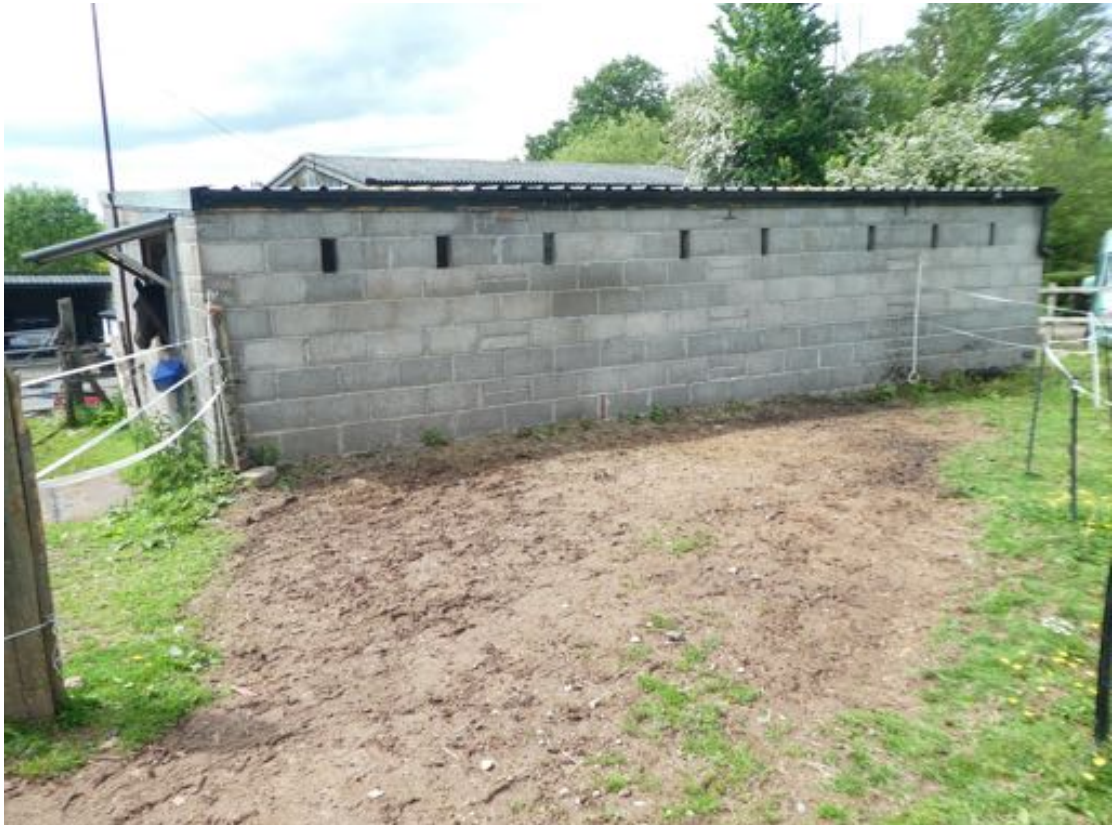
0605

The eastern side of the stable to the left and the barn to the right, but with no partition between both parts, is shown in this image. A conversion would also require a small extension within the area shown on this side of the building. Note the eight ventilation openings in the rear wall

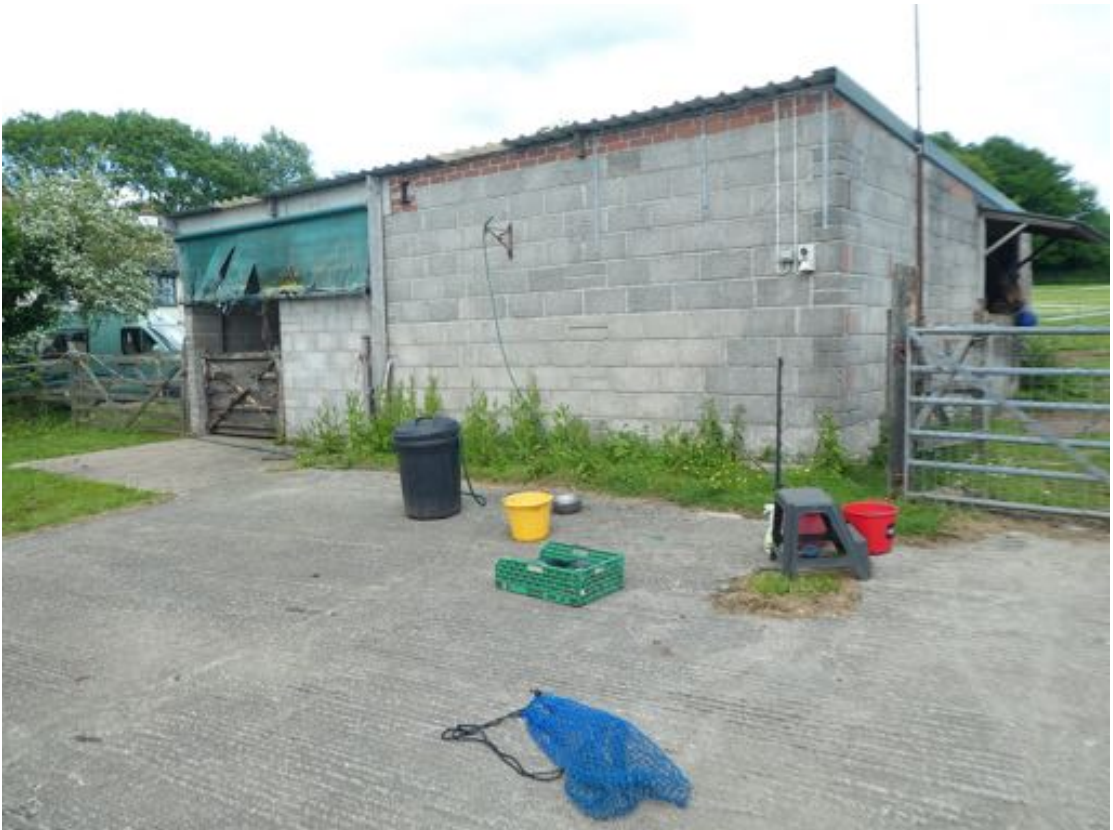
0615

The western side of the stable/barn is shown in this image, with the barn part behind the gate and the green screen

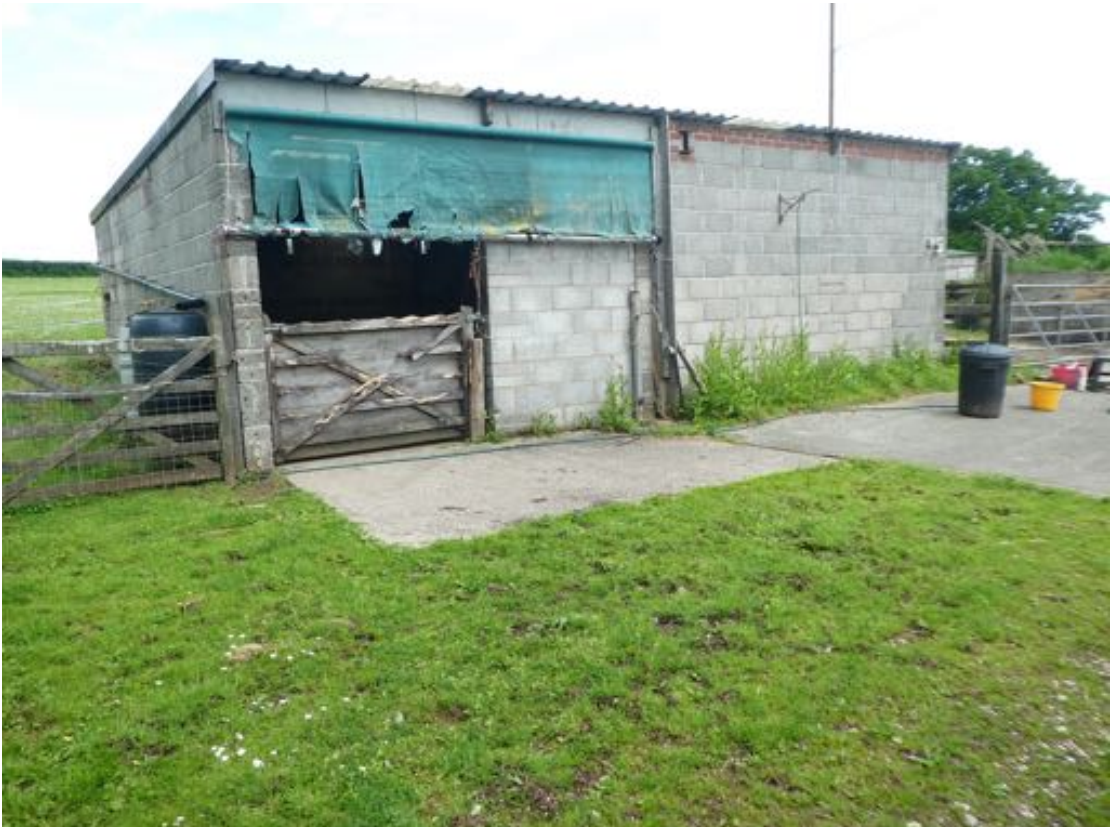
0616

The western side of the stable/barn is shown in this image, with the barn part behind the gate and the green screen. A corrugated plastic panel set into the roof provides an abundance of natural light in the barn part. Both sides of the single floor area building are very well ventilated as well as well lit

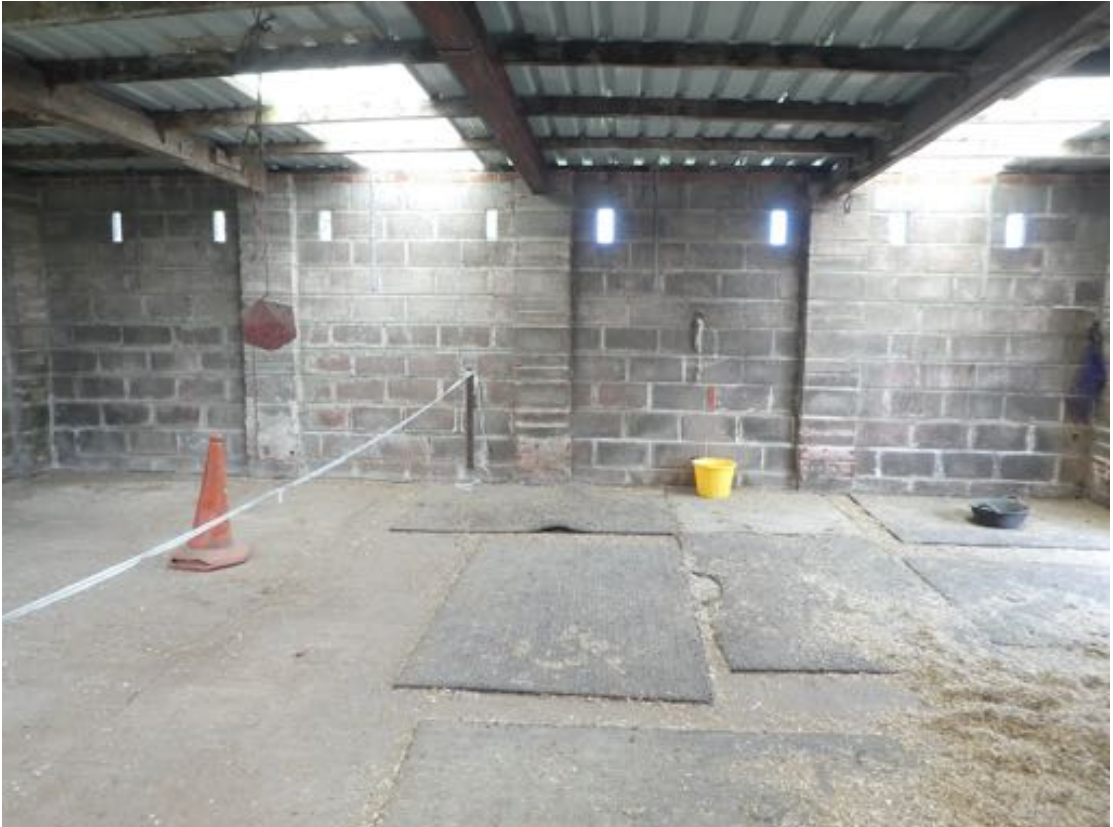
0607

This image was taken inside the barn area to the left and the stable part to the right, shows how well-lit and well ventilated the building is

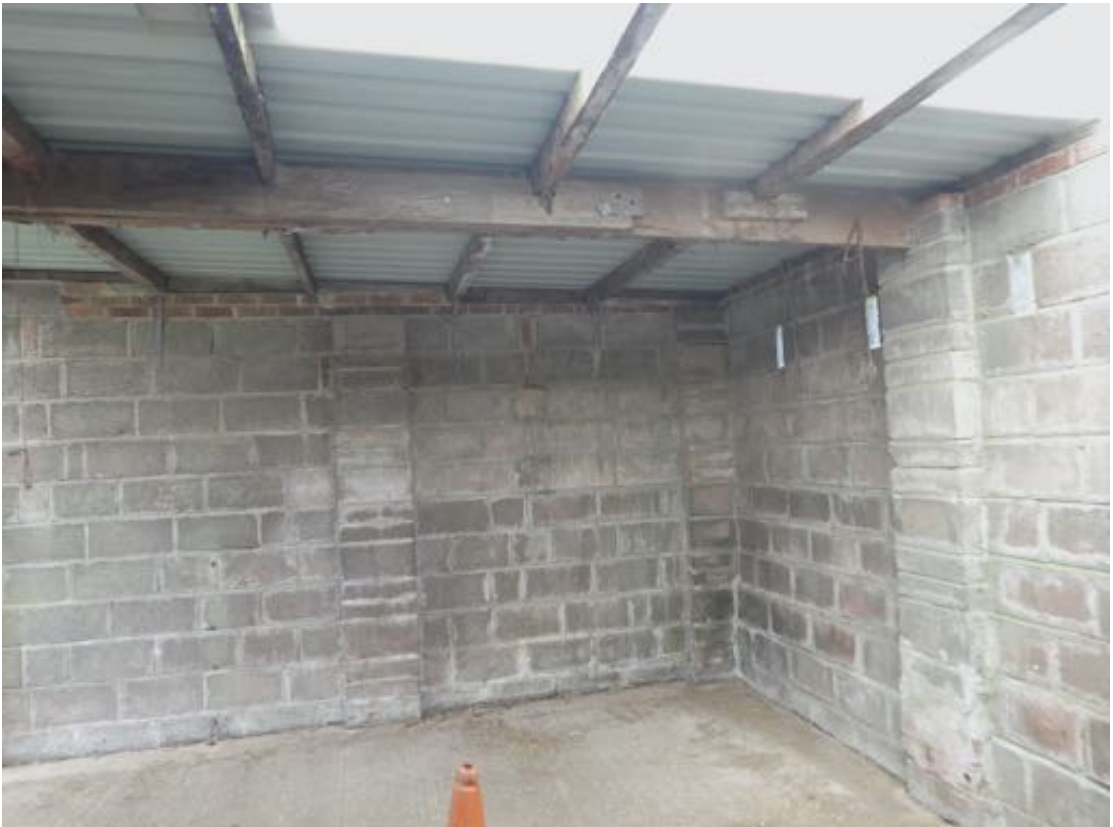
0608

This image was taken to show the barn part of the building. It shows how well-lit and well ventilated the building is

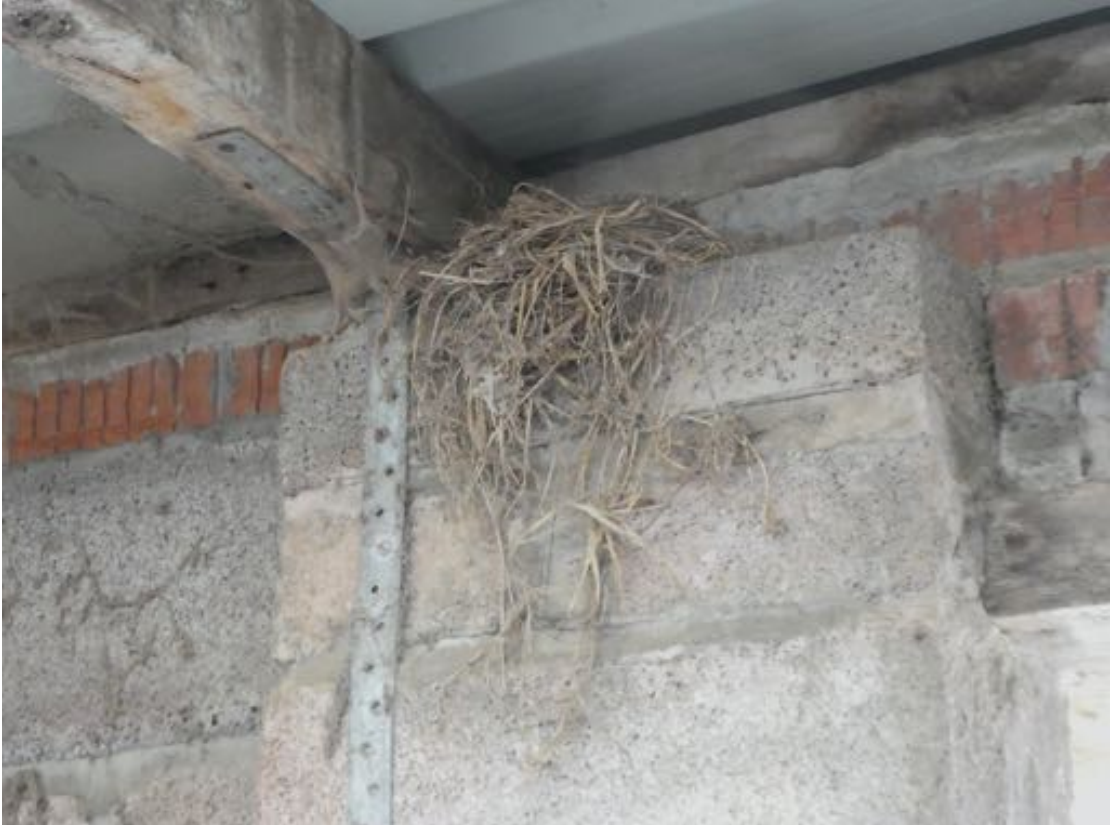
0612

An old blackbird's nest was built in one of the blockwork support pillars, but the bird has not returned to re-use the nest during the current nesting season

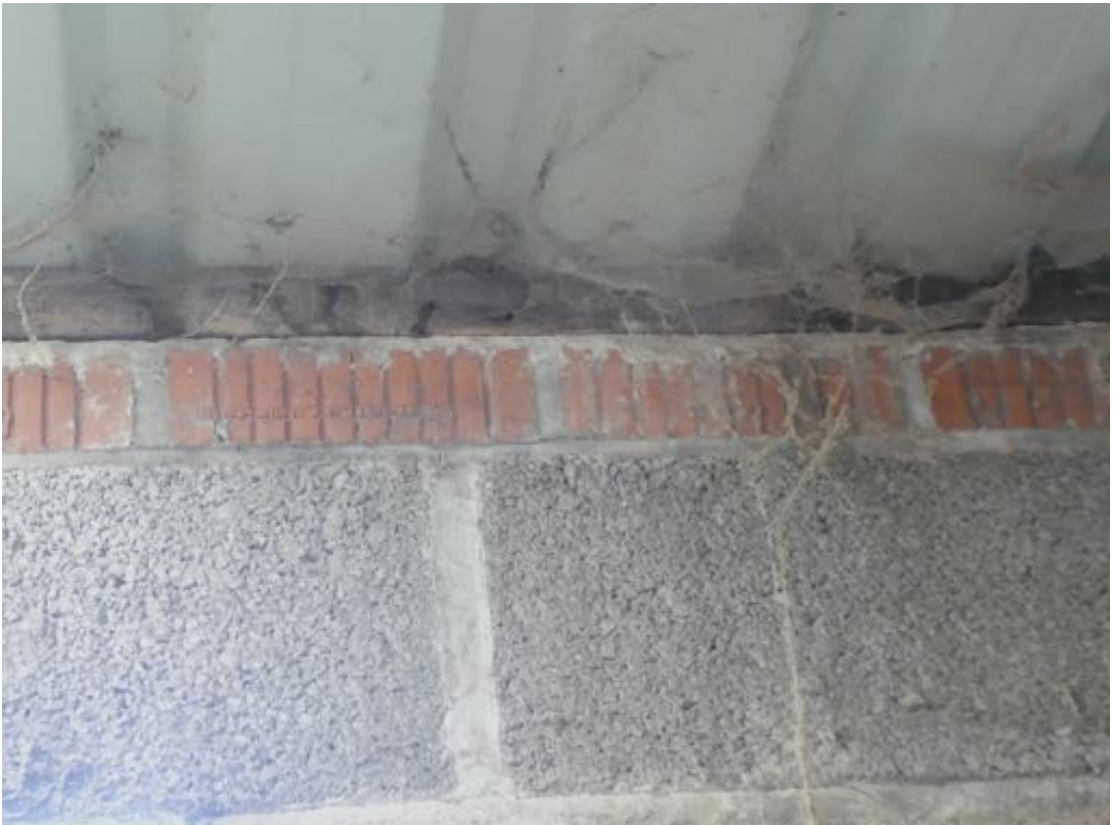
0613

The join between the roof-support beam that rests on the top of the brick-capped blockwork wall, and the corrugated metal roof covering, is festooned with cobwebs. That demonstrates a lack of disturbance by any flying animals
