Ecology Photo Record

26 Mannings Road, Drybrook, Gloucestershire, GL17 9HS

26 MANNINGS ROAD

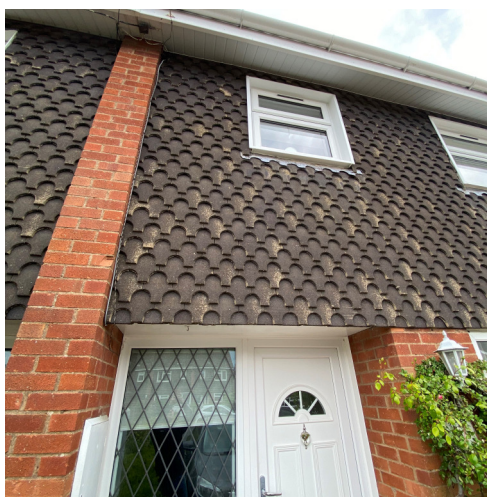
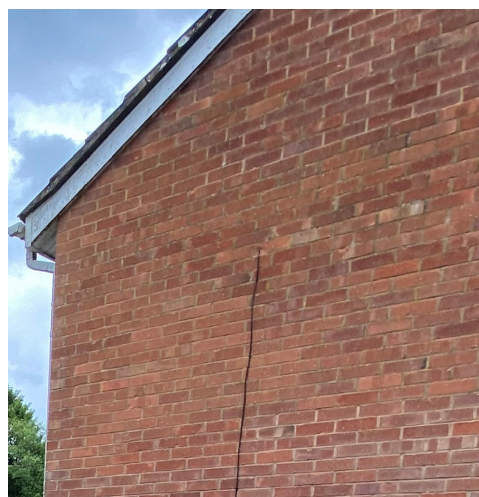
PHOTOS 1 & 2

The existing house walls consist of brickwork and tightly butted wall tiles with no crevices on show (PHOTOS 1 & 2).

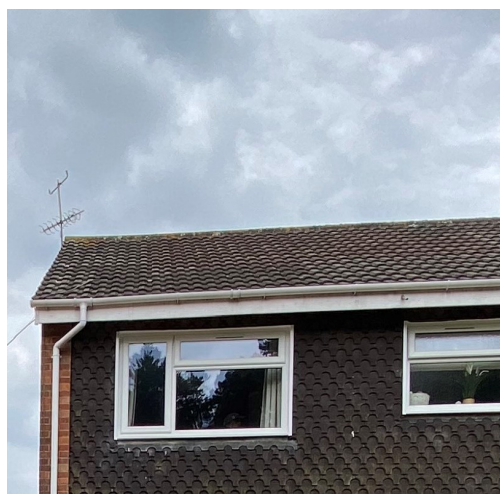
PHOTO 3

The house has concrete interlocking roof tiles that are in good condition with tightly butted joints, no visible gaps, or crevices (PHOTO 3).

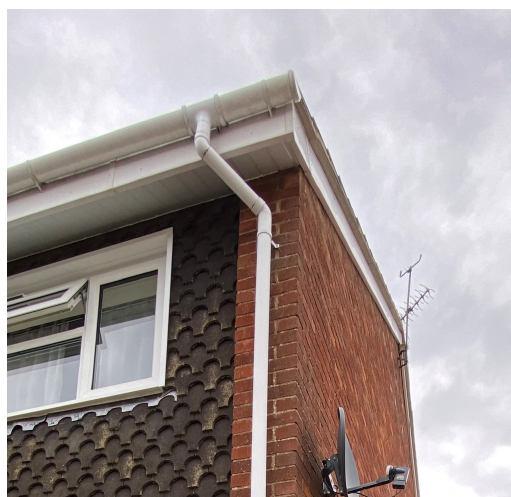
PHOTO 4

The house has UPVC soffit boards below the fascia that offer no gaps or crevices into the loft space. There are also no crevices or gaps along the bargeboard (PHOTO 4).

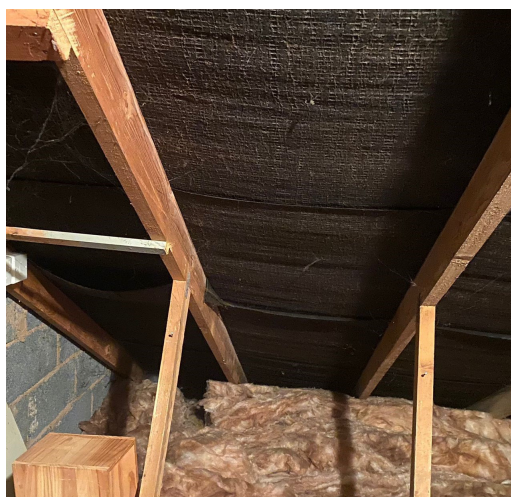
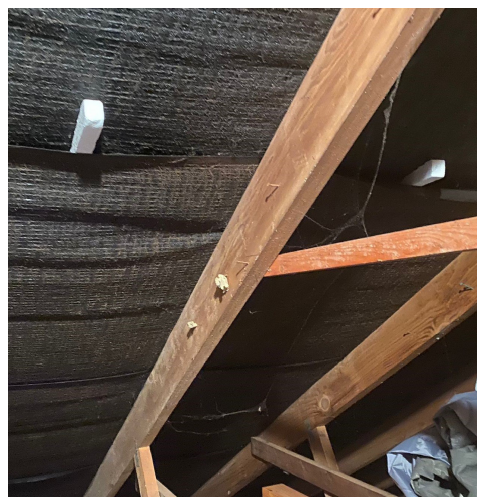
PHOTOS 5 & 6

The house also has a loft area that is regularly used for storage. Upon inspection of the loft space it was found that the roof membranes were intact with no daylight gaps at ridge, eaves or along roof slope. There were also numerous cobwebs within the loft void which would suggest bats are not present (PHOTO 5 & 6).
