**Re. WW E22136 - The Frocester Inn, Peter's Street, Frocester, Stonehouse, GL10 3TQ**

This letter report is regarding the Preliminary Roost Assessment (PRA) undertaken by Wildwood Ecology on the 8<sup>th</sup> of August 2022, at the Frocester Inn. The survey was requested by Stroud District Council (SDC) to inform a planning application, for alterations to the existing barn attached to the Frocester Inn, Peter's Street, Frocester, Stonehouse, GL10 3TQ.

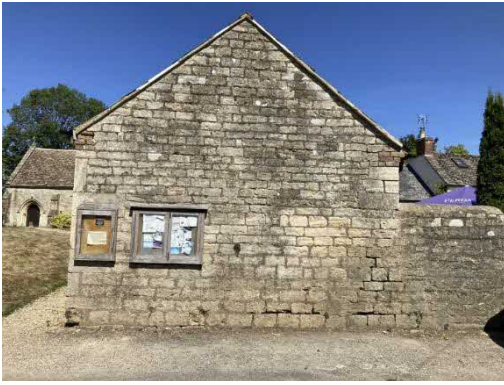
At the time of the survey, the onsite barn was a single-storey building, of mixed Cotswold stone and red brick construction, situated at the western part of the Frocester Inn site (see **Photograph 1** to **Photograph 3** in **Appendix II**).

Photographs 1: South building aspect.

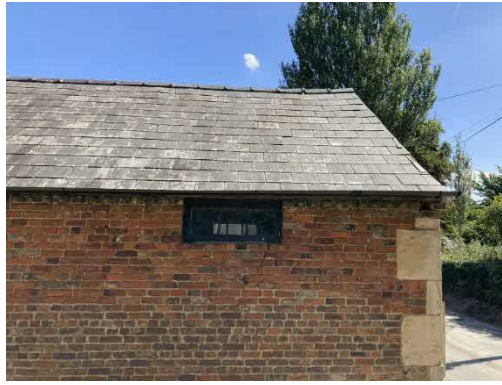
Photograph 2: West building aspect.

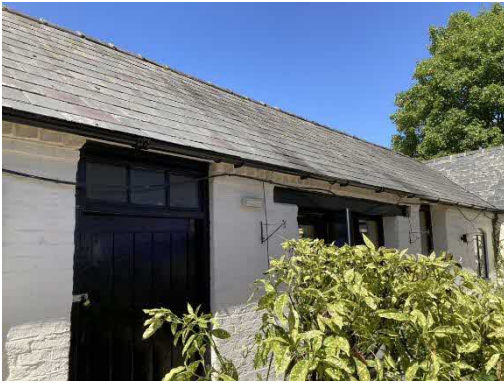
Photograph 3: East building aspect.

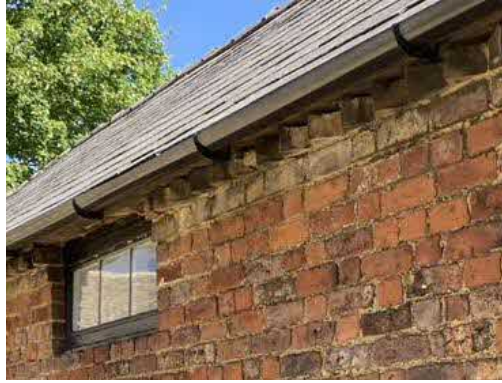
The roof of the building was comprised of slate tiles, although the ridge tiles were in places also secured by lead flashing. There were no eaves to the roof, instead, decorative half-bricks were located along the top of the building’s walls (see **Photograph 4**). Internally, the building ceiling was partially vaulted with exposed beams, and was in active use by Frocester Inn as a function room, bar, and storage space (see **Photograph 5**).

Photograph 4: Decorative half-bricks.

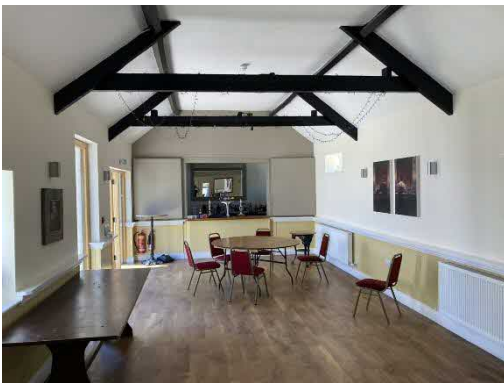
Photograph 5: Internal space.

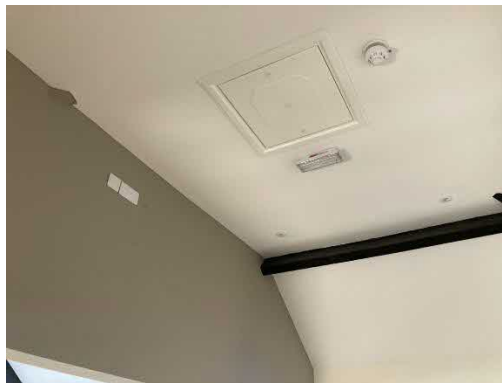
Based on the dimensions of the roof, the internal loft space is likely to be around 1– 1.5m apex height.. A single loft hatch was present (see **Photograph 6**), however, the internal loft space was not possible due to health and safety reasons, i.e., the height of the loft hatch and its location away from any supporting walls, making access via a ladder dangerous.

Photograph 6: Loft access hatch.

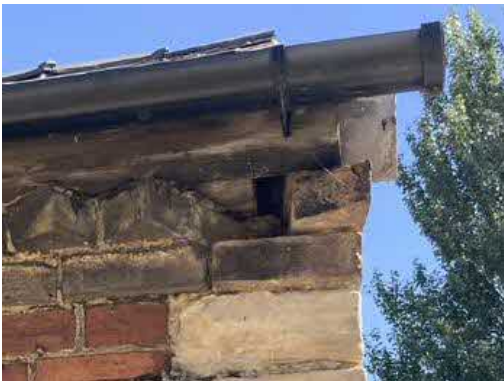
The main access point into the building for bats (if present) could be a gap in the brick wall on the south-west elevation of the building, where one of the decorative bricks was missing (see **Photograph 7**). This feature could allow direct access behind the southern wall and up beneath the roof tiles. There were also a small number of small gaps (approximately 4) between the roof tiles (see **Photograph 8**), that could be used by individual crevice-dwelling batson an opportunistic basis, but due to the size of the features their use by bats is considered unlikely.

Photograph 7: Gap in brick wall.

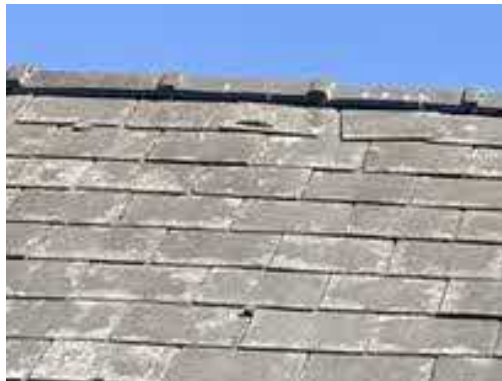
Photograph 8: Small gaps between tiles.
