# 6 Mulberry Farm, West Pennard

**Design, Access & Heritage statement**

12/09/22 - Initial Issue

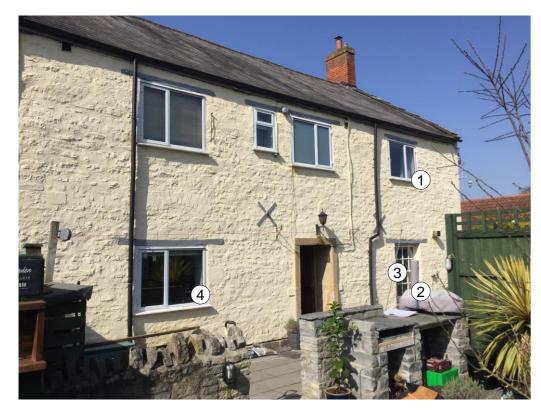
Existing East elevation (rear) of the dwelling showing the 6no. windows to be replaced.

- 2no. at ground floor (including 1 uPVC casement and 1 sash)
- 4no. at first floor (4 uPVC casement).

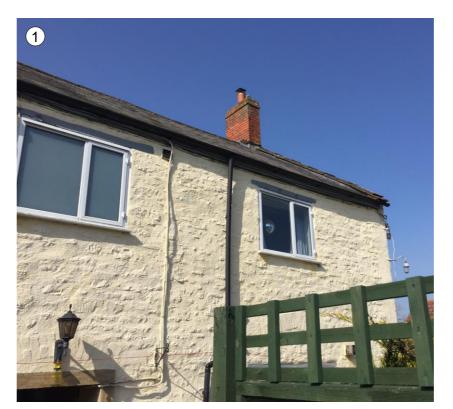
All existing uPVC casement windows to be replaced on East elevation.

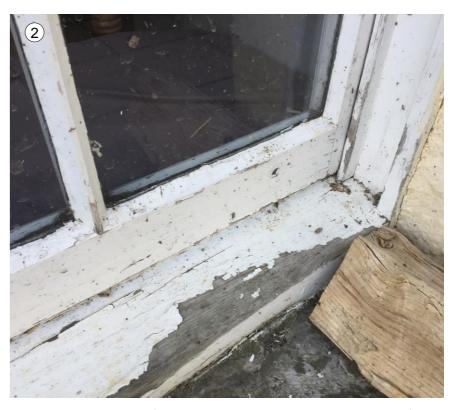
Current deterioration of paintwork and condition to sash window. (Exterior)

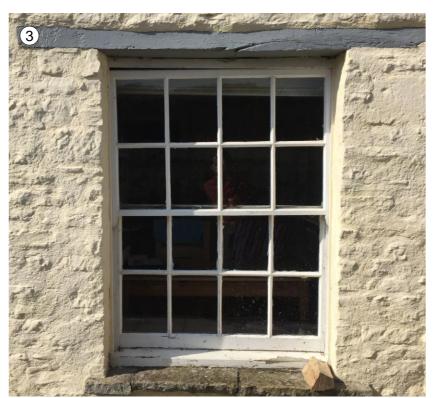
Cill to be raised and window widened to match the existing size of other ground floor window on the East elevation, with existing stone cill to be retained at new height.

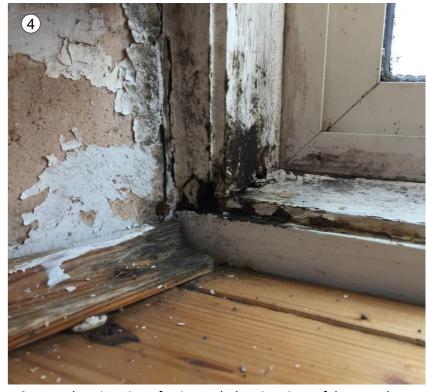
Current deterioration of paintwork showing signs of damp and mould damage to timber frame of uPVC casement window. (Interior)
