Arboricultural Report

Proposed development at
The Geyhound PH
The Street
Tibenham
Norfolk

3rd. June 2022 (JBA)

Document	Arboricultural Report
Version	1.3 (revised 6 th June 2022)
Date of original	20 th June 2020
Author	Ben Hogben BSc Hons, Dip Surv (Rural), MICFor Edited by JBA (update site plan only)
Reviewer	Etienne Swarts B Compt (Hons) F Deg Sc ACIEEM

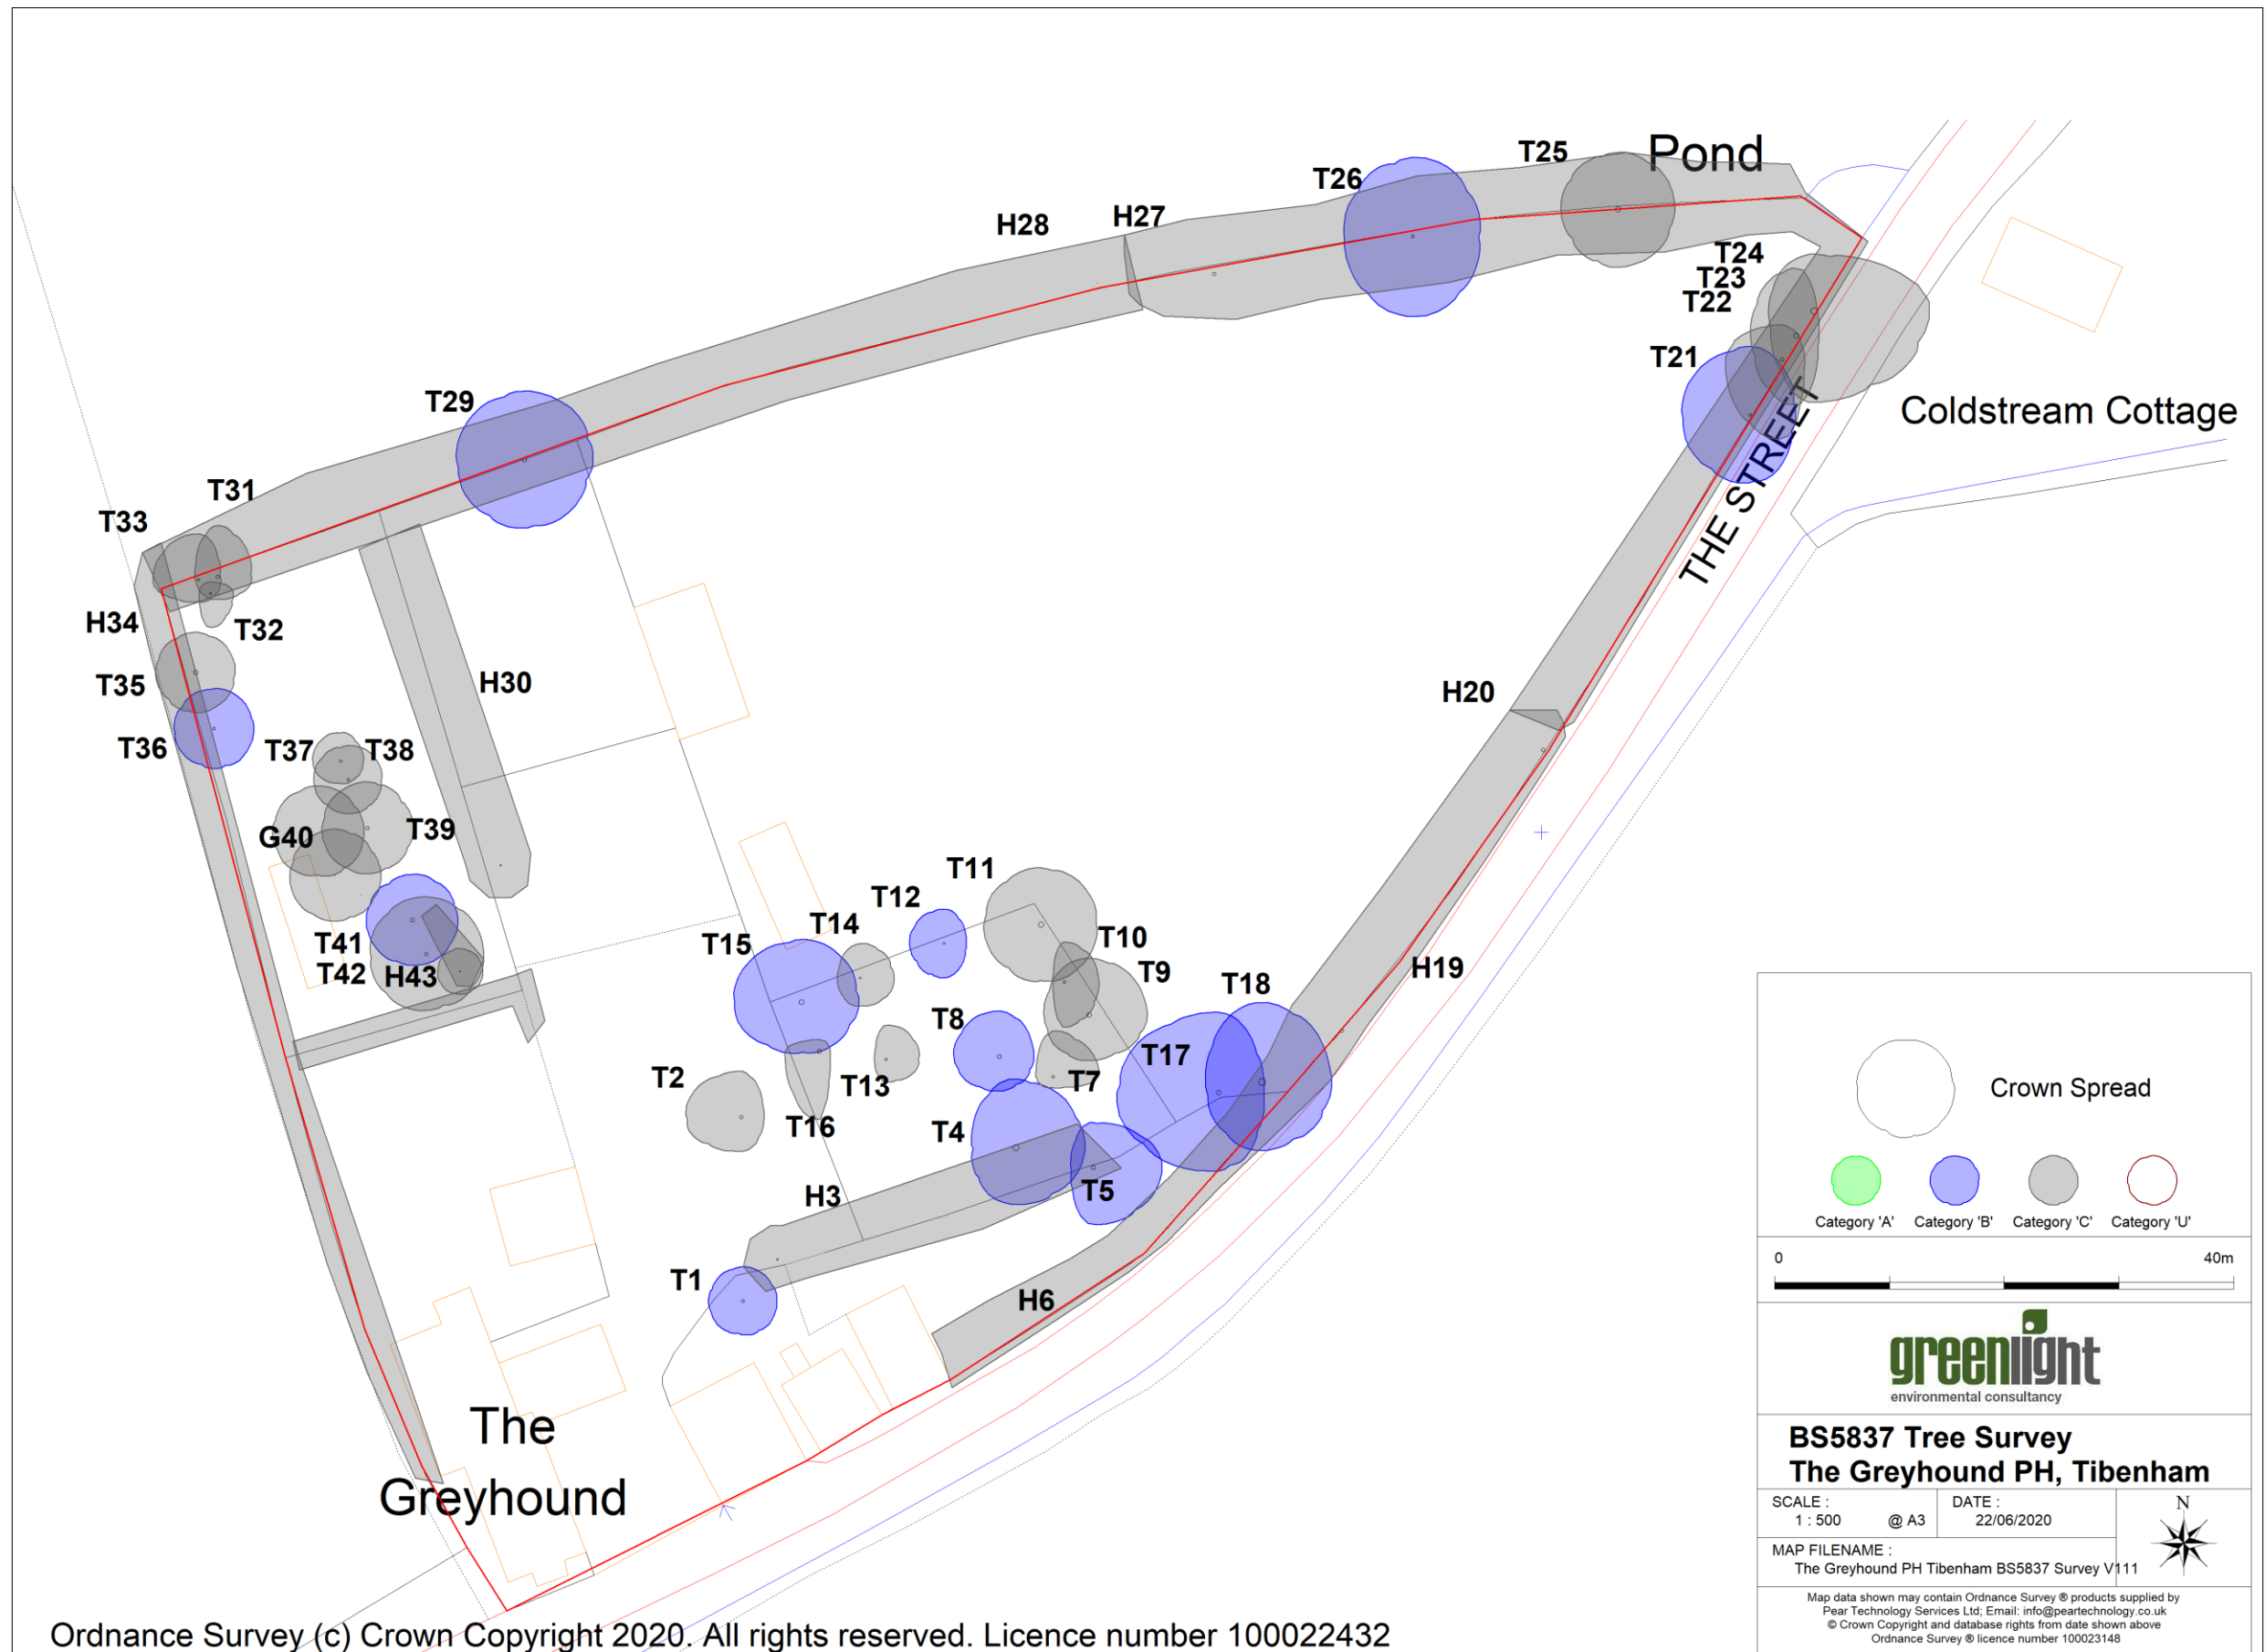
Figure 2: Tree Survey Barns

- 5.1 The trees likely to be affected on the site are plotted on a plan shown in Figure 2 above and their quality assessment according to the grading categories stipulated in the British Standard. A schedule of the detailed survey data is reproduced in a table at appendix A.

- 5.2 There are no trees deemed of high quality category A. The taller stature trees are making a high landscape contribution and many are awarded a category B grading. They are downgraded due to a reduced future contribution being derived from coppice stools, and the species. The more recent planting and hedgerows are of lesser quality and are graded category C along with a number of lesser trees with inherent defects. The cascade chart for tree quality assessment from BS5837:2012 is reproduced in appendix D.

- 5.3 It would be necessary to remove the group of small fruit trees by the existing static caravan to make room for the development. It is also proposed to remove a substantial section of roadside hedgerow to achieve a suitable visibility splay.

- 5.4 T2 is to be retained in the car park and will be protected.
- 5.5 There is a minor encroachment from the proposed driveway into the Root Protection Areas (RPA) of T11, 12, 14, 15 and T21-23. On all occasions the encroachment is less than 20% at the periphery of the RPA. A No-Dig construction for the driveway to the new dwelling in Plot 1 is advised.

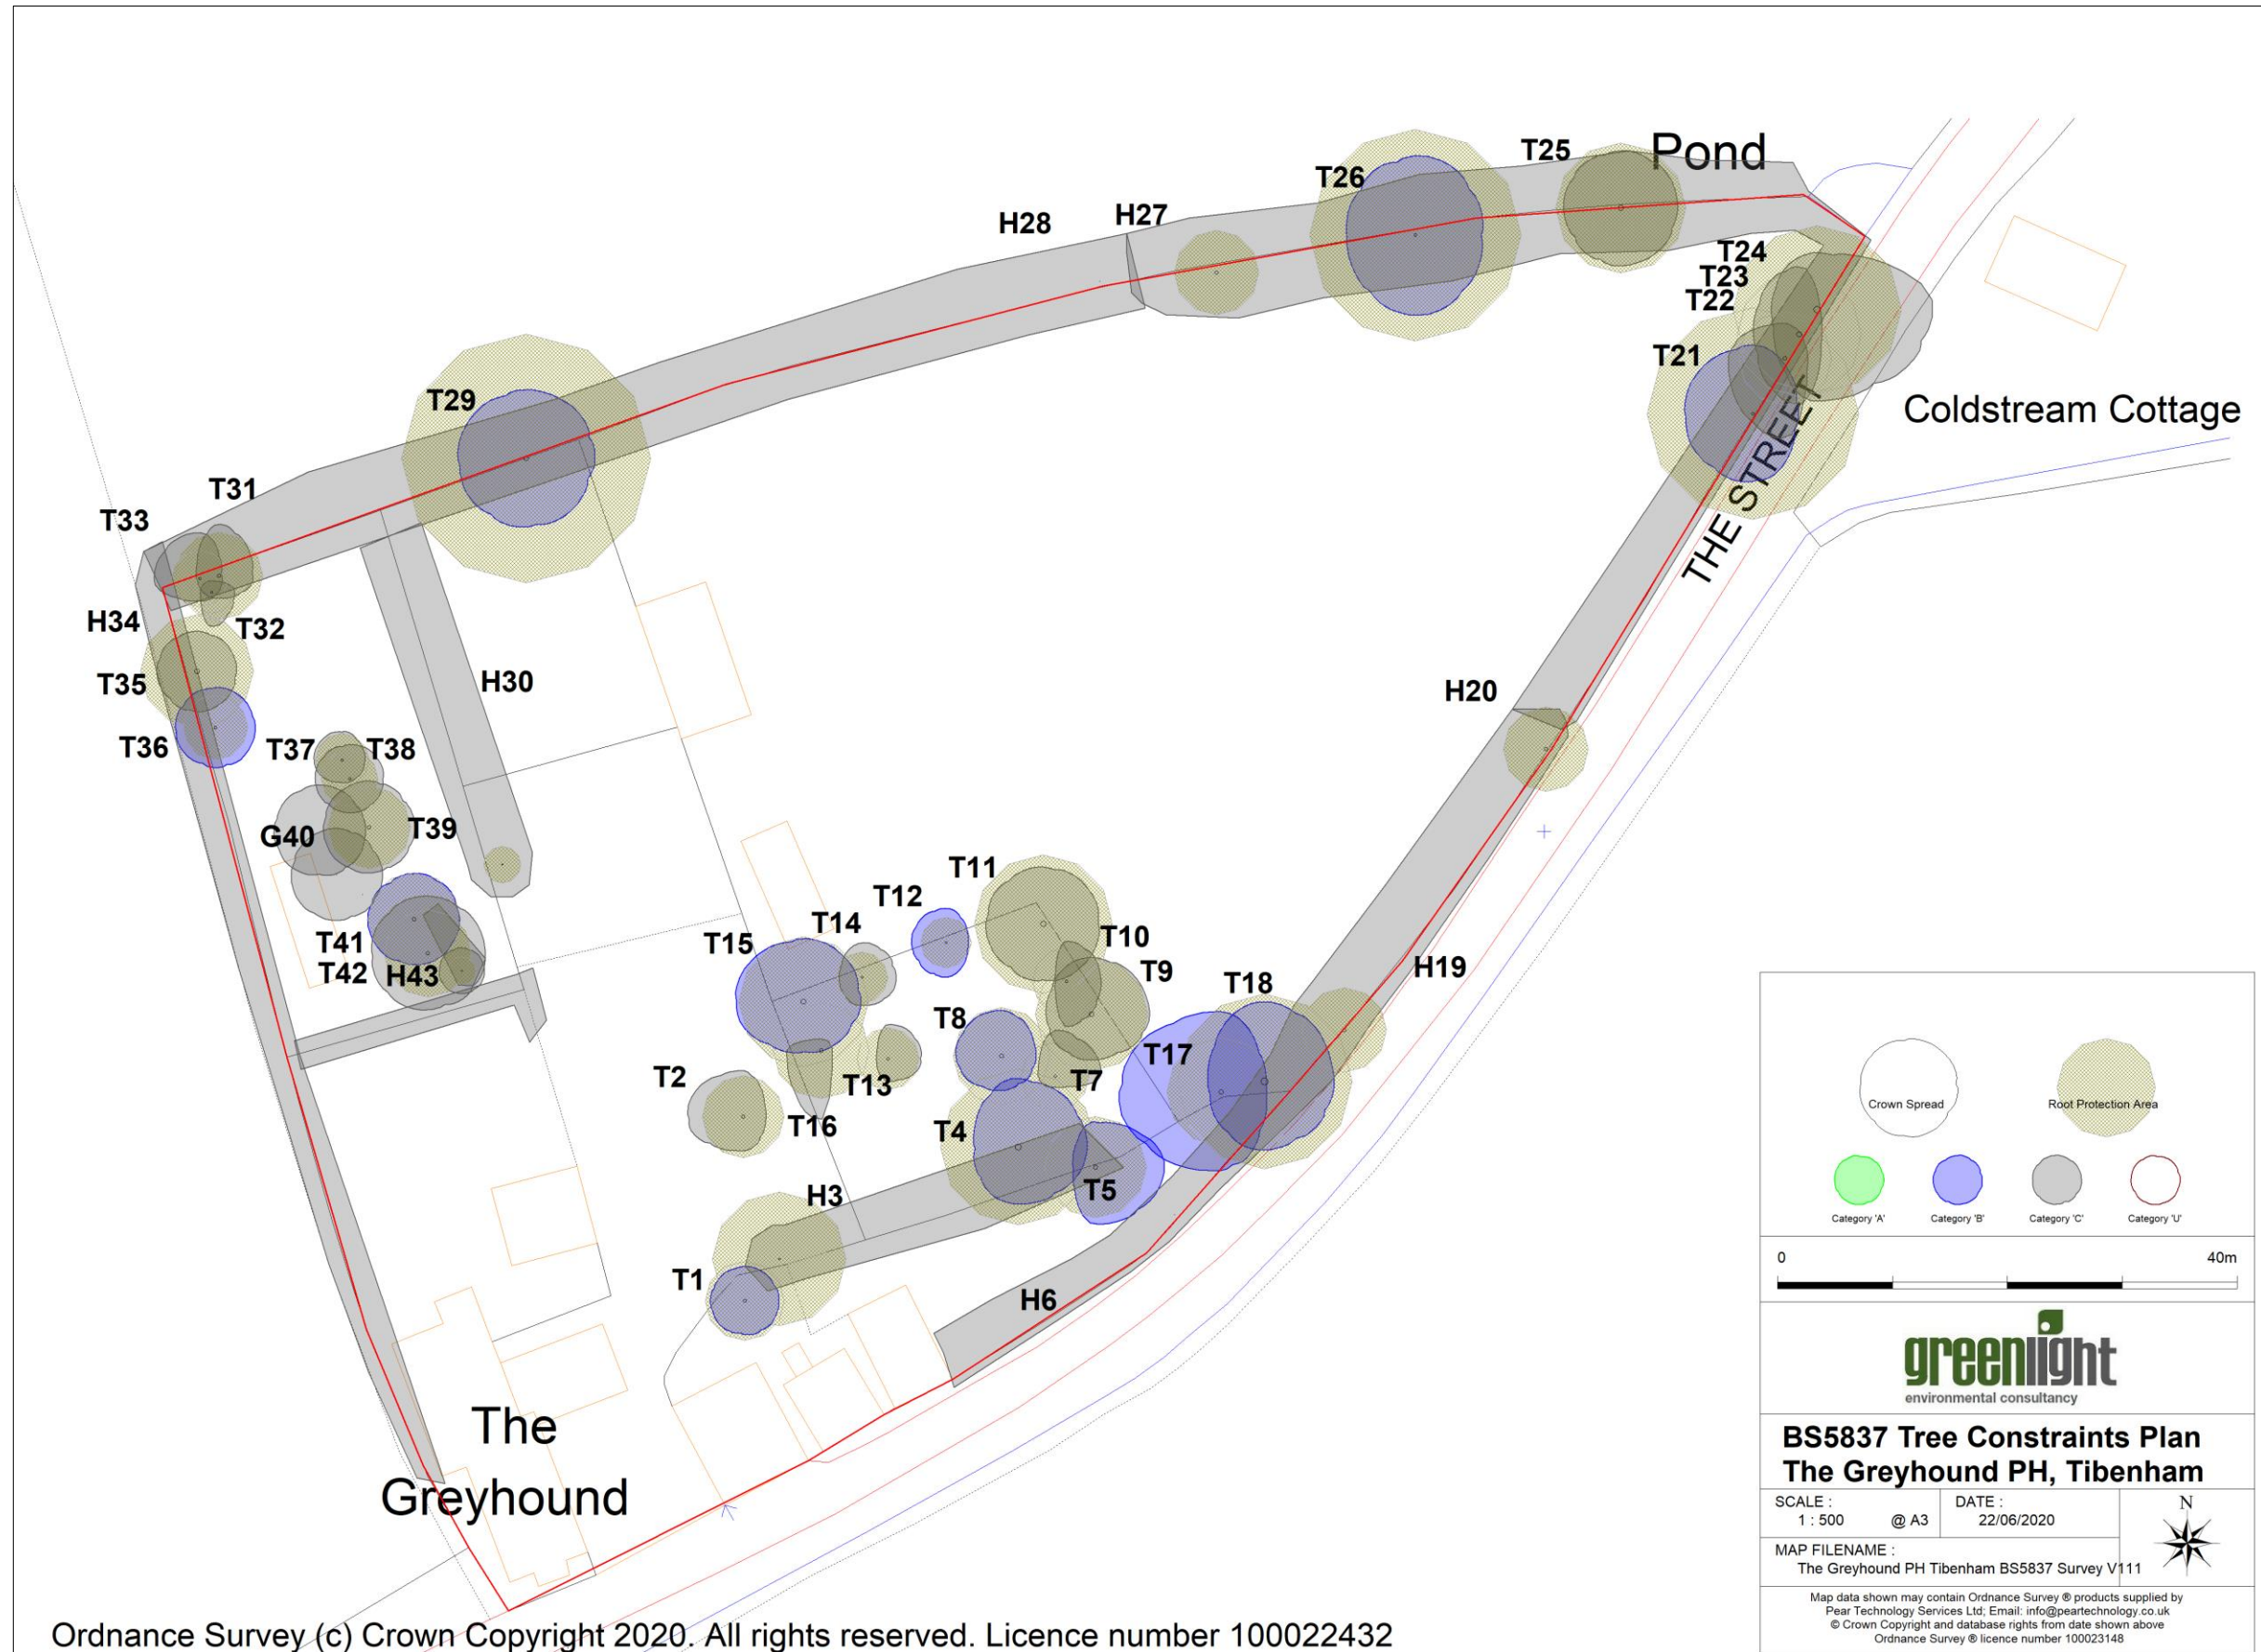
Figure 3: Tree Constraints Plan

- 5.10 The Tree Constraints Plan in Figure 3 shows the distance that construction should normally be kept away from retained trees to provide the Root Protection Area (RPA) recommended in BS 5837:2012. Full protection of the RPAs should be reinforced by creating Construction Exclusion Zones (CEZ) through the erection of protective fencing constructed to at least a minimum standard as prescribed in BS 5837:2012 and described in the Appendix C. This fencing should carry warning notices to prevent inadvertent encroachment.

- 5.11 In order to provide access for construction, the protective fencing is set back from the driveway. Further detail is provided in the Arboricultural Method Statement in appendix E.

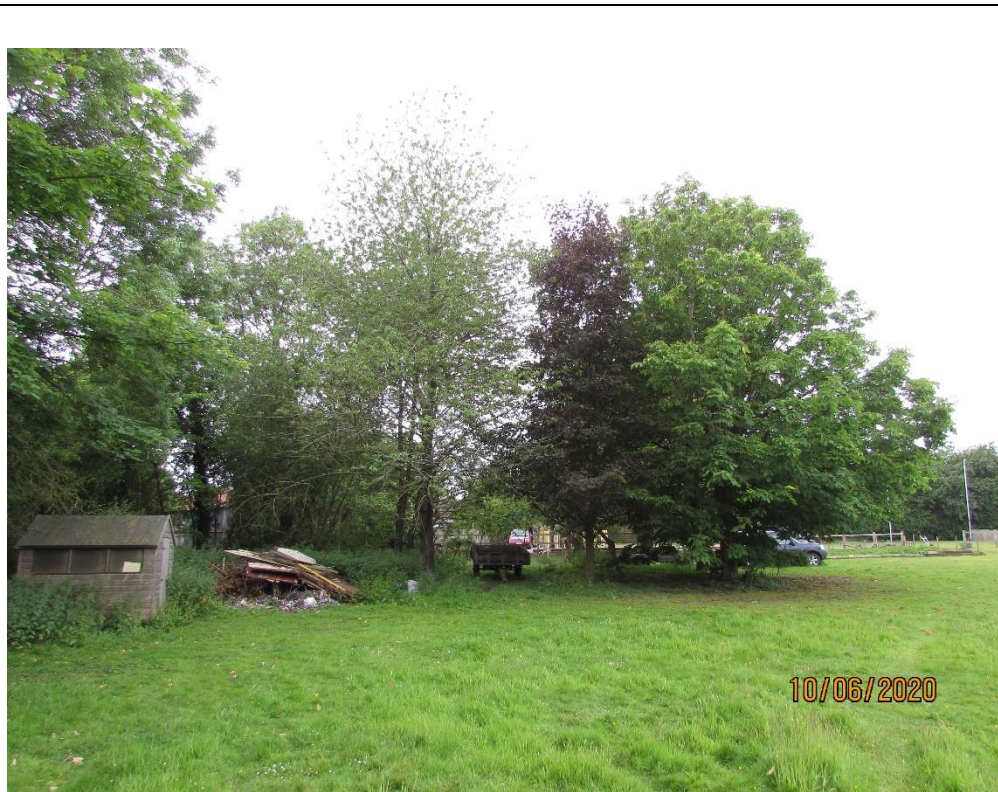
Overview of route of new access road

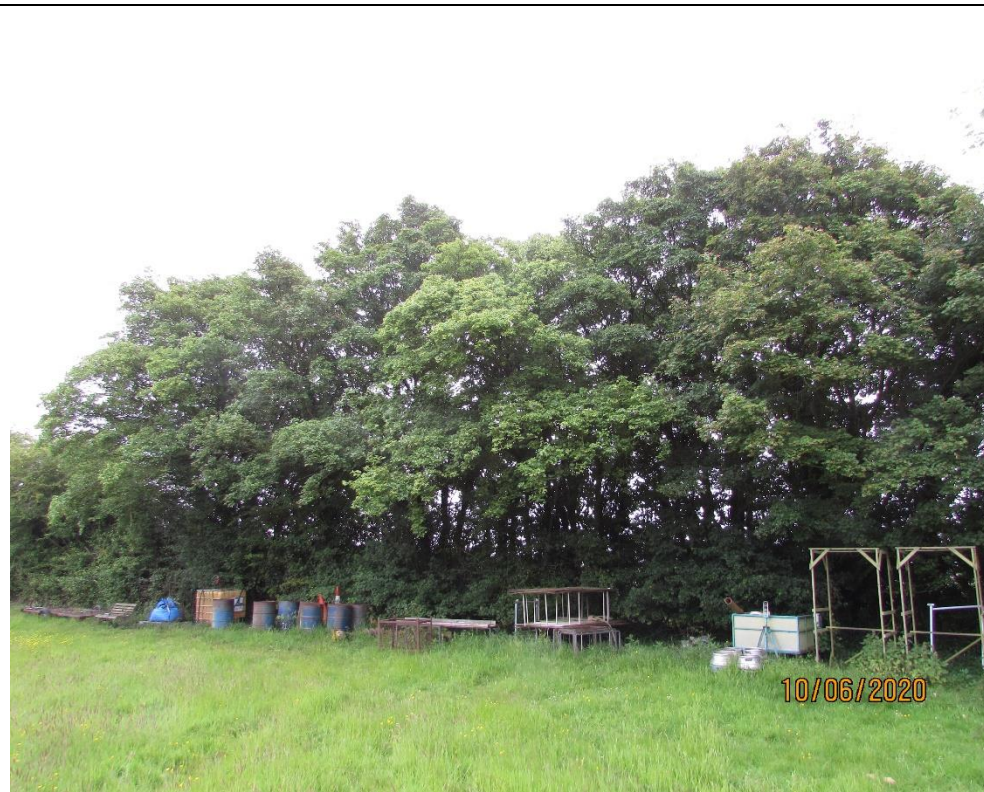
Roadside hedge H19

- 5.6 A new hedgerow is proposed at the back of the visibility splay by way of mitigation for the loss of the overgrown hedge. The trees T5, T17 and T18 will be crown lifted and retained. It is considered that there would be minimal impact on the landscape provided care is taken with materials and design.

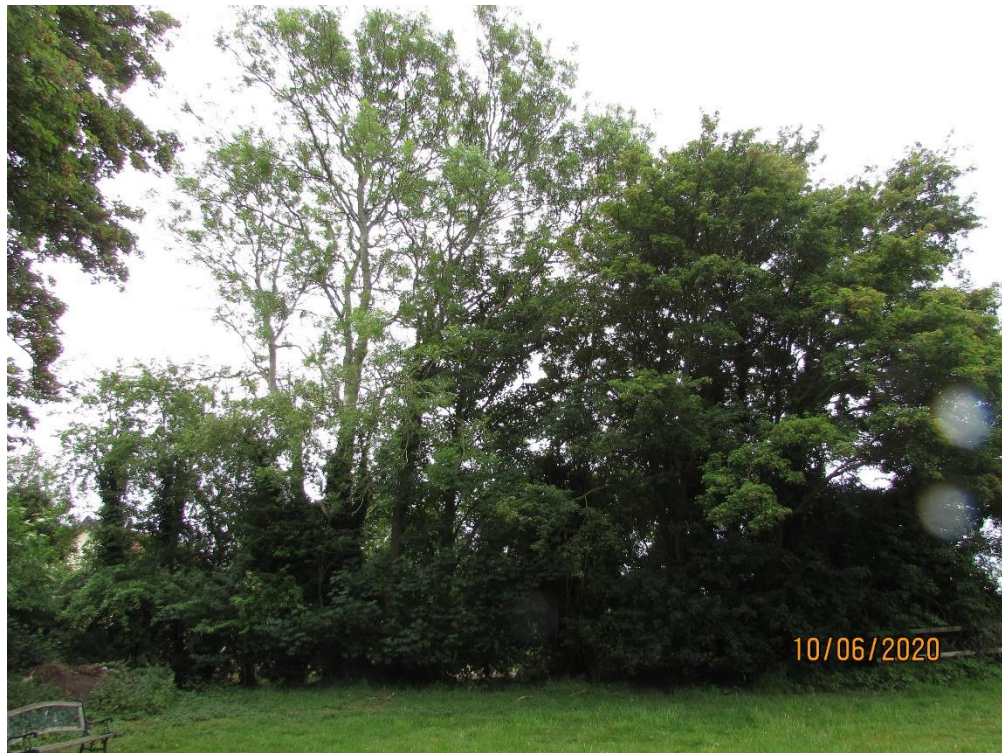
Multi-stemmed ash and field maple adjacent to proposed access for new dwellings

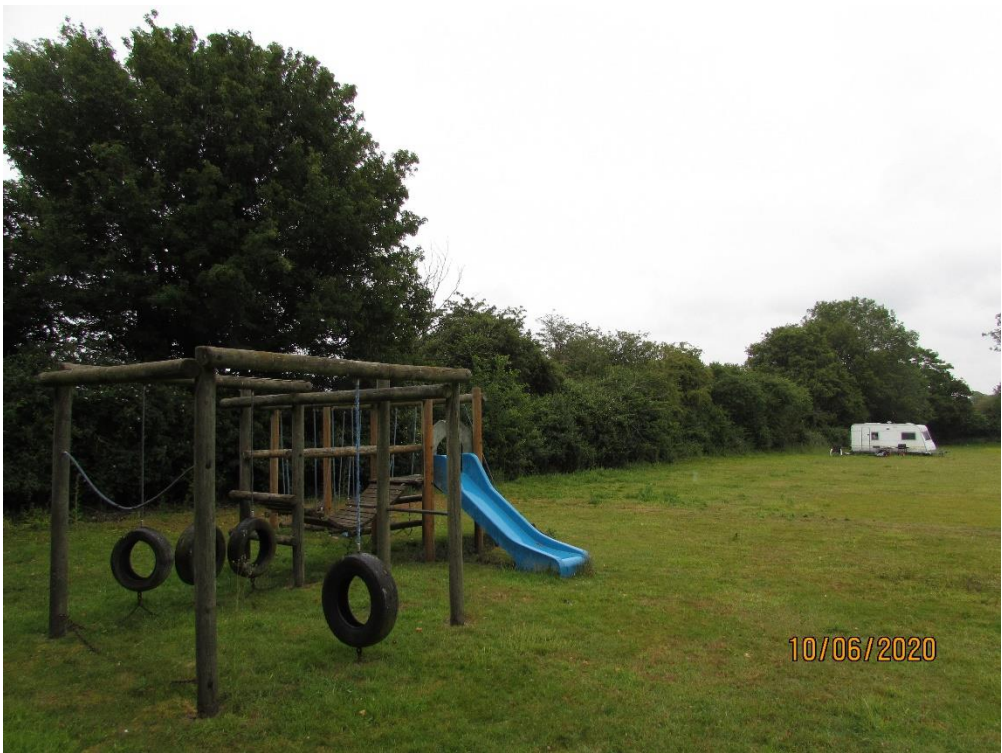
Northern boundary hedge H28

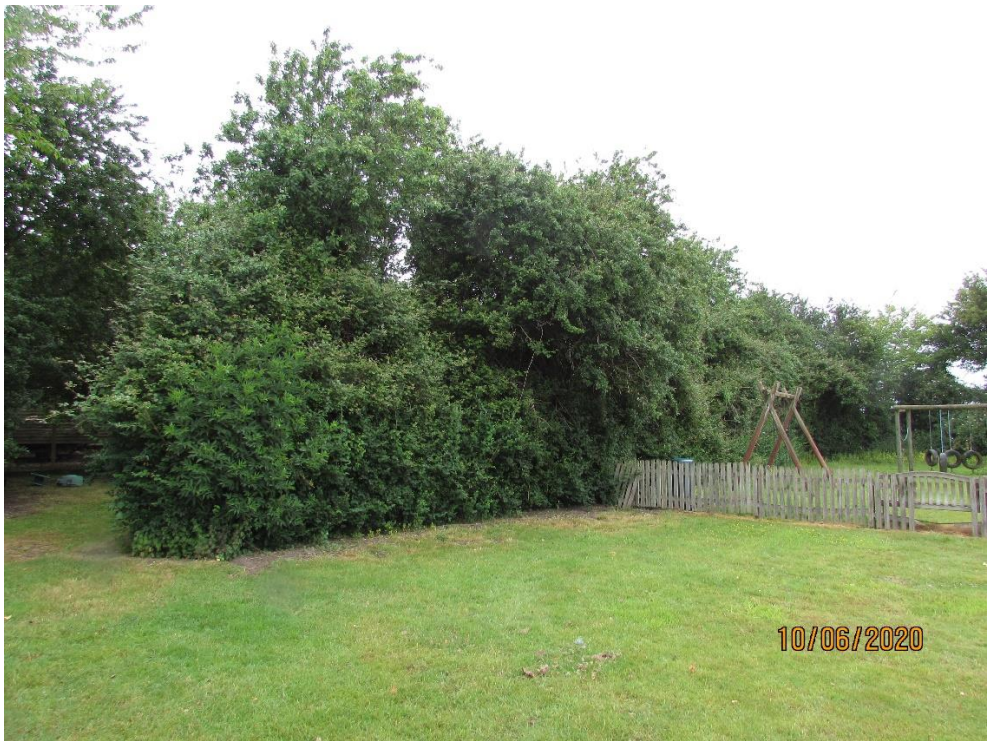
Hedge H30 to be removed
