Arboricultural Impact Assessment and Method Statement for: Lower Lodge, Ston Easton

5th October 2022

LowerLodge_AMS_102022

Building extension
with new site access
and parking

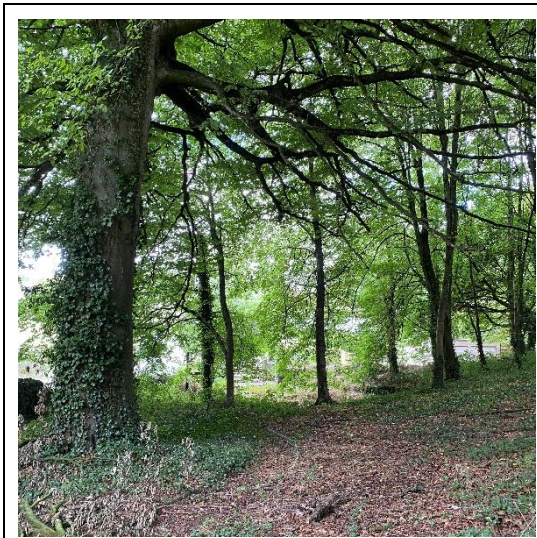
Plate 3: View of T08 from the south with trees 09-15 in background.

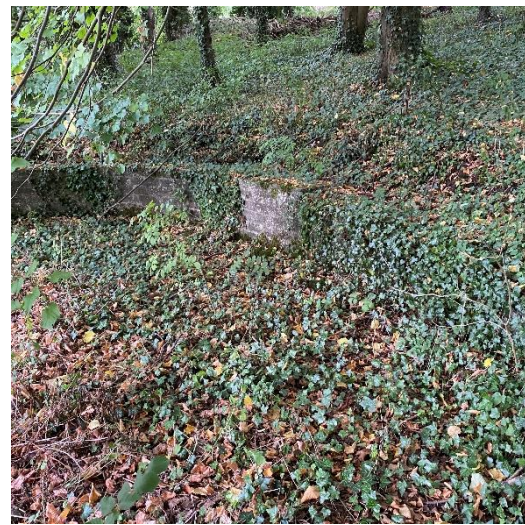
Plate 4: View of retaining wall around existing gravel parking area that will have restricted root growth of adjacent trees.

- 12.4 There is likely to be roots exploiting the soil to the rear of the retaining wall surrounding the existing carparking area to the north. The removal of the retaining wall within the RPA of tree 09 to achieve a continuous gradient between the parking area and the proposed driveway is likely to expose roots to damage therefore the driveway must be graded to the north leaving existing levels within the RPA of T09 unaltered.

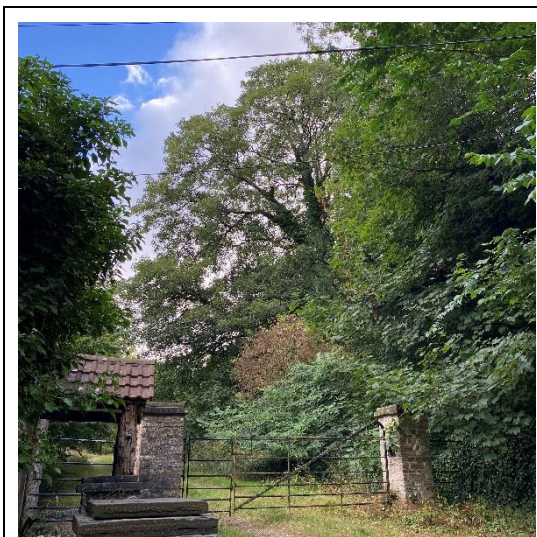
Plate 5: View of the south entrance drive with retaining wall on right that will have contained the roots of trees 18 and 19.

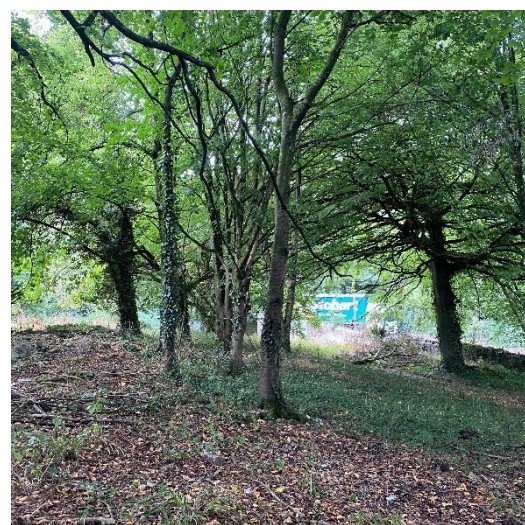
Plate 6: View from the north-east of trees 02-07 with T08 on right in background.

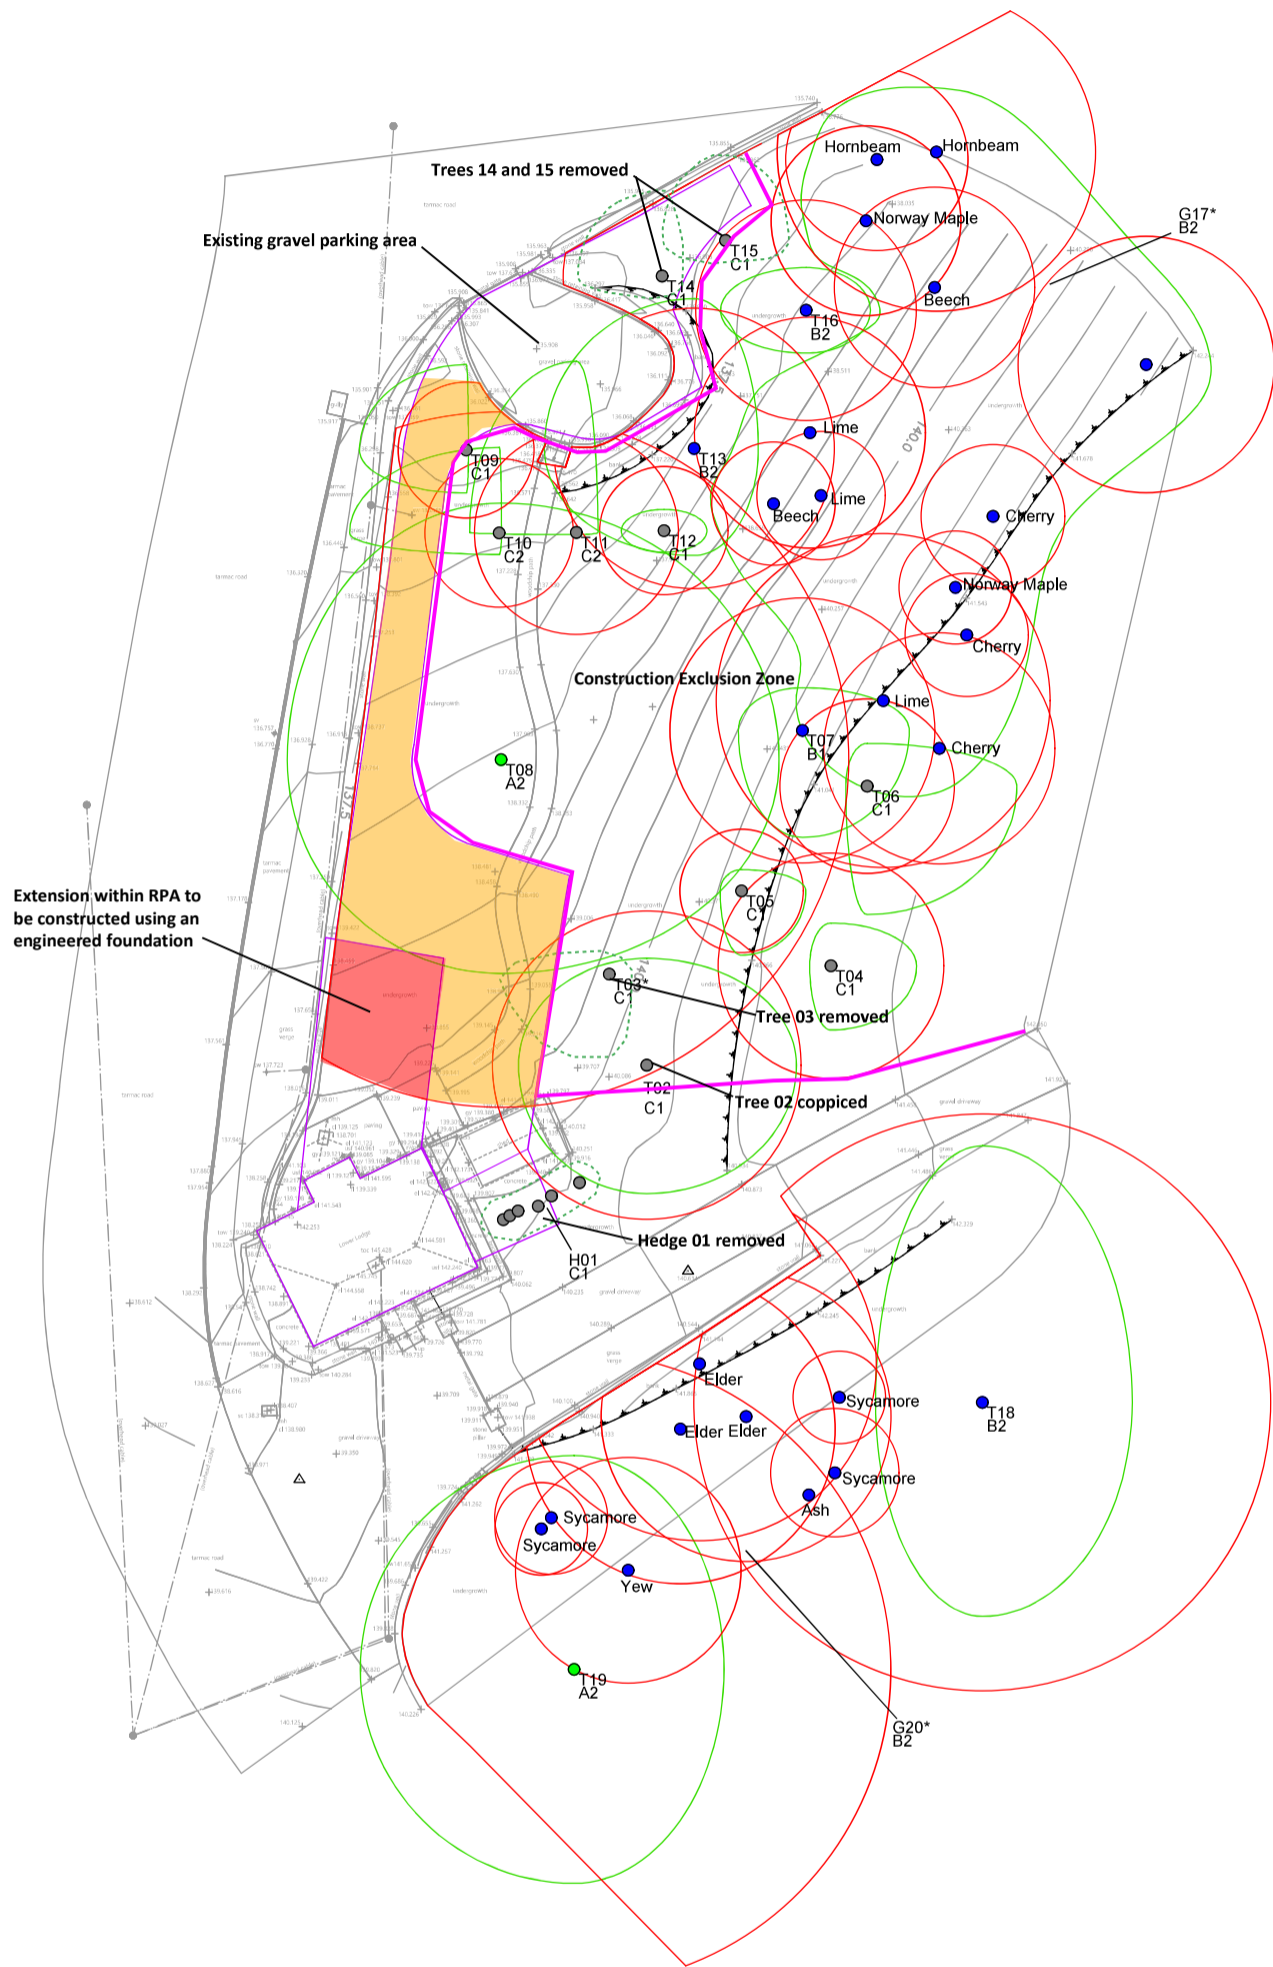
Drawing Title:
Tree Protection Plan

12.1 **Building extension:** The extension of the existing building to the north impacts 5% of the total amended RPA of T08. Conventional strip foundations are likely to sever significant roots and a traditional concrete floor slab will cause ground compaction and the asphyxiation of underlying roots. To prevent root damage an engineered foundation must be used within the RPA that prevents the severance of significant roots, prevents ground compaction and allows continued gaseous exchange from underlying roots. Such foundation types include pile and beam which requires a series of small diameter holes to be hand dug in order to avoid severing significant roots over 25mm in diameter. A ring beam is then formed on the piles above existing ground level onto which the extension can be constructed.

12.3 **Driveway and parking works:** It is proposed to extend the existing parking area on the north site boundary and create a driveway link along the west site boundary to Lower Lodge. The extension of the parking area will require the removal of trees 14 and 15 but has been designed to avoid the RPA of retained trees. The new driveway is within the RPA of T08, conventional driveway construction techniques will cause ground compaction and damage underlying roots therefore the driveway must be a NO DIG construction using a permanent ground protection system such as Cellweb⁵, surfaced with a porous wearing course.

15.1 **Barriers:** Following tree removals and before the commencement of any demolition or construction works on site, temporary protective barriers will be installed in the positions shown on the Tree Protection Plan.

16.1 **Driveway construction:** Following the erection of protective barriers and prior to any construction works on site permanent ground protection will be installed in the positions shown on the Tree Protection Plan to create the proposed driveway. The ground protection will consist of a 150mm deep⁶ Cellular Confinement Ground Protection System⁷, which will be laid in strict accordance with the manufacturer’s instructions and with *Arboricultural Guidance Note 12 The use of cellular confinement systems near trees: A guide to good practice*⁸.
