LISTED BUILDING CONSENT APPLICATION

REINSTATEMENT OF PART OF THE ROOF DESTROYED IN FIRE

THE MANOR,
HERRINGSWELL,
BURY ST. EDMUNDS,
SUFFOLK, IP28 6SH

OCTOBER 2022

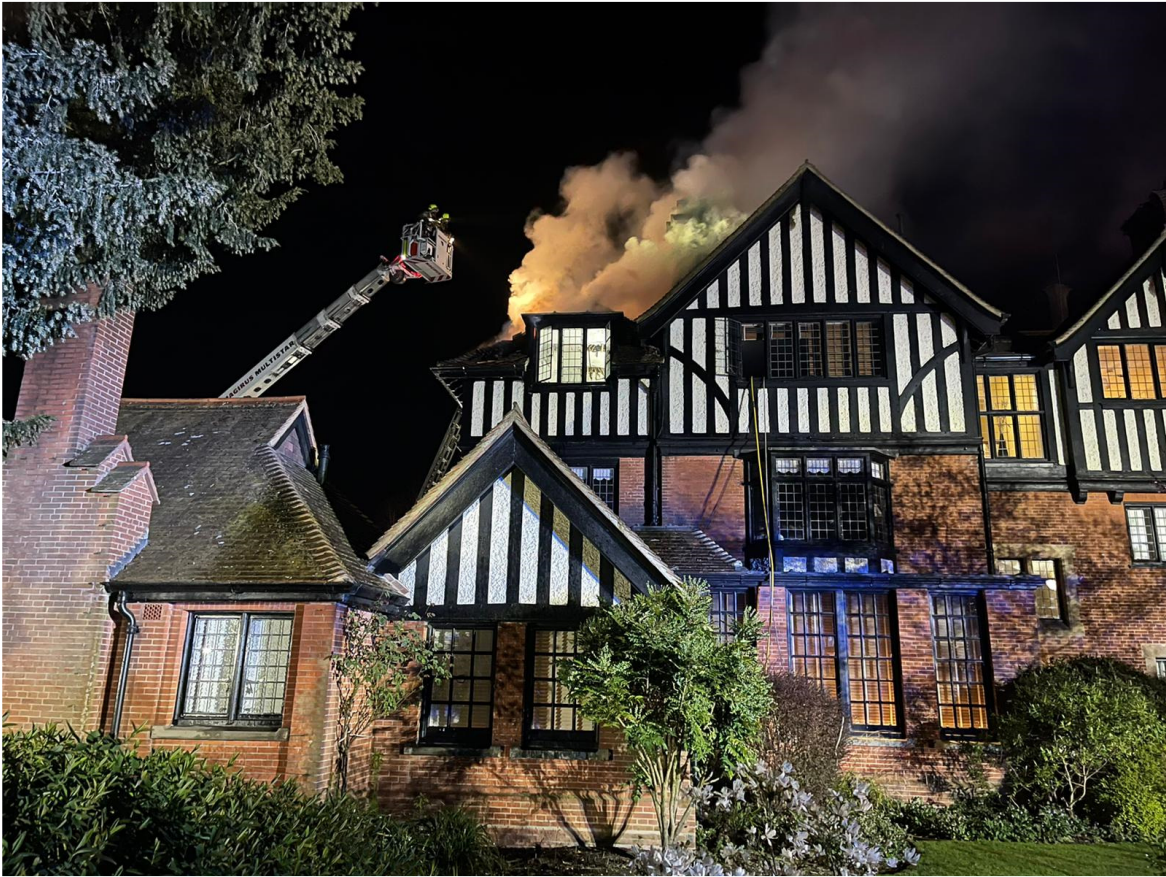
Above: photograph showing the extent of fire.
Below: The fire originated within the kitchen of Apartment 10.

The fire of Herringswell Manor took place on 26 March 2022 and damaged apartment No.10 as well as in small part external envelope of apartment No.8. This is a proposal to reinstate part of the roof as well as internal finishes and structures damaged in fire.

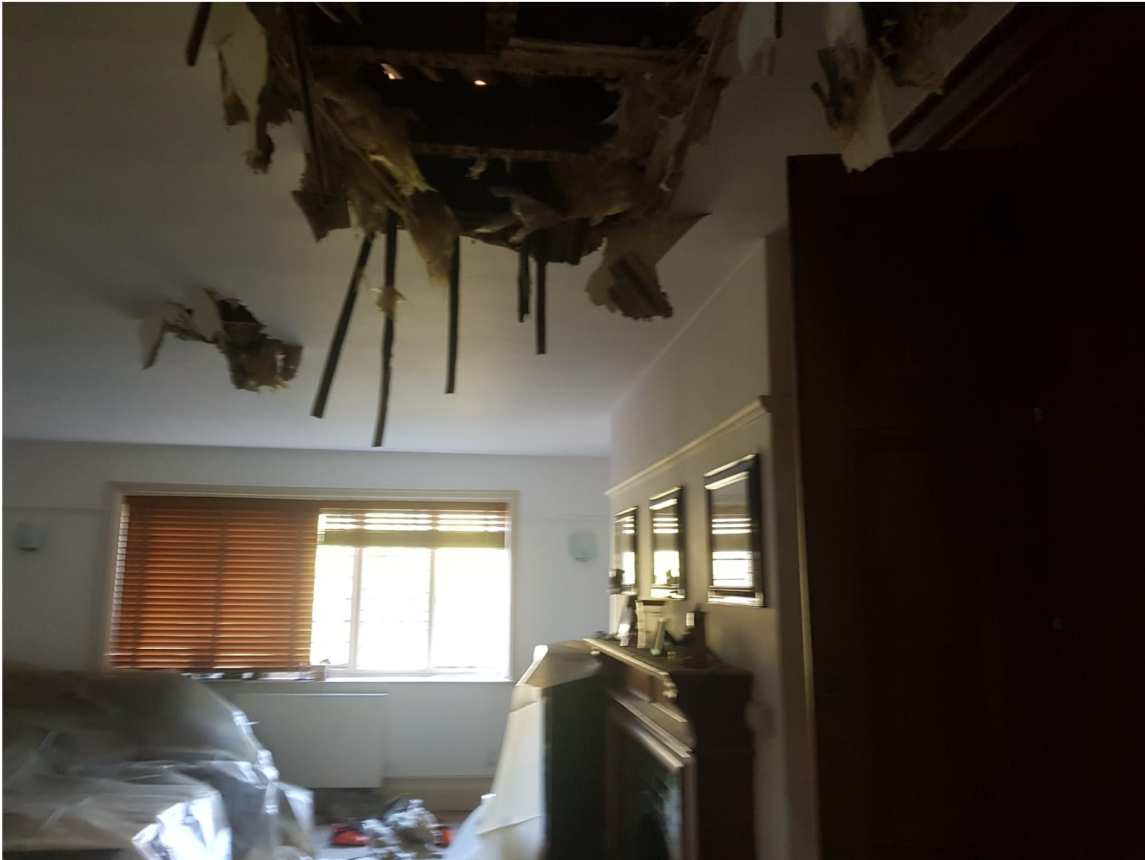
Above: fire damage to the apartment 10 living room.

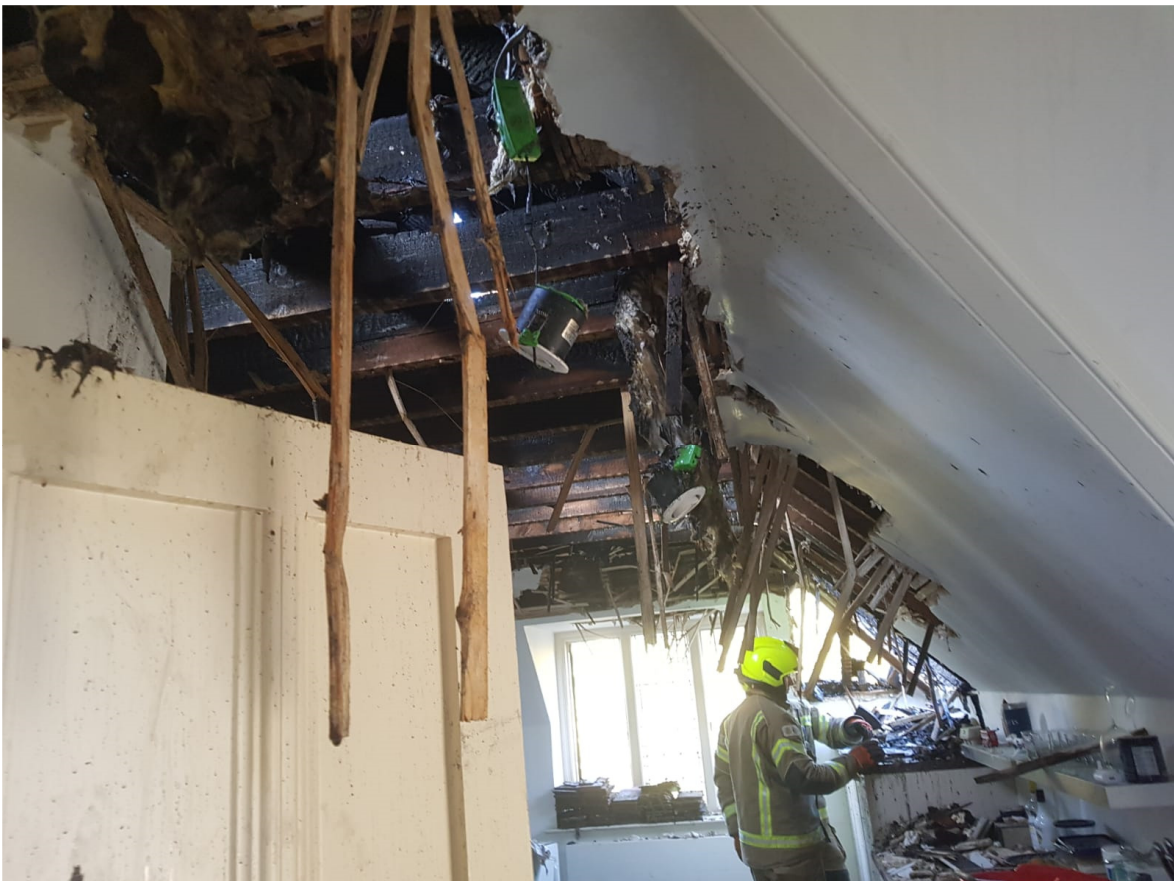
Below: photograph showing damage to the kitchen of the apartment 10.
This was the origin of the fire.

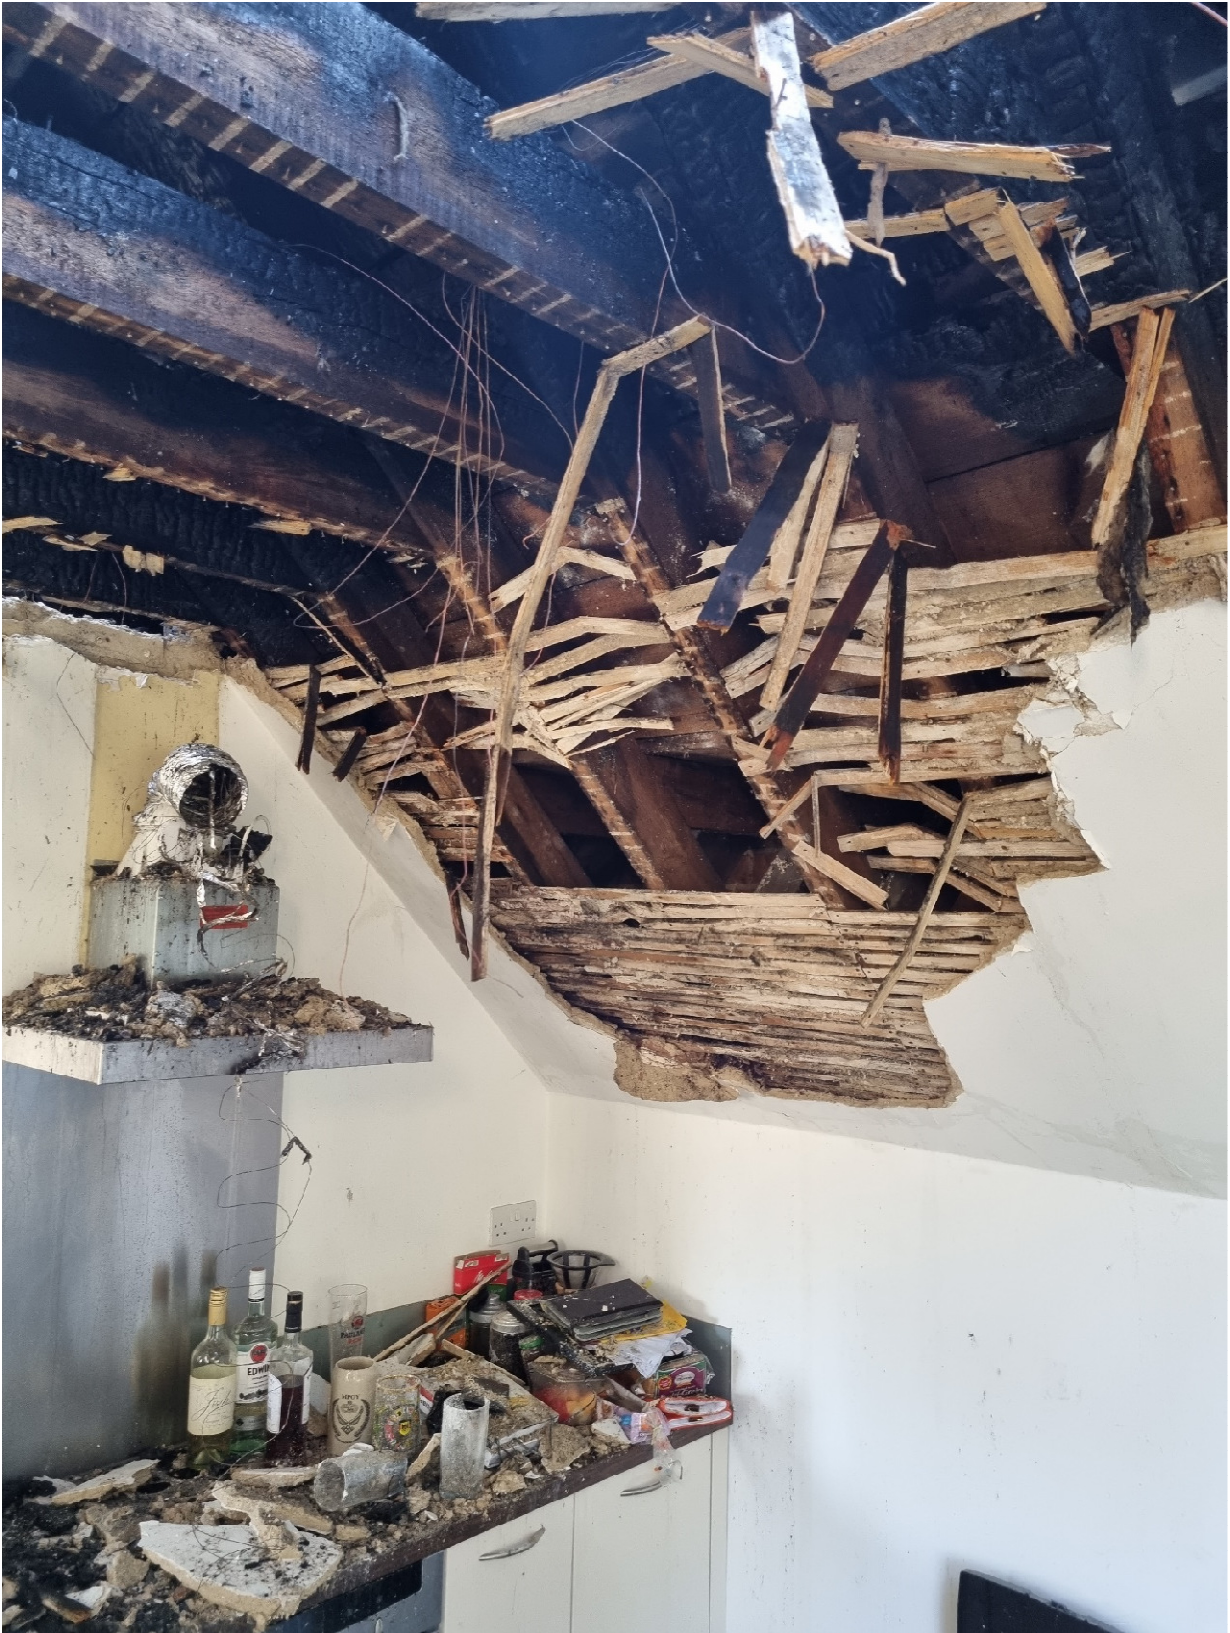
Above: photograph showing damage to the kitchen of the apartment 10.

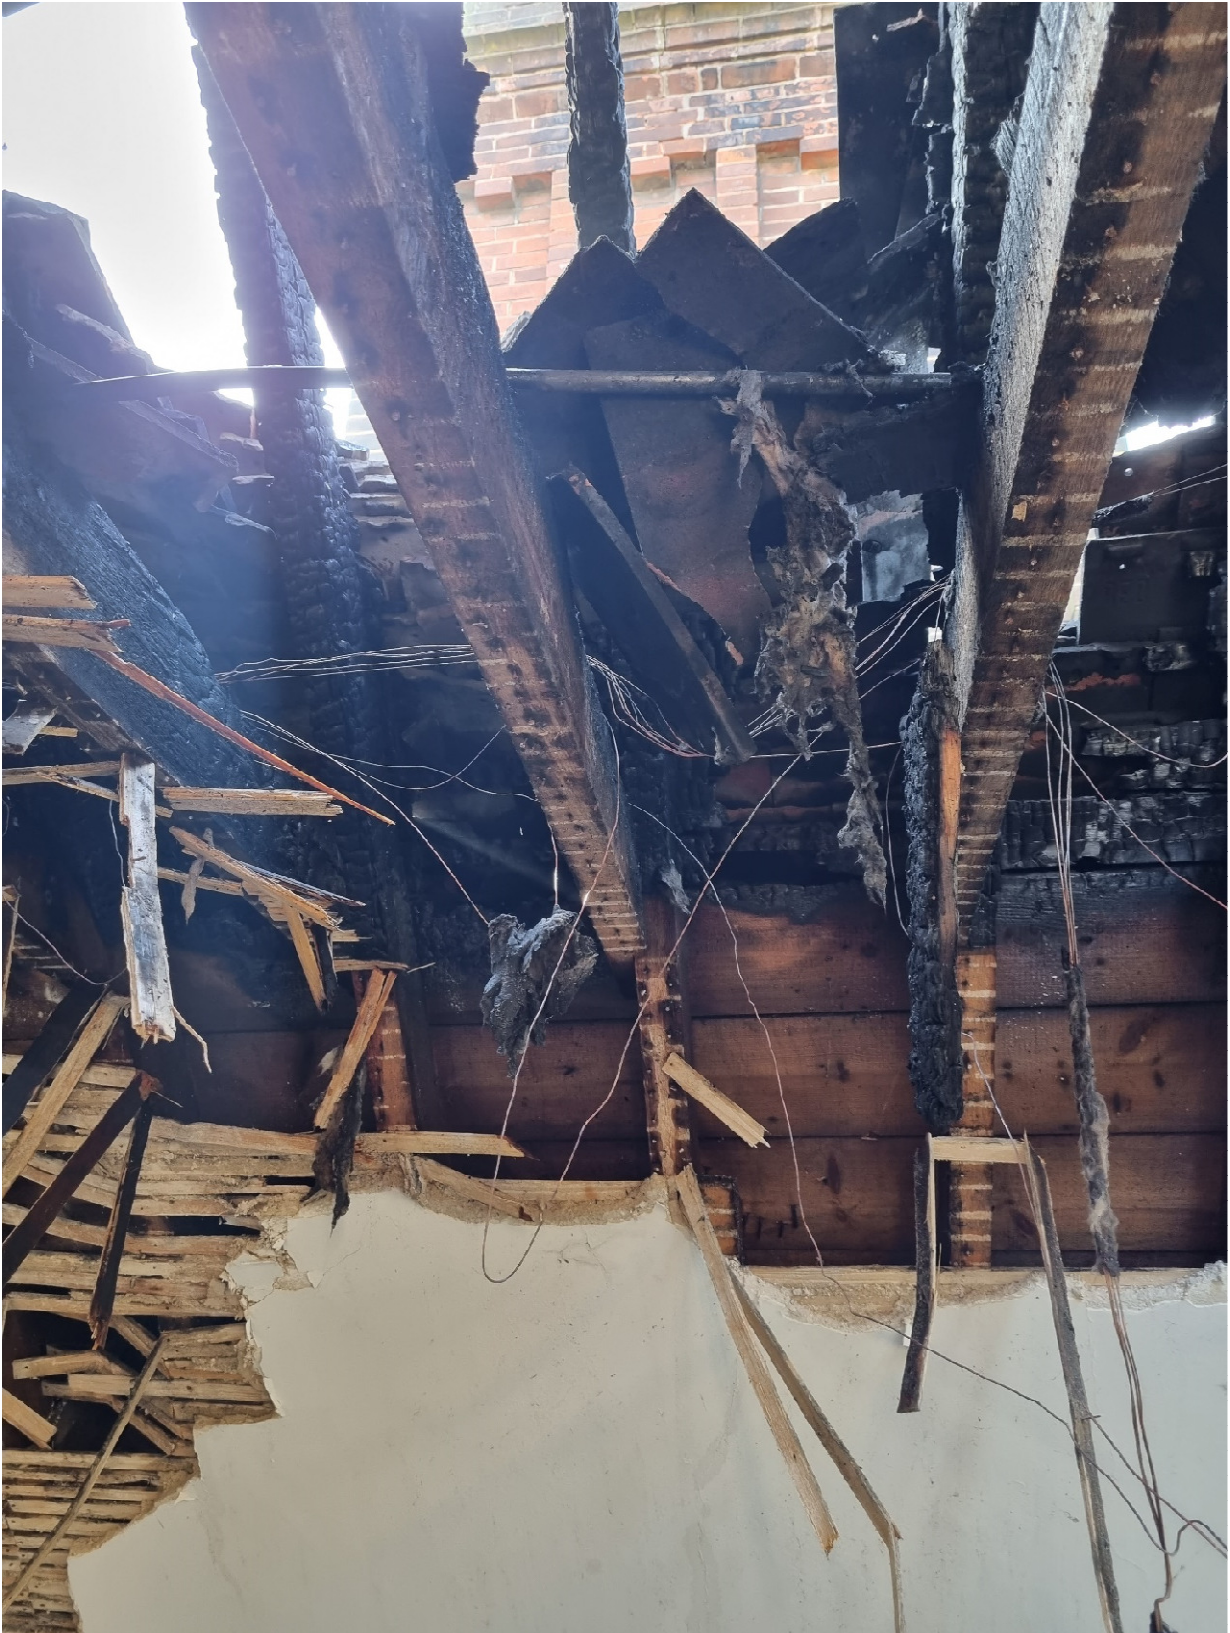
Above: kitchen of the apartment No.10. The location of the origin of the fire.

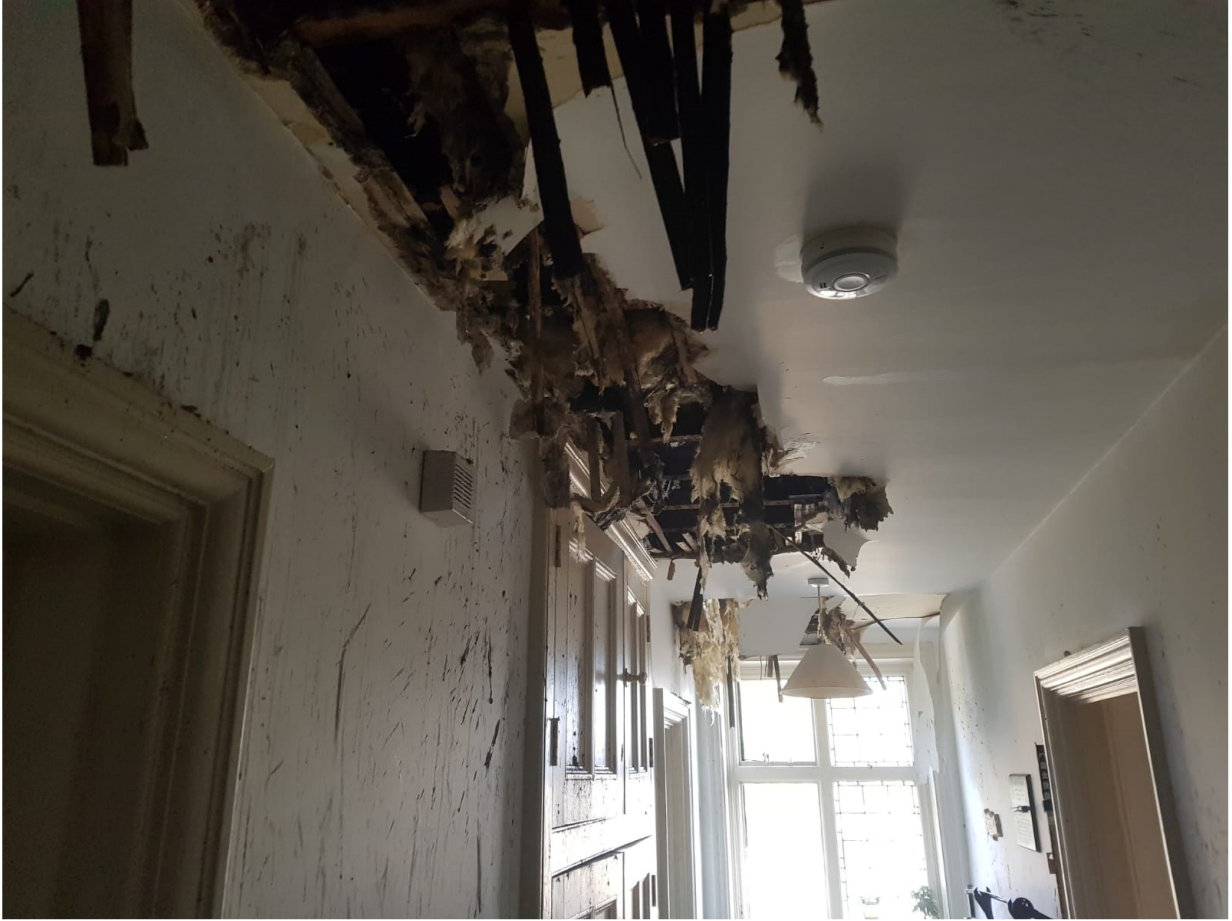
Above: photograph showing the extend of the damage to the hall of the apartment No.10.
