Project  
Refurbishment Works at The Old Rectory  
Clyst St Lawrence, CULLOMPTON, EX15 2NW  
for Drs Dixon

Dwg title  
Proposed Works  
Proposed Ground Floor Layout  
05 Window Repairs

dwg no	MD22 0411 - 45	Initial
scale	1:100	date
		drawn
		chkd.
		AJP

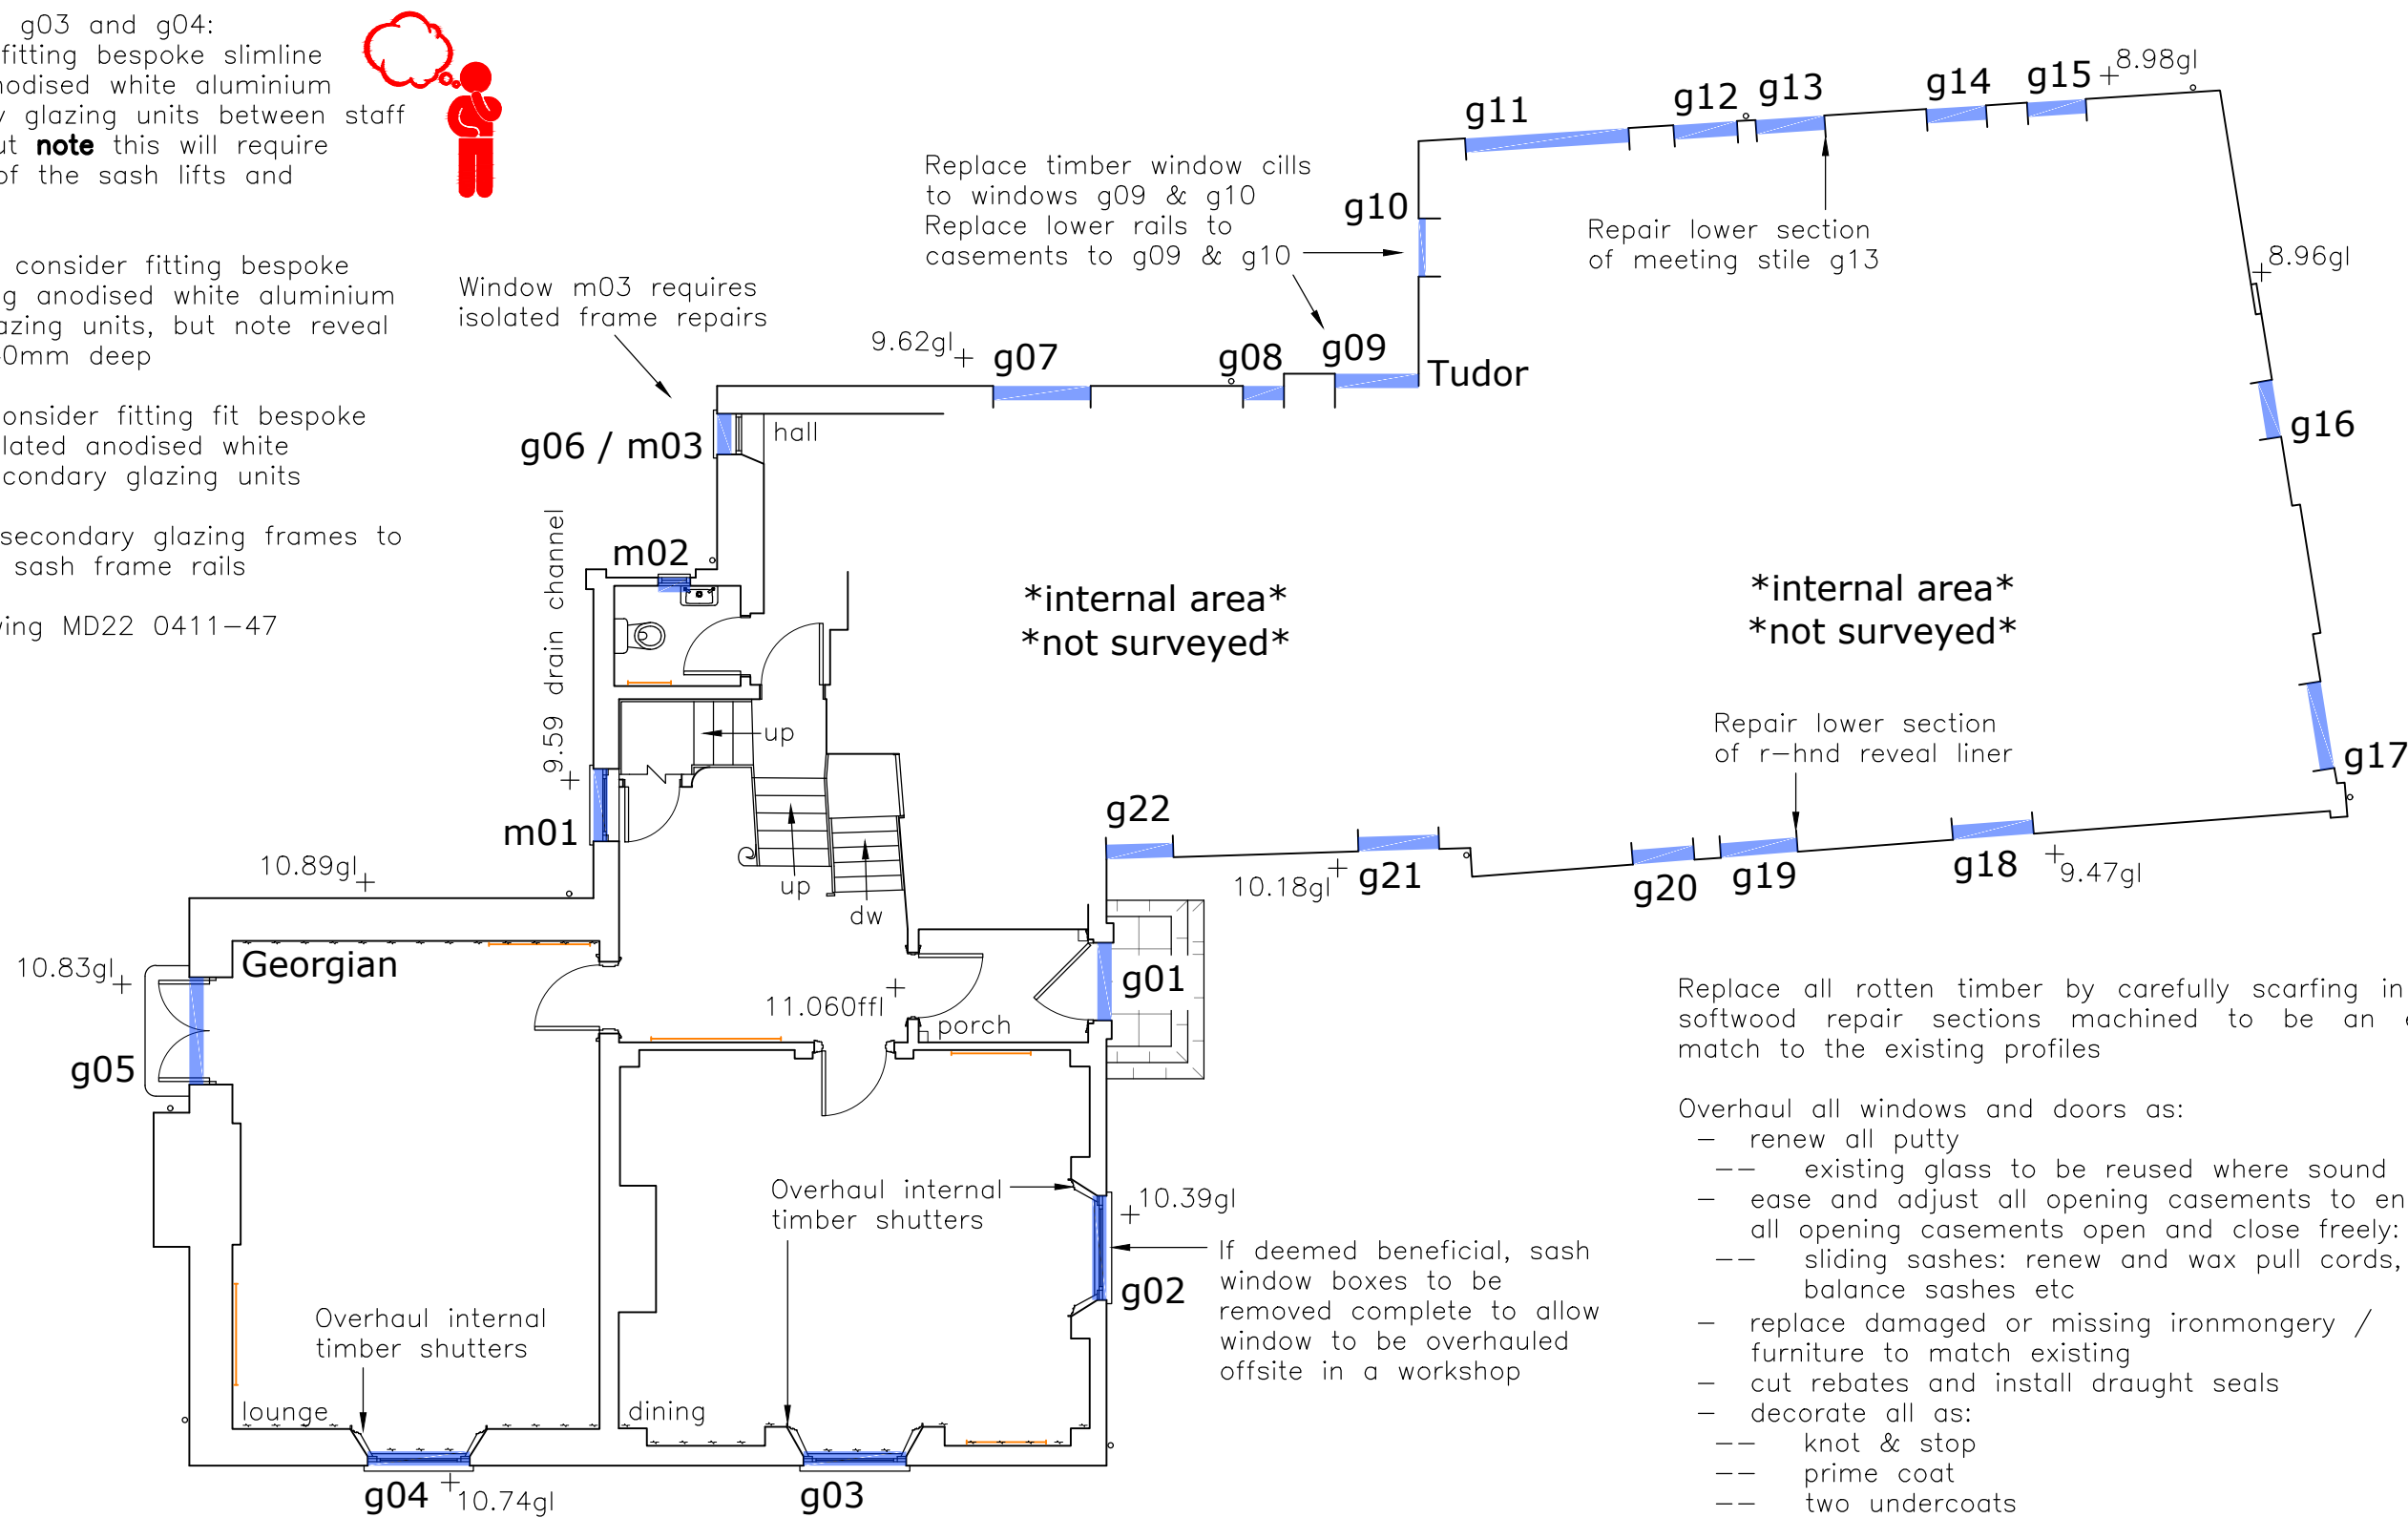
**Proposed Ground Floor Layout 1:100  
(05 Window Repairs)**

- windows g02, g03 and g04:
  - consider fitting bespoke slimline sliding anodised white aluminium secondary glazing units between staff beads, but **note** this will require removal of the sash lifts and fasteners
- window m01; consider fitting bespoke slimline sliding anodised white aluminium secondary glazing units, but note reveal only 30 to 40mm deep
- doors g05; consider fitting fit bespoke fixed & ventilated anodised white aluminium secondary glazing units
- all windows; secondary glazing frames to coincide with sash frame rails
- refer to drawing MD22 0411-47

Replace all rotten timber by carefully scarfing in new softwood repair sections machined to be an exact match to the existing profiles

Overhaul all windows and doors as:

- renew all putty
  - existing glass to be reused where sound
- ease and adjust all opening casements to ensure all opening casements open and close freely:
  - sliding sashes: renew and wax pull cords, balance sashes etc
- replace damaged or missing ironmongery / furniture to match existing
- cut rebates and install draught seals
- decorate all as:
  - knot & stop
  - prime coat
  - two undercoats
  - two topcoats; colour to match existing
  - ensure all opening casements open and close freely following decoration

If deemed beneficial, sash window boxes to be removed complete to allow window to be overhauled offsite in a workshop
