# DESIGN AND ACCESS STATEMENT

**Fir Grove Farmhouse, Wreningham**

**Listed Building and Planning Application**

**October 2022**

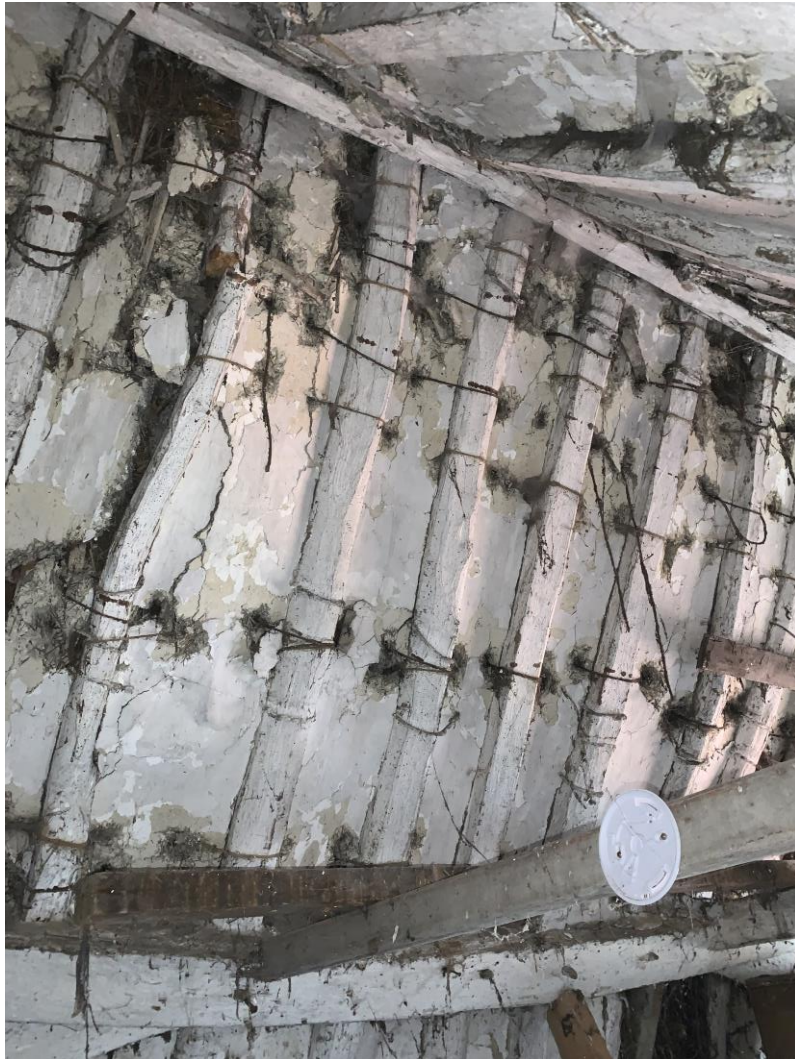
**MODERN ROPE TIES AROUND PREVIOUSLY LIMEWASHED RAFTERS**

The thatch is in need of replacement. It is causing water ingress which has led to extensive decay and breaking of the original roof framing (mostly oak, possibly with some ash or other smaller timbers). There are some older rope ties around the rafters, indicating installation before the rafter and daub ceiling were limewashed. But there is also evidence of a modern fixing of the thatch with rope which is not limewashed. This indicates original thatch was removed when the roof was recovered in the late C20th by the previous owners.

Repairs to the extensively damaged and missing rafters will need to be carried out following complete removal of the decayed and soaked thatch. Although there may have been a 'permanent' foundation layer when the thatch was laid, the long-term damage and soaking which has occurred means even a dense layer must now be removed in order to carry out traditional repairs and replacement of the most damaged rafters.

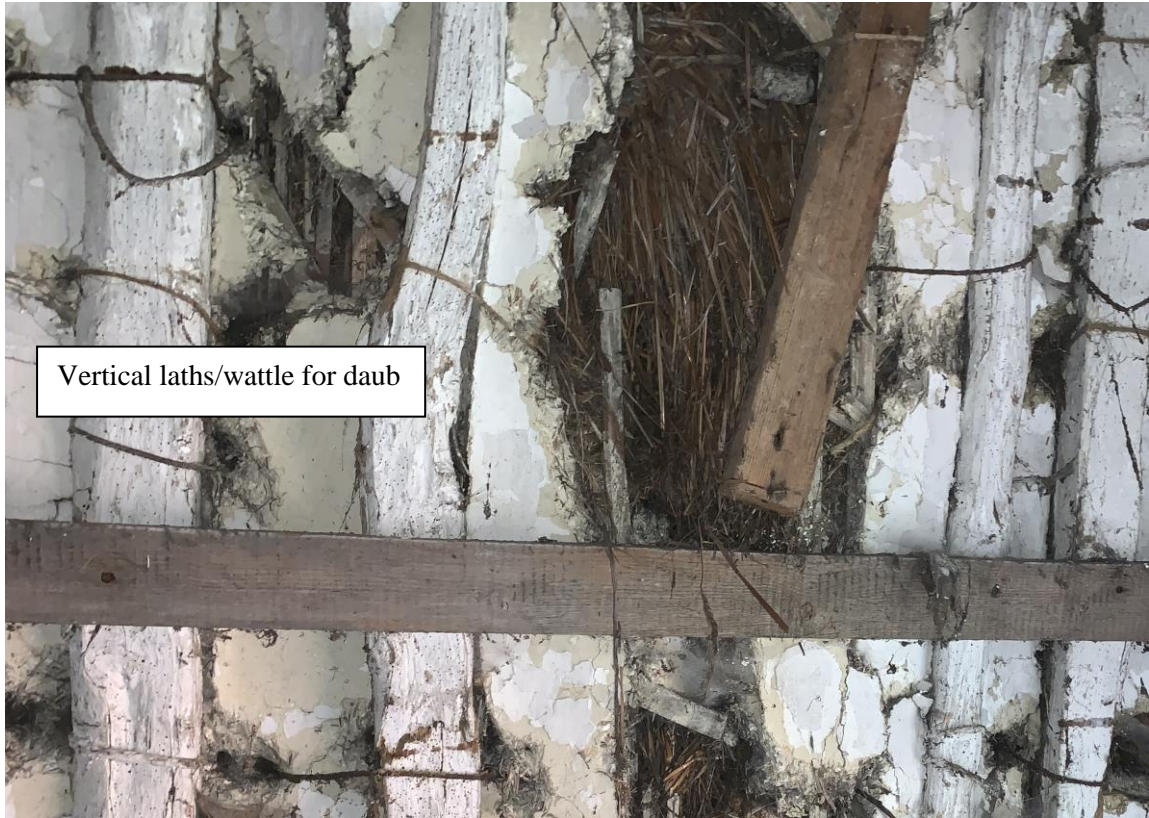
The presence of a separate layer of wattles/laths to support the daub ceiling panels suggests that retention of the daub may be possible as it is on a separate structure to the thatch. There are indications of the horizontal battens under the thatch.

Vertical laths/wattle for daub

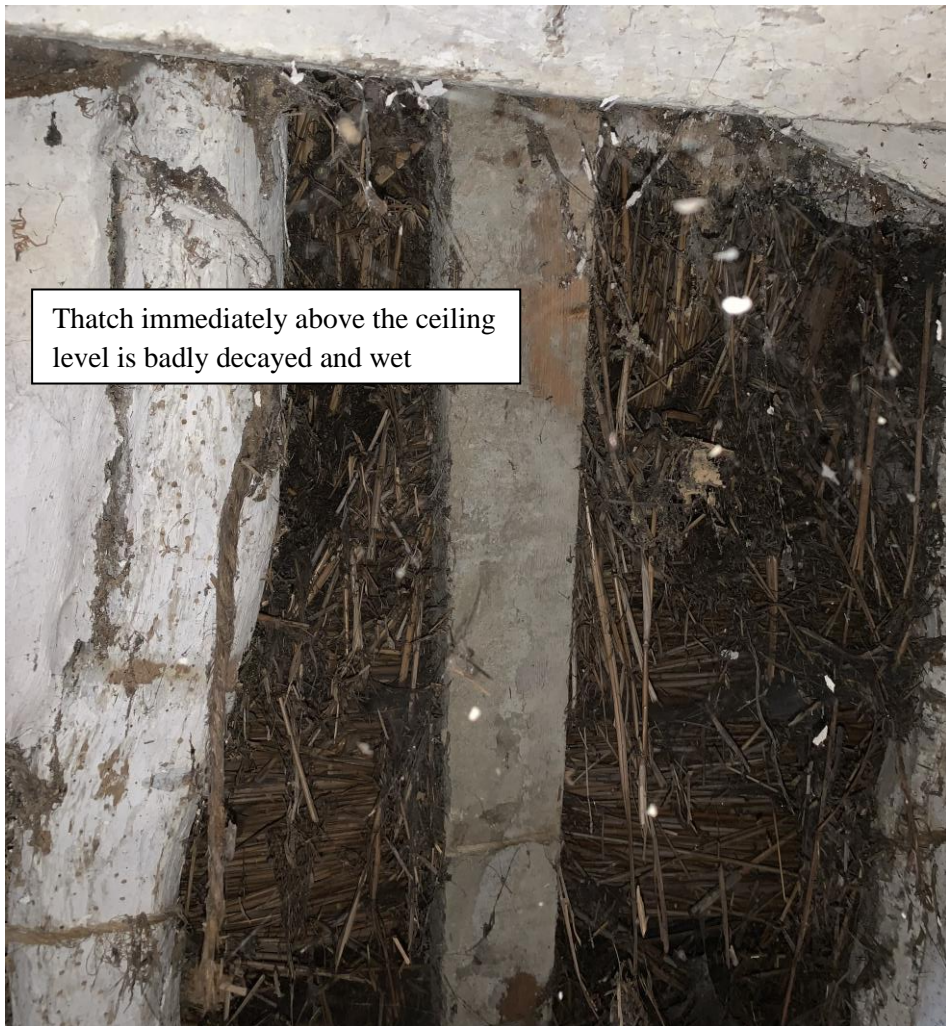
Thatch immediately above the ceiling level is badly decayed and wet

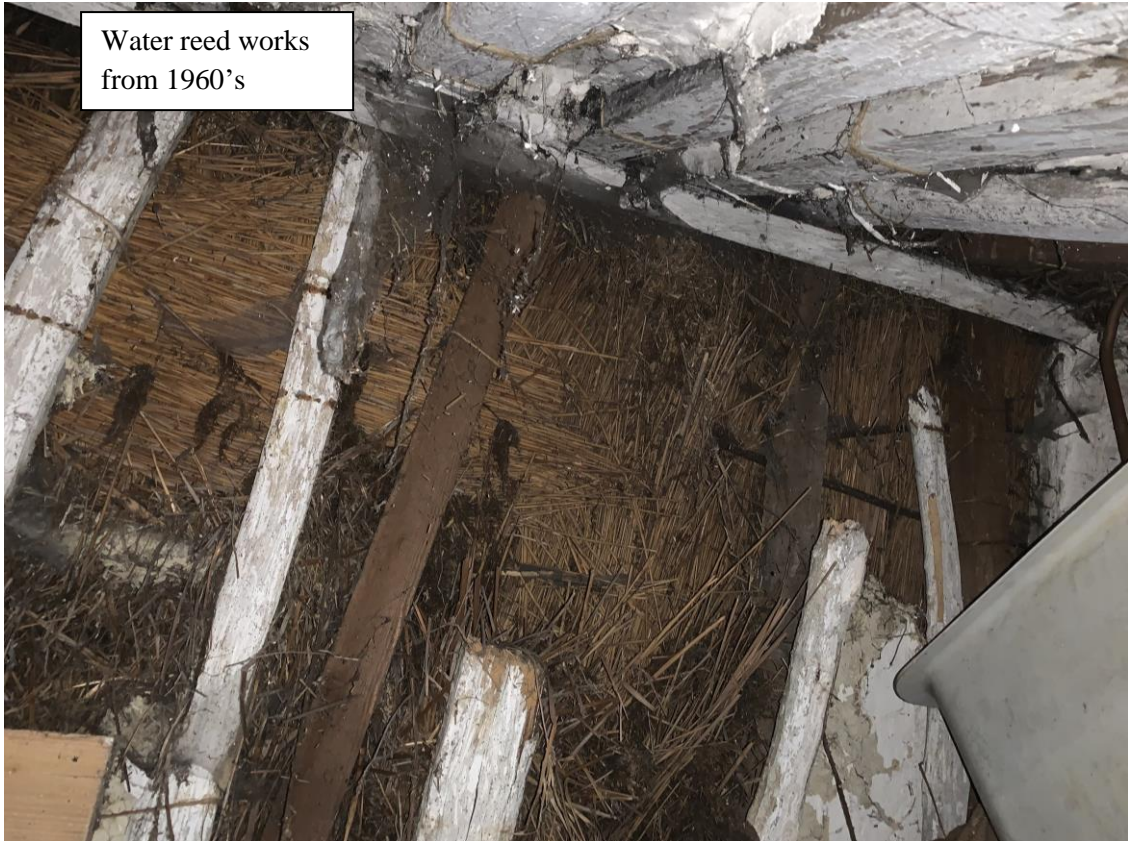
**EXPOSED UNDERSIDE OF REPLACEMENT THATCH & EXTENSIVE RAFTER DECAY**

**However** - the proposal is to remove the thatch in order to carry out the timber repairs as justified above, then to tile the main roof with plain clay tiles (or pantiles if preferred). Justification for this is the high cost of insurance for houses with thatch and the extreme difficulty in finding insurance for a house of thatch combined with timber framed and wattle and daub walls.

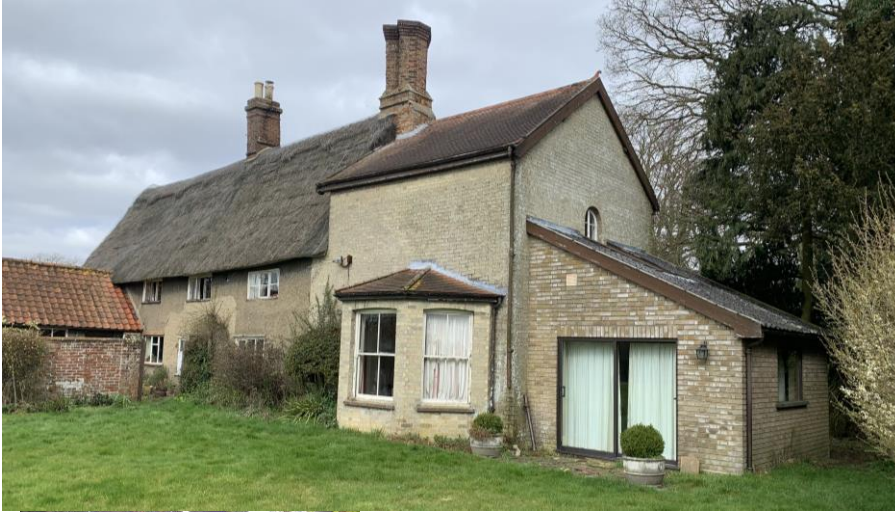
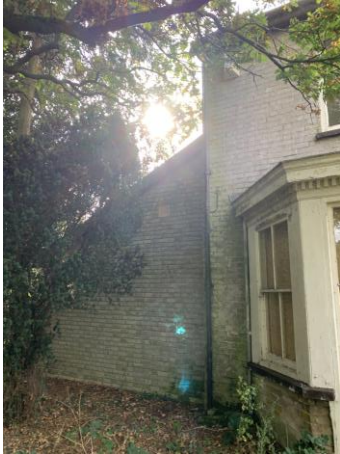
The eastern lean-to is of late C20th construction although there is no record of an application although it is mentioned in the Listing dated 1983. It could be said that the extension is unauthorised and must be removed. The proposal within this application (Phase 1) is to remove the modern extension and temporarily cover the opening into the house, awaiting a further application for Phase 2 to determine the permanent infill at this end of the house.

**EASTERN LEAN-TO TO BE REMOVED**

11.	<b>REMOVE EASTERN LEAN-TO</b>
12.	Remove modern brick lean-to complete, including foundations and floor; make good garden area where structure removed.

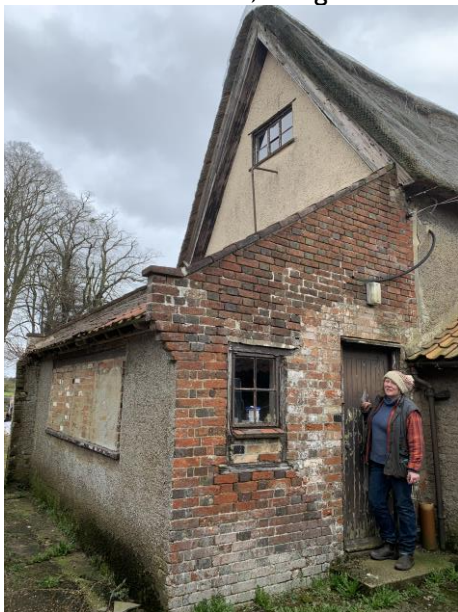
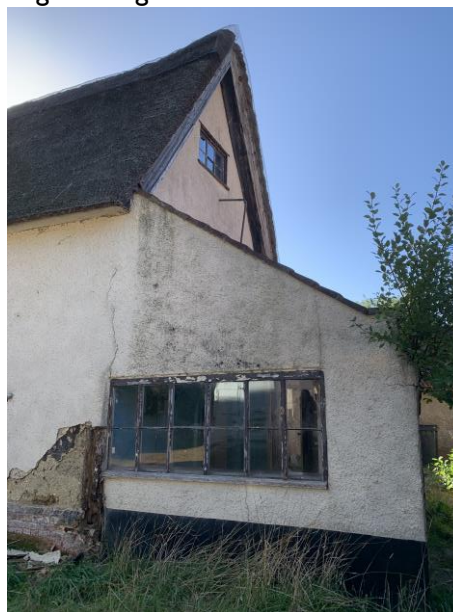
The western lean-to is of a low-quality brick construction which is also in a state of decay. It's removal will expose the historic end of the gabled house and also set the house back from the neighbouring clay lump agricultural shed. The existing internal doorway will be addressed in the future Phase 2 works, along with lime rendering of the gable wall.

**WESTERN LEAN-TO TO BE REMOVED**

8.	Carefully take down lean-to roof tiles and set aside for repairs elsewhere. Remove roof structure, redundant modern windows & doors & brick walls all round
