DEMOLITION OF EXISTING DWELLING/STABLES. PROPOSED RESIDENTIAL DEVELOPMENT OF 2NO. THREE BEDROOM DWELLINGS WITH ASSOCIATED PARKING. PROPOSED CONSUTRUCION OF NEW STABLE BLOCK/BARN.

MARCHUP HEIGHTS, SILSDEN ROAD, ADDINGHAM, LS29 0LQ

DESIGN AND ACCESS STATEMENT, JULY 2022

REF: M3735

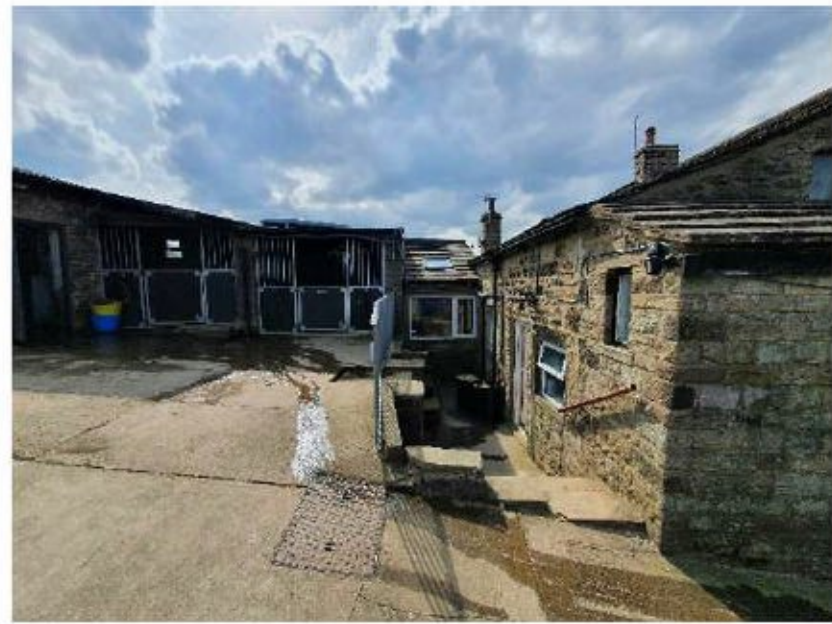
Existing stable block/ rear elevation

Description and comments
Garages	There is no garage at the property.
Permanent outbuildings	There are some permanent outbuildings at the property. These are in a poor condition and consideration needs to be given to the roofing material and structure of these. Asbestos roofing sheets are a problem to dispose of and it is likely that any work will require the removal of these.
Grounds	The property has several small water features and other features to the rear with dry stone wall boundaries. It is advisable to ascertain responsibility for these walls as repairs can be costly.
Paved areas	The paved areas and patio are in a fair condition with uneven flags and gaps which need re-pointing.
Boundary and retaining walls	There are boundary walls, with a dry stone walls to the side and rear. (Please see Grounds)

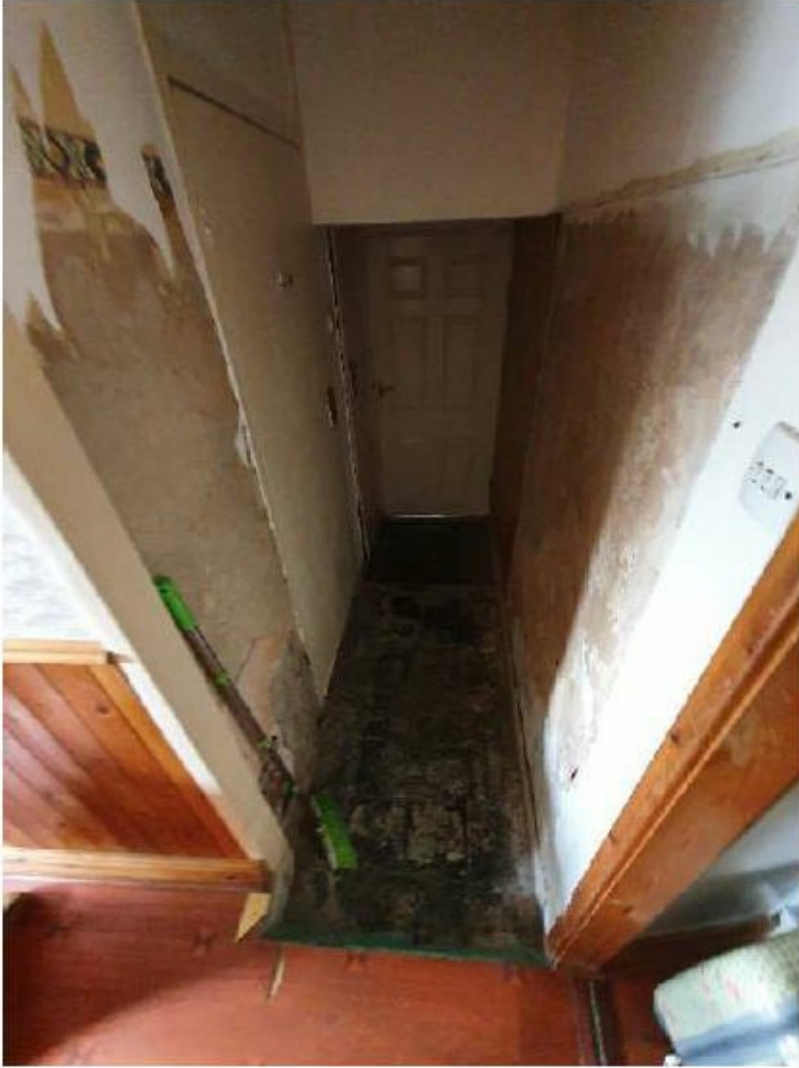
Dining room to living room level differences

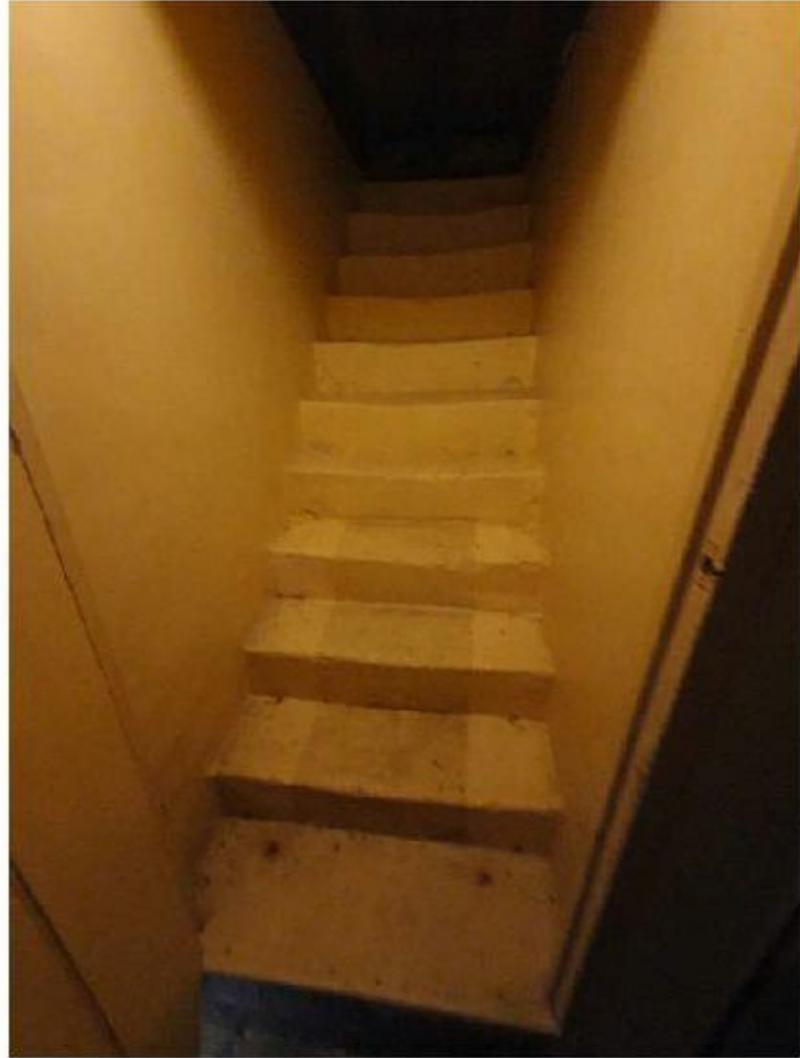
Redundant stair up to FFL

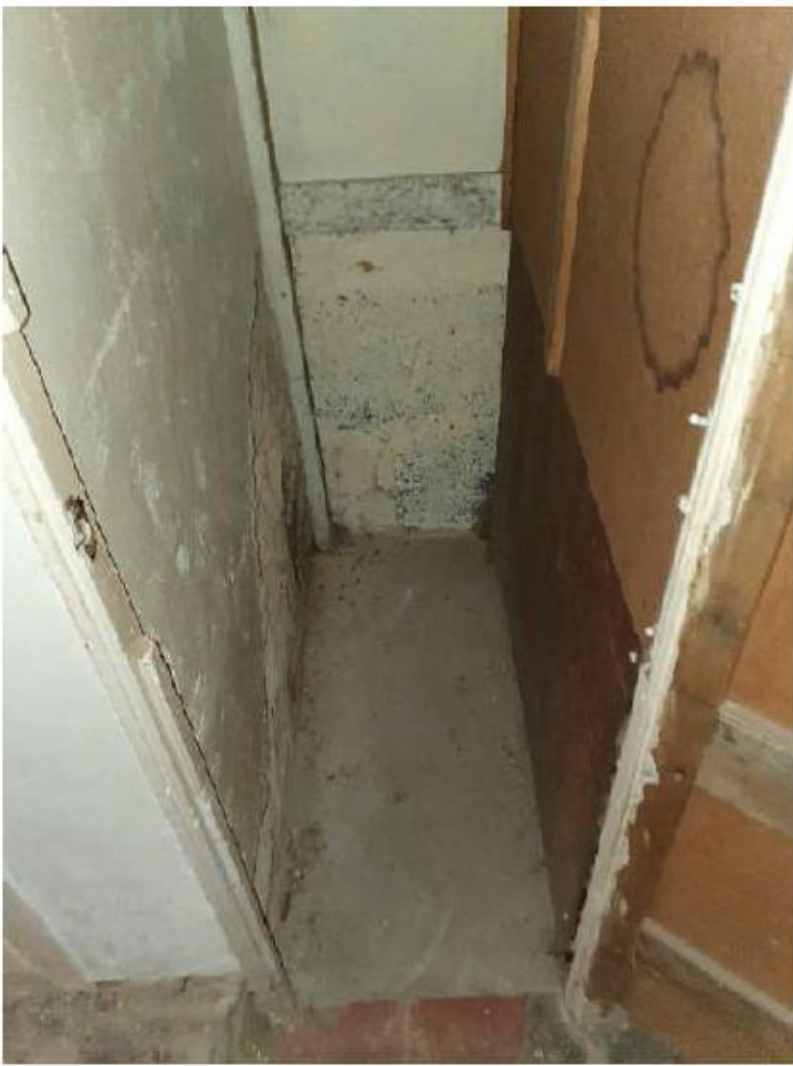
Evidence suggesting poor use of internal space

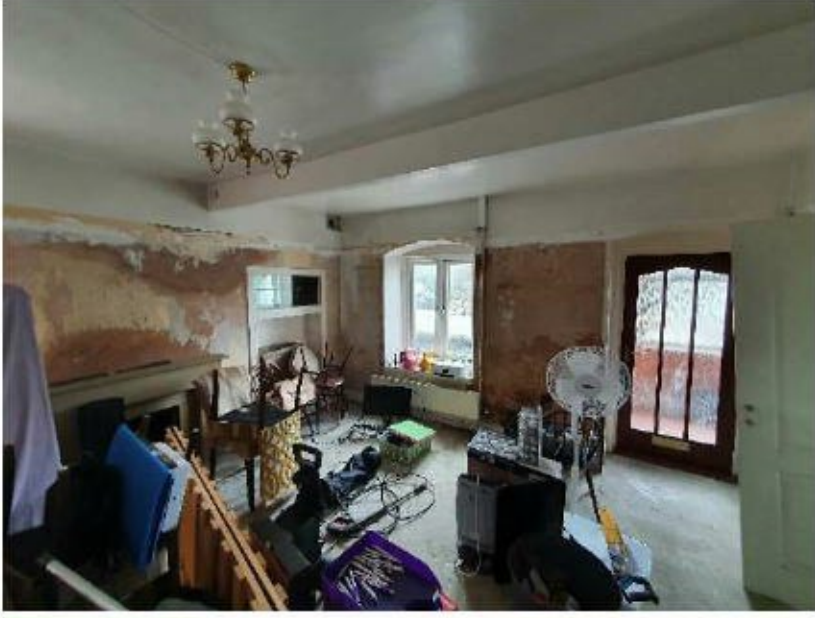
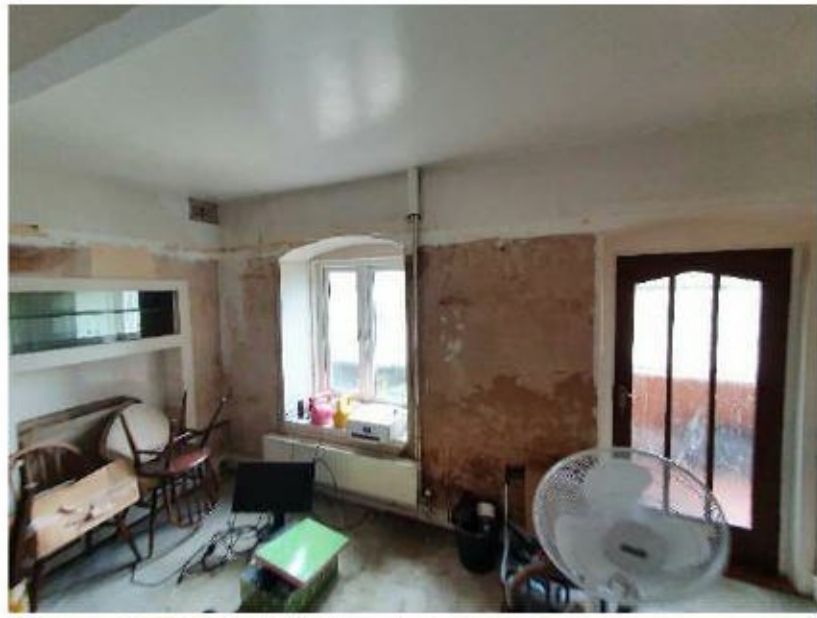
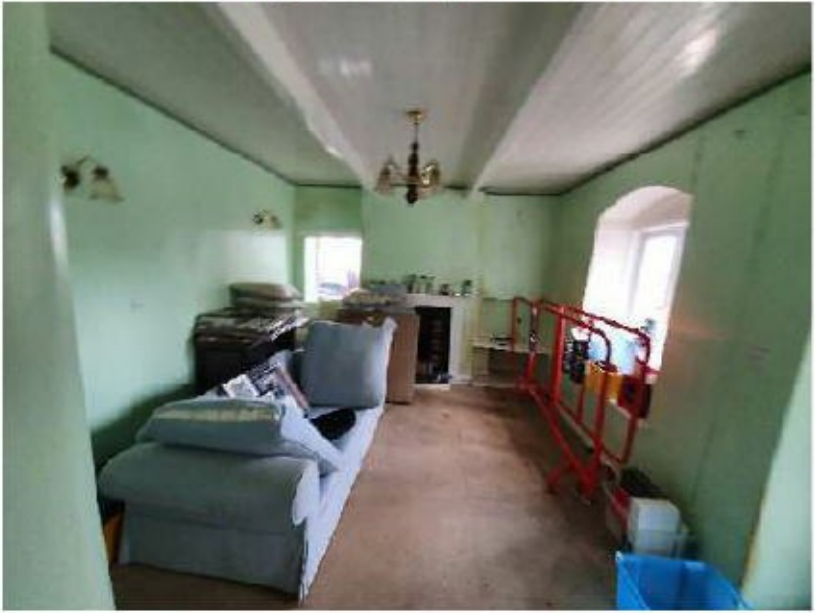
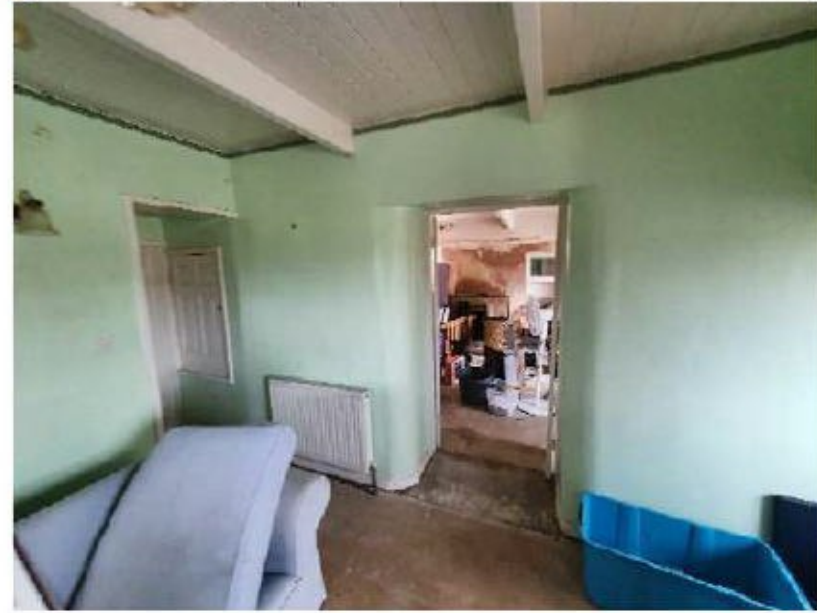
Existing living areas, currently too damp to occupy.

E.3. Internal walls:	3
<p>The walls in the house appear to be in good condition at the time of inspection apart from high moisture readings to the ground floor to large areas. Some areas have been panelled but still had high readings of moisture. The first floor had several areas of damp evident in the front bedrooms and rear bedroom adjoining wall to the front bedroom near the window. The layout of walls is quite complicated with stairs and cupboards due to the combination of the two properties, but it would be advisable to consider a completely new damp course installation due to the age of the property and the amount of damp walls detected.</p>	
E.4. Internal Floors:	3
<p>The property has a mixture of suspended timber floors to the ground floor and suspended timber floors to the first floor area. The floors have laminate, carpet and ceramic tile covering so no inspection was possible of condition, but there was no excessive movement or deflection evident at the time of inspection. Inspection of the ground floor in the cellar showed evidence of wood worm infestation and some timbers had been replaced but treatment of remaining timbers should have been carried out and guarantees provided. These need to be sourced as it would be advisable to have the work checked by a specialist.</p>

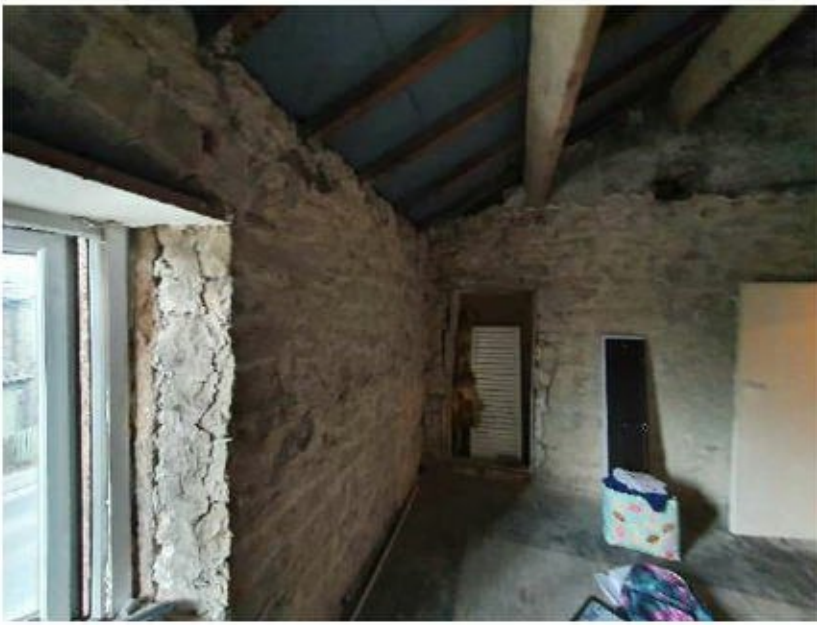
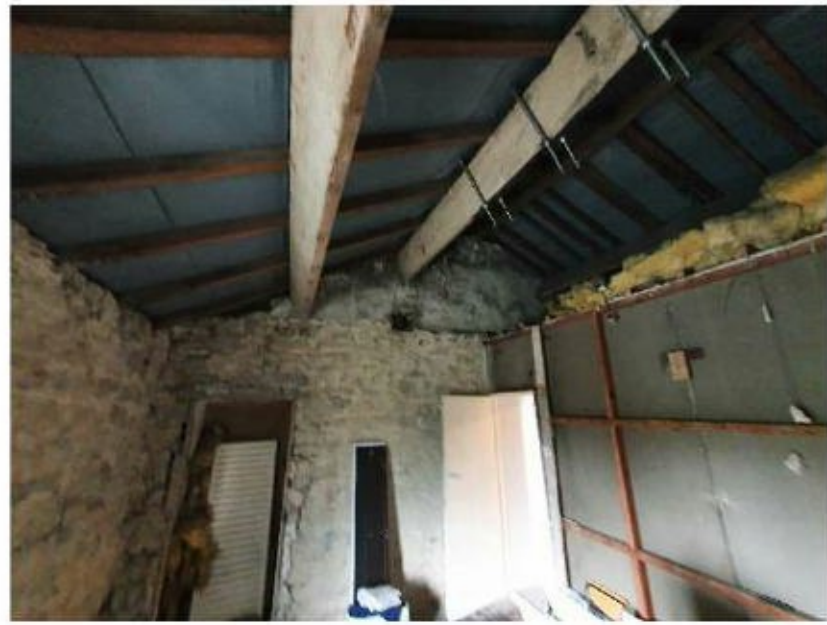
Poorly repaired roof as highlighted in Home Condition Survey report.

Internal Inspection.	
E.1. Loft Area:	3
<p>The loft area inspection showed some serious problems with the roof. Although a new roof has been installed some time ago there was evident that this was not done correctly. Some of the rafters have been replaced but attached to pieces of the old defective rafters with either wood rot or woodworm parts still remaining. It is good practice to remove all defective timber from these areas to prevent re-infestation. It would therefore be wise to check any guarantees and treatment that was used to carry out the work.</p> <p>There is also a visible crack in the gable end wall visible from the loft space.</p>	
E.2. Internal Ceilings:	3
<p>The internal ceilings are showing signs of leaks from the roof with brown areas and patches to both ground and first floor ceilings, This again calls into question the quality of the workmanship that was used to install a new roof with a waterproof membrane. Because of the layout of the roof space access to the affected areas was not possible however damp readings clearly showed the problem is current.</p>
