3.0 DEVELOPMENT OF THE HERITAGE ASSET

4.0 THE HERITAGE ASSET AND ITS SIGNIFICANCE

4.1.2 EAST BARNES

4.1.3 WEST BARN

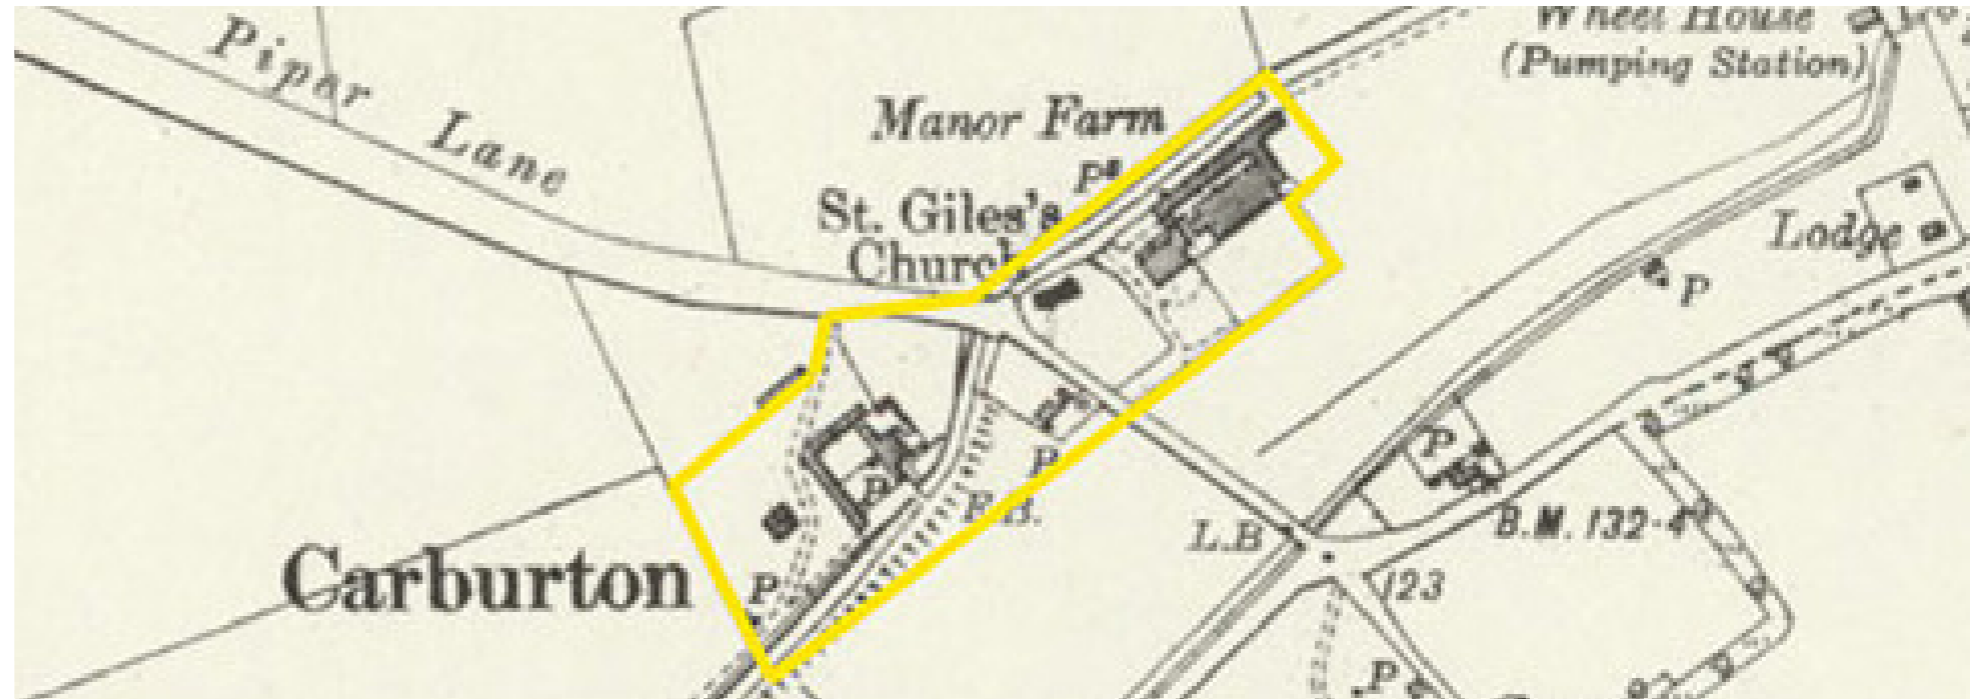
Figure 3.11
1920 Plan of Carburton
(Source : www.nls.org).

The 1920 OS plan retains the three general elements to the site.

The farm buildings to the east of the Manor House appear to have gained a large outbuilding, that takes up the majority of the space in the easternmost yard.

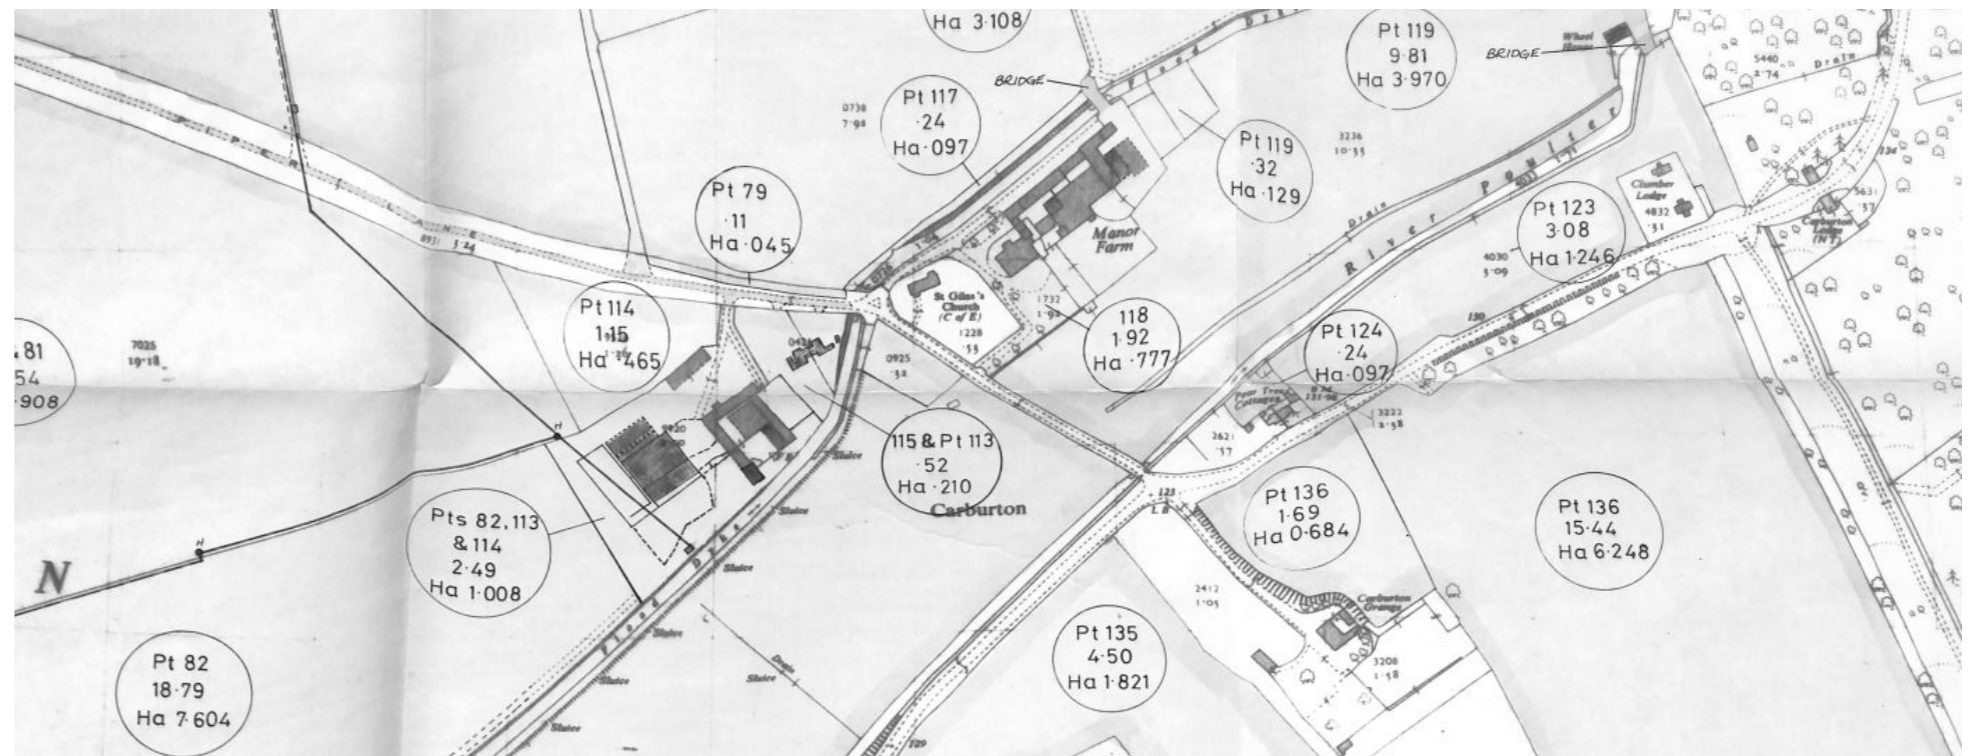
Figure 3.12
1988 Plan of the site buildings from Tenancy Agreement
(Source : The Welbeck Estate archive).

The plan to the right is believed to date from a tenancy agreement in 1988.

The farm buildings to the east of the Manor House appear relatively unchanged.

The farm buildings to the west have gained a couple of large structures to the far west, which remain in existence today. The three-sided courtyard seemed to have been significantly infilled by a structure to the north-east side, which has been removed during the intervening years to the present.

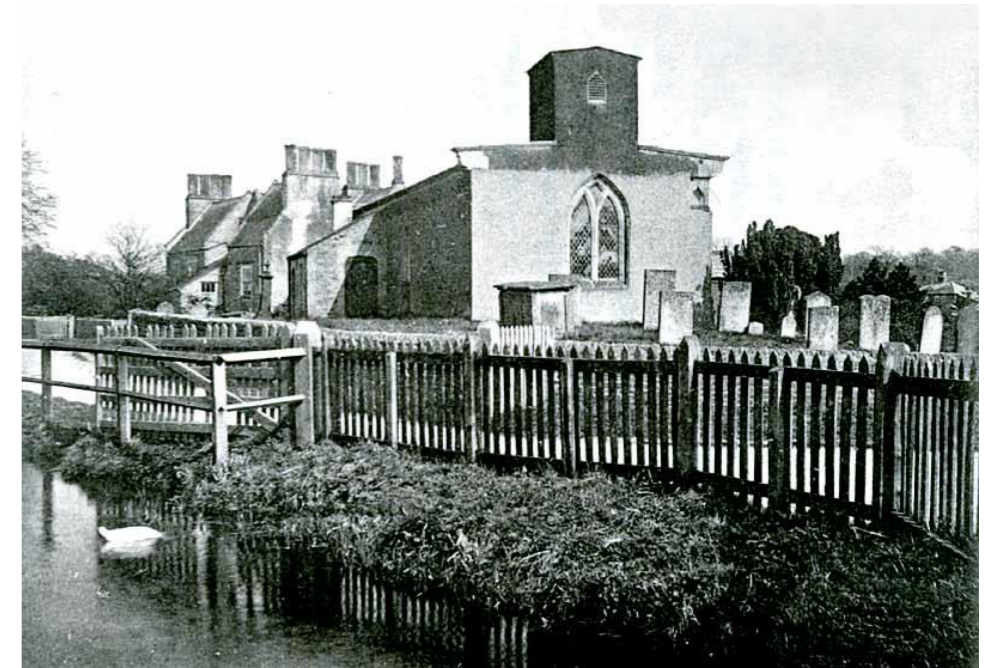
Figure 4.1
1914 Manor House beyond showing single storey extension from the rear third bay.
(Source : Unknown).

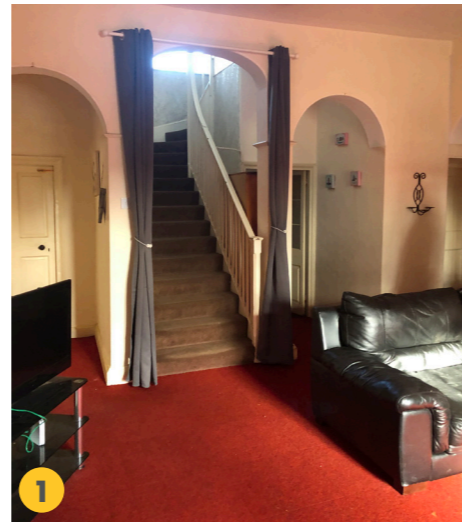
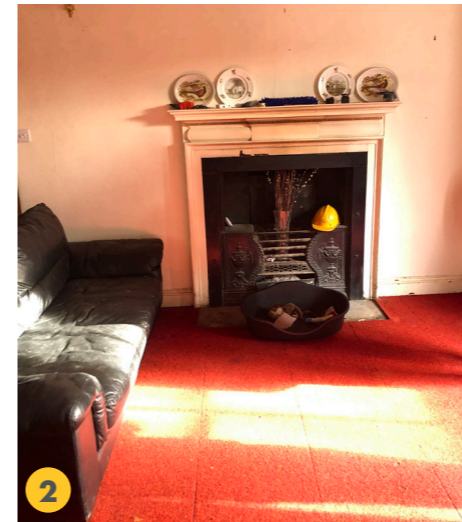
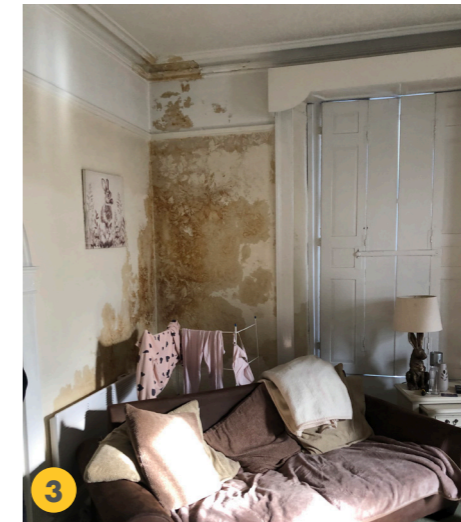
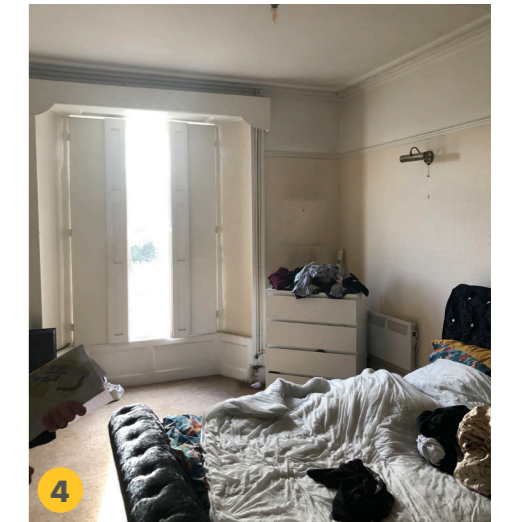
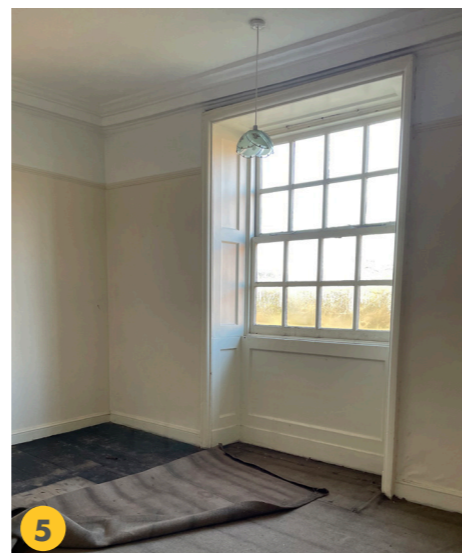
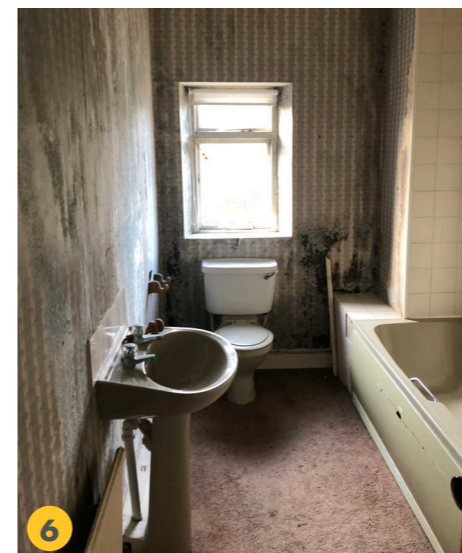
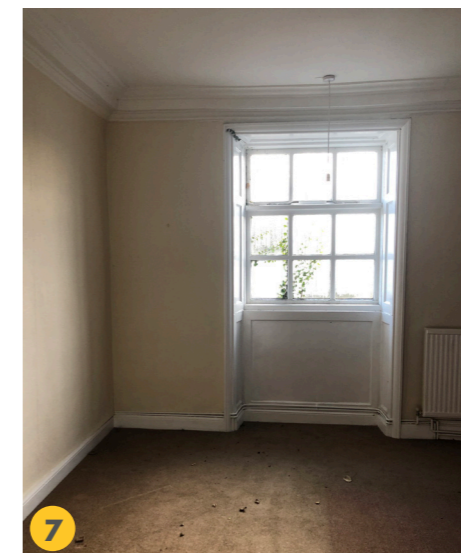
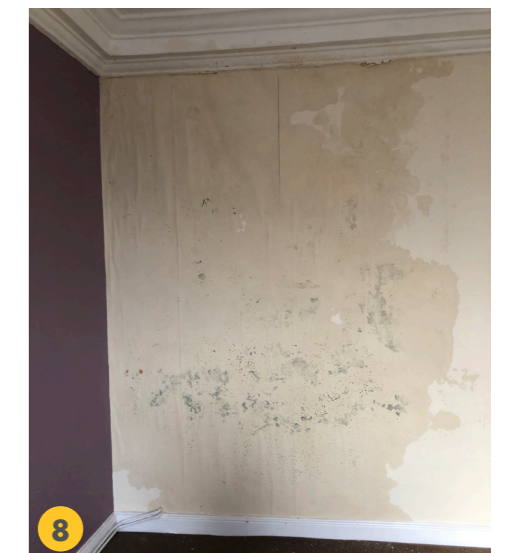
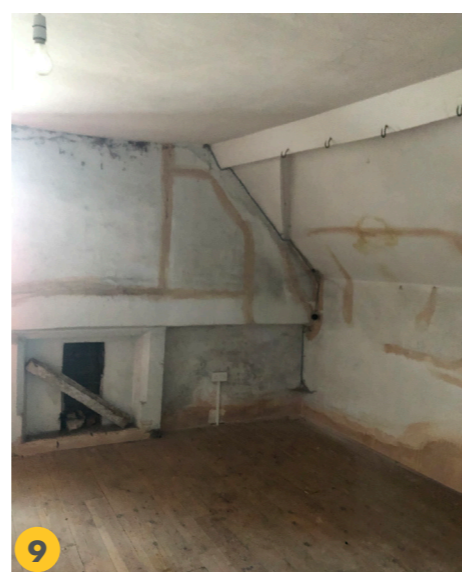
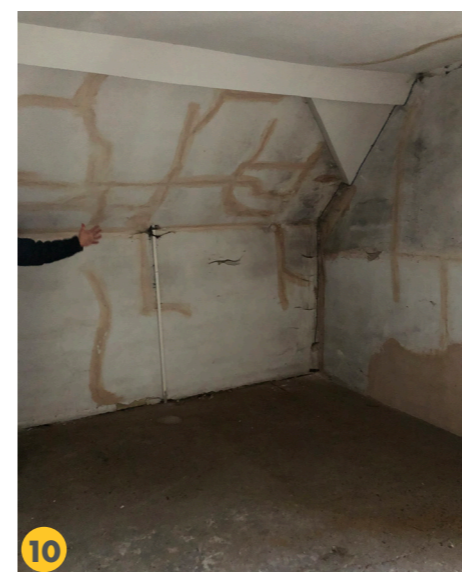
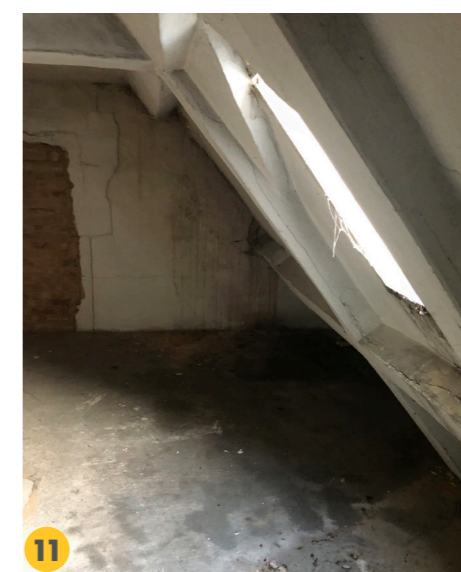
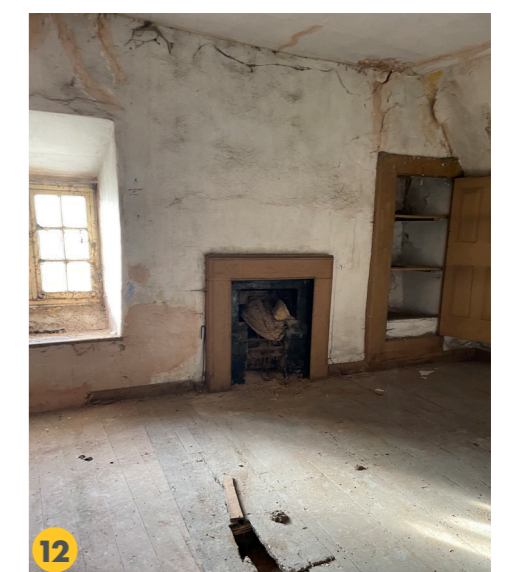
- 1 — 4 Manor House - Ground Floor Photographs
- 5 — 8 Manor House - First Floor Photographs
- 9 — 12 Manor House - Second Floor Photographs

The main entrance room is dimly lit by the main door and decorated with modern finishes but retains a cast iron fireplace and surround. The room has been used as a living space.

The principle reception rooms have modern carpets and fittings however retains the coving details and timber shutters throughout the rooms. There is modern wallpaper throughout and considerable damp within the corner of the room which looks to have penetrated through the wall from outside.

The northern rooms to the ground floor have fallen largely into disrepair, with finishes peeling and blistering.

The first floor is currently used as a bedrooms. They have been decorated with modern wallpaper and carpets however retain the decorative covings and timber shutters. There is evidence of water ingress, damp and mould throughout the rooms.

The roof area has been converted into rooms and the timber roof structure has been painted over. Decorations has generally failed in this area and is peeling and blistering throughout. There is evidence of mould and damp throughout.

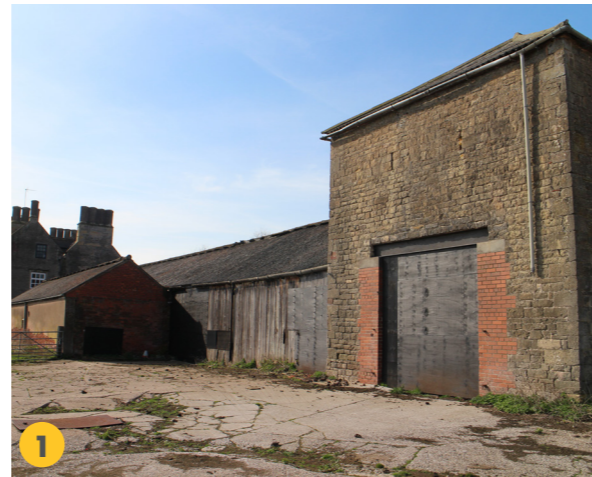
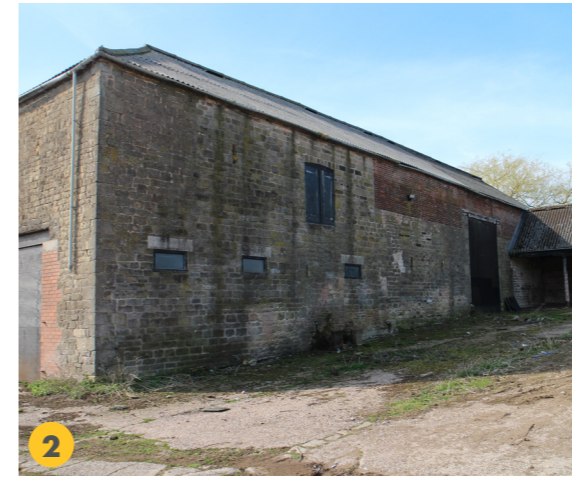
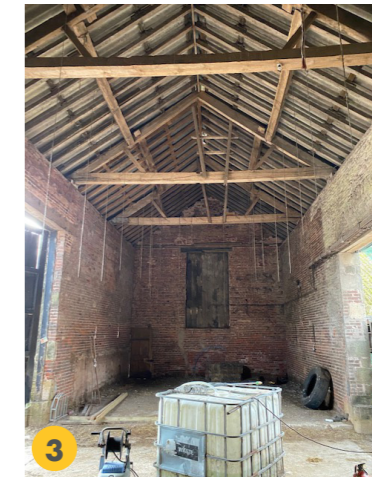
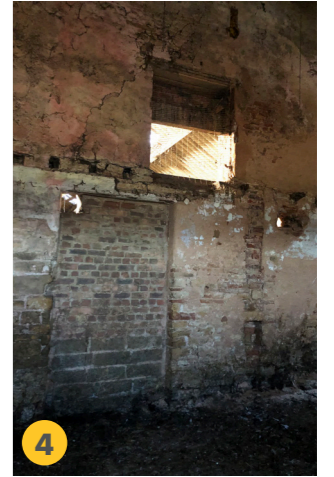
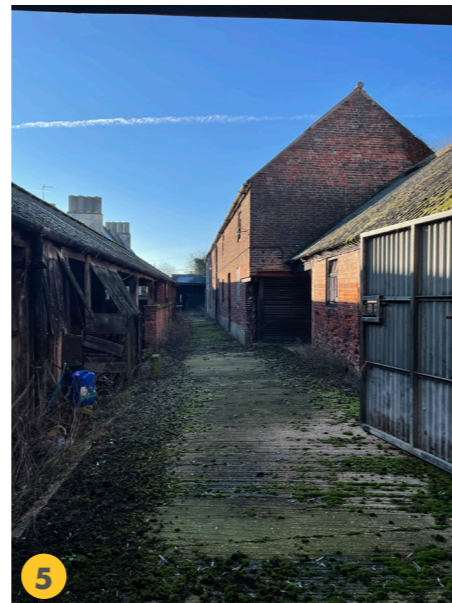
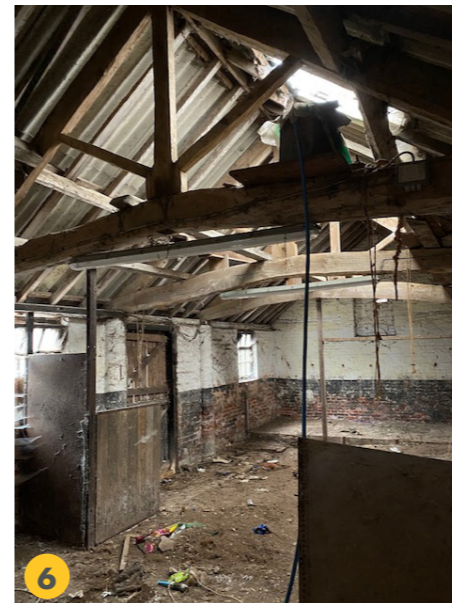
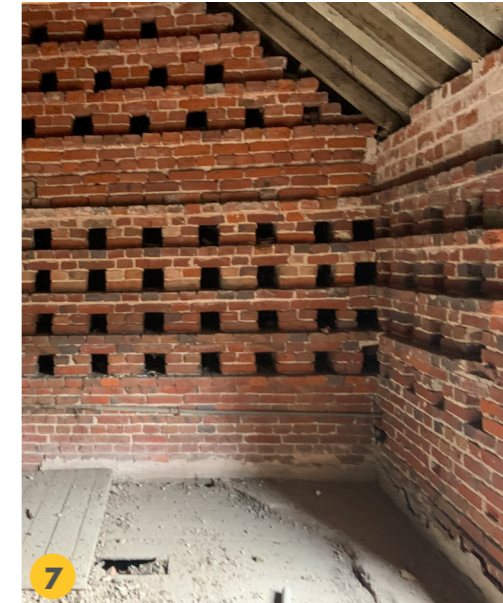
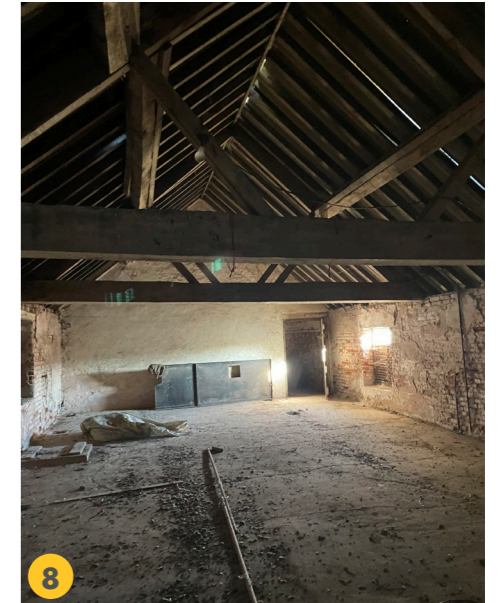
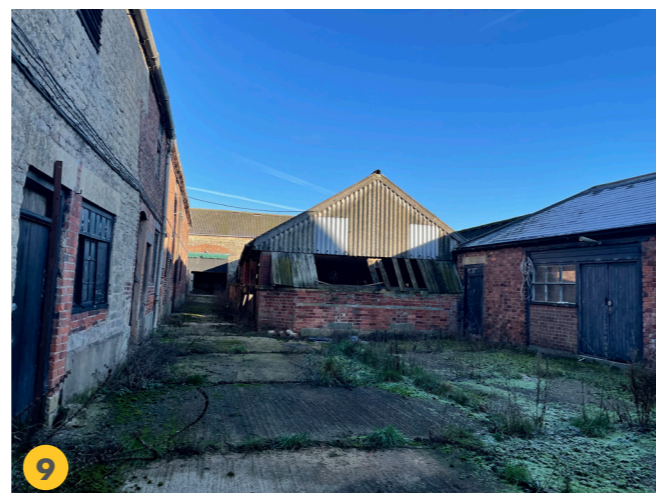
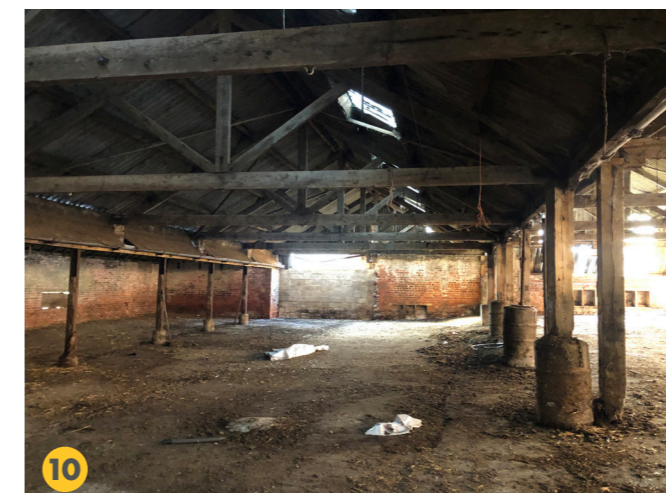
- 1 — 4** East Barns - Threshing Barn Photographs
- 5 — 8** East Barns - Two Storey Barn Photographs
- 9 — 10** East Barns - Single Storey Photographs

The barns are a collection of 19th century and 20th century barns built in a mixture of both limestone rubble and red brick. The outer perimeter barns have appeared on the ordnance survey since 1884 however the change in materials suggests that it has been largely rebuilt. There is evidence of pre-existing openings that have since been blocked up and or altered, with new steel lintels installed to one gable. Many historic features still remain with many of the historic timber doors still intact including the large doors to the threshing barn.

In the early 20th century the large outbuilding was built which is open on one side. The walls seem in a fair condition and the timber roof structure visually impressive with a corrugated metal roof covering.

Internally the buildings have exposed timber trusses generally and retains low level bitumen skirting and timber stalls in some buildings. There is a dove cote to the first floor and an internal gutter system running through the centre of the space. Stairs and internal walls are generally intact and where alterations have been made they are generally obvious adaptations.

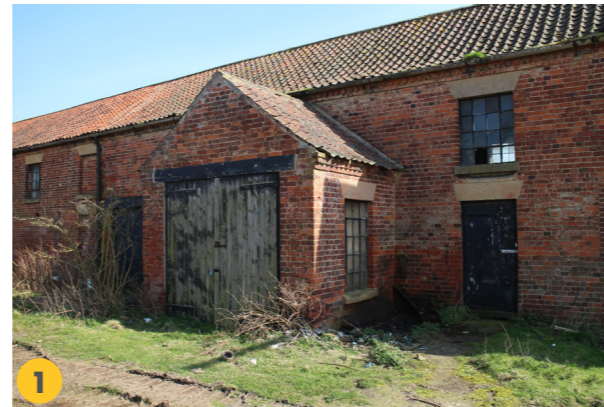
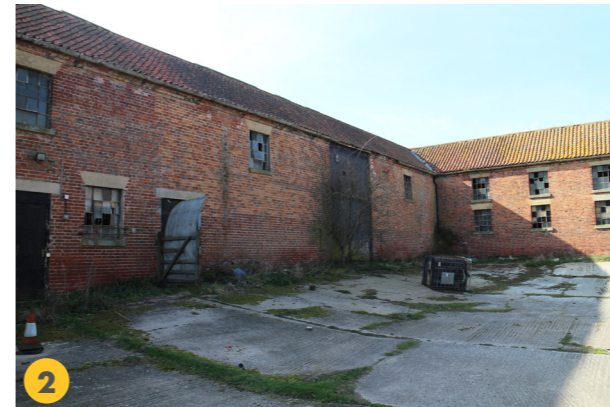
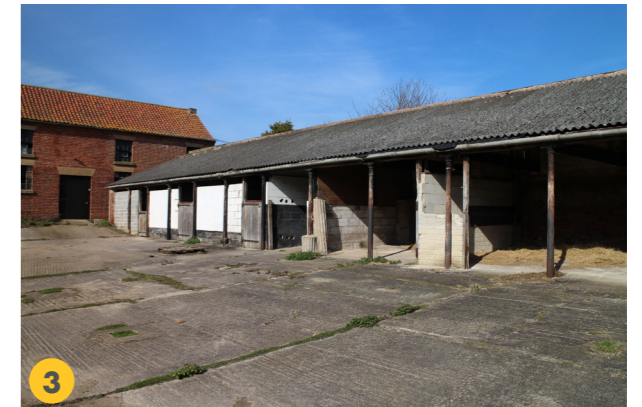
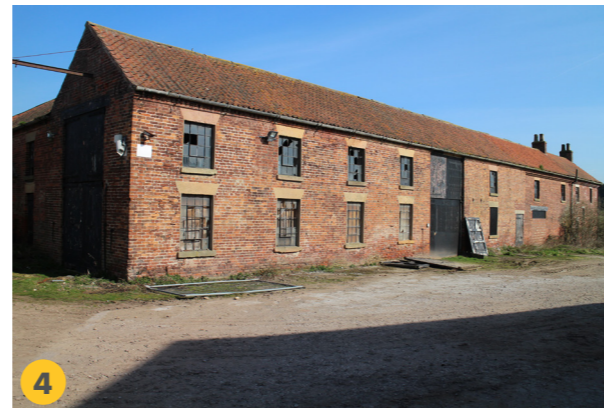
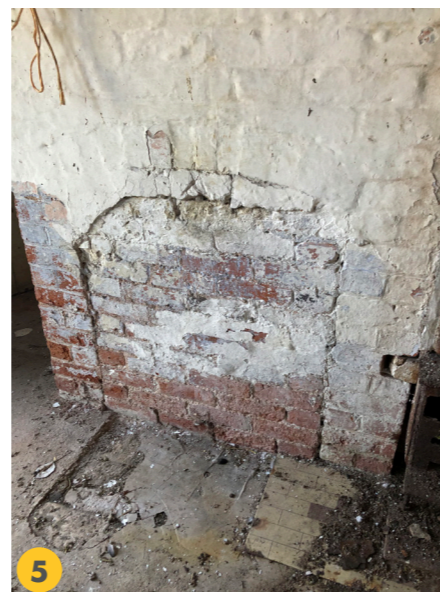
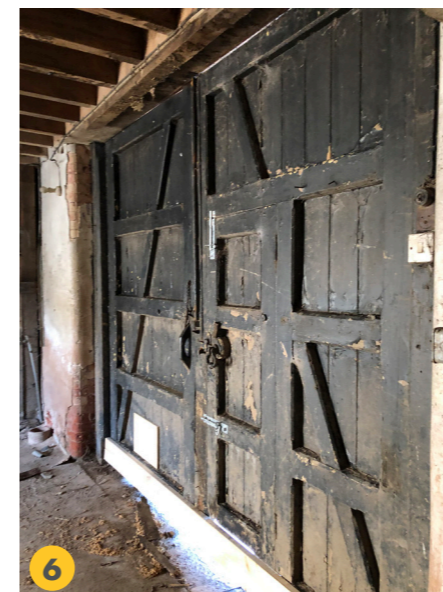
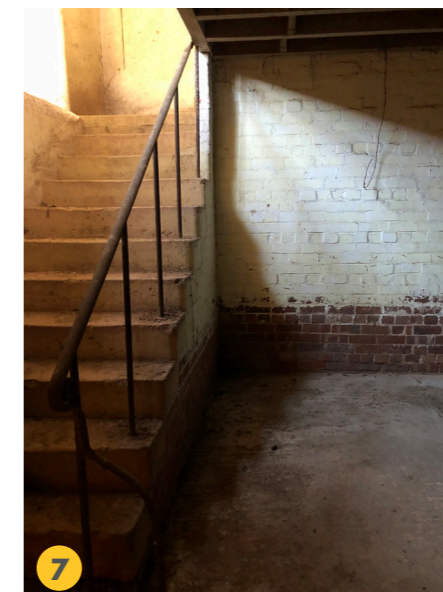
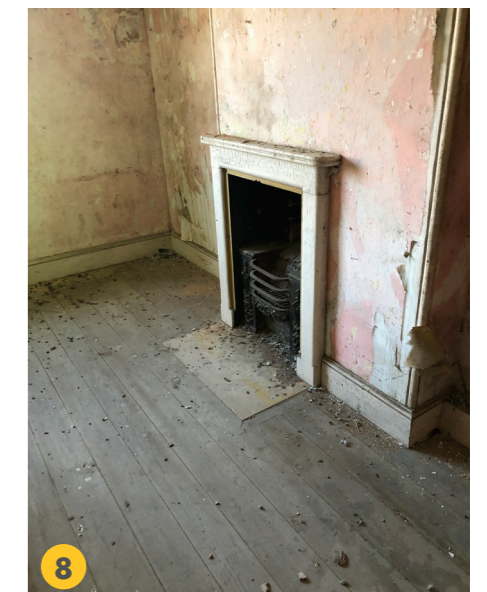
- 1 — 4 West Barns - External Photographs
- 5 — 8 West Barns - Internal Photographs

The barns to the west of the site are grade II listed and date from the early 19th century. The main two storey range provides generous internal spaces and is currently in relatively good condition.

The condition internally throughout the barns is currently sound with timbers generally looking in good condition with partitions largely retained.

Internal circulation remains in situ and in a good condition, whilst some areas have been infilled.

The internal lime render and lime wash is in a varied condition however there has been a fresh application of plaster to the roof internally which looks to remain in a sound condition.
