ARBORICULTURAL IMPACT ASSESSMENT REPORT
BS 5837:2012 'Trees in relation to design, demolition and construction. Recommendations'

Land North of Cornells Lane,
Widdington
CB11 3SP

DATE: 25 June 2021
OUR REF: SHA 1244 Rev B

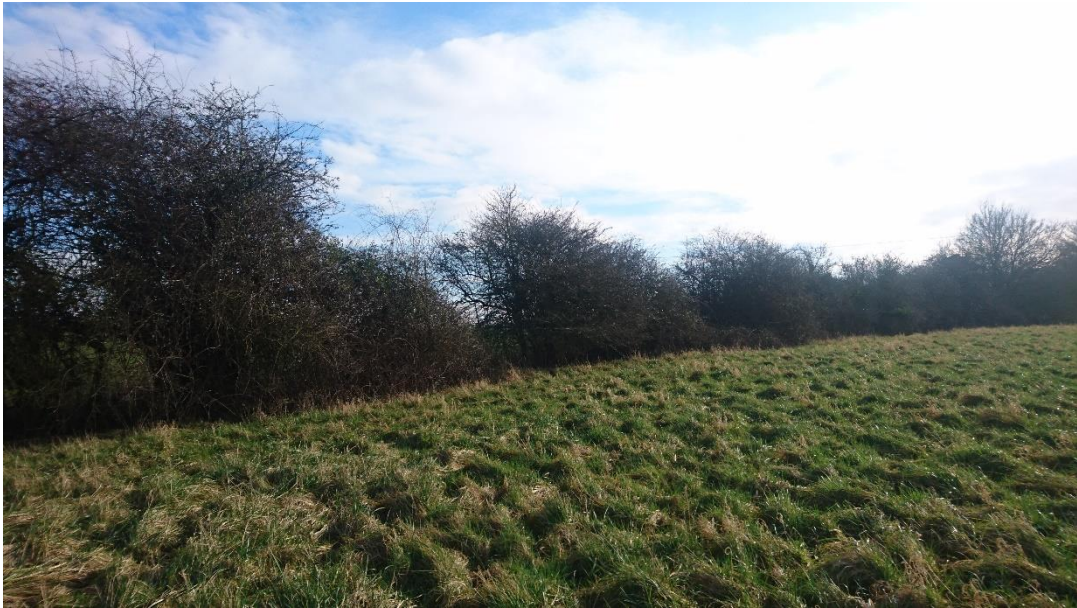
Photo 1 of the boundary hedge H29 and H30 February 2018

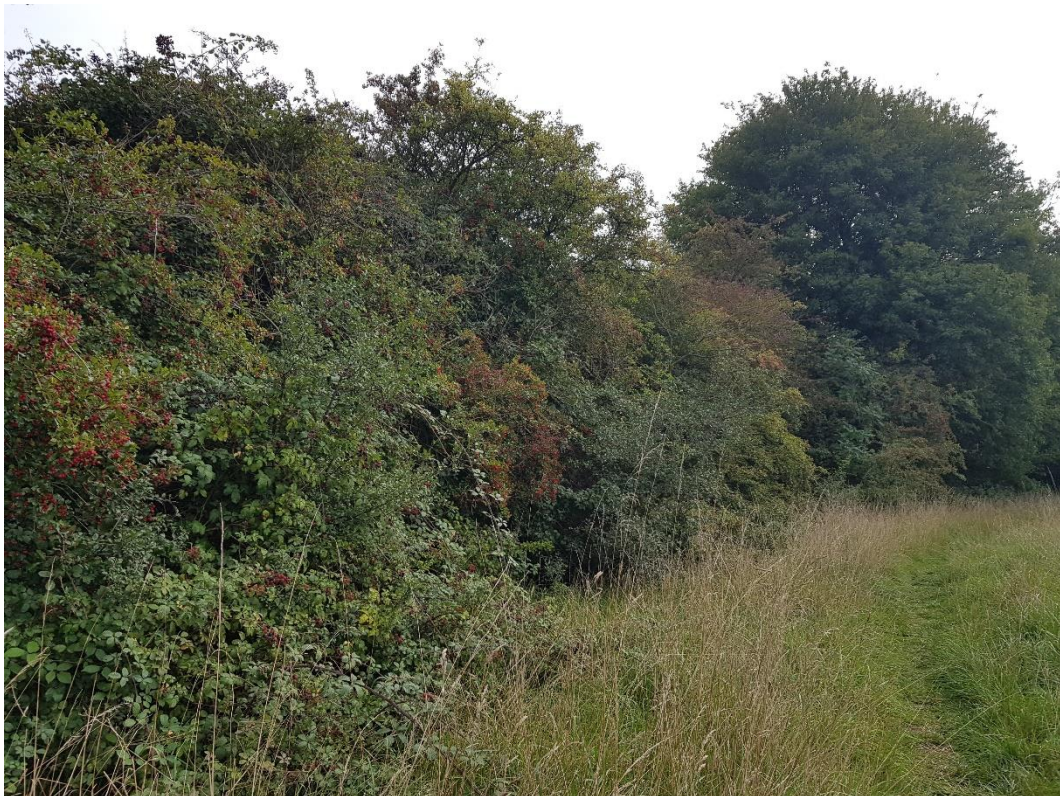
The hedge is unmanaged and the woody species is almost entirely hawthorn, with some patches of blackthorn which lean in towards the site. Parts of the hedge have dense bramble and ivy. The hedge has varying heights and widths, and parts are denser than others. Management will prolong the safe useful life expectancy and improve the appearance of the hedge. Subsequent to the survey, I understand that some cutting back of the hedgerow has occurred to enable creation of a footpath corridor.

*Photo 2 of the hedge in the paddock adjacent to the eastern boundary looking south in
September 2020*

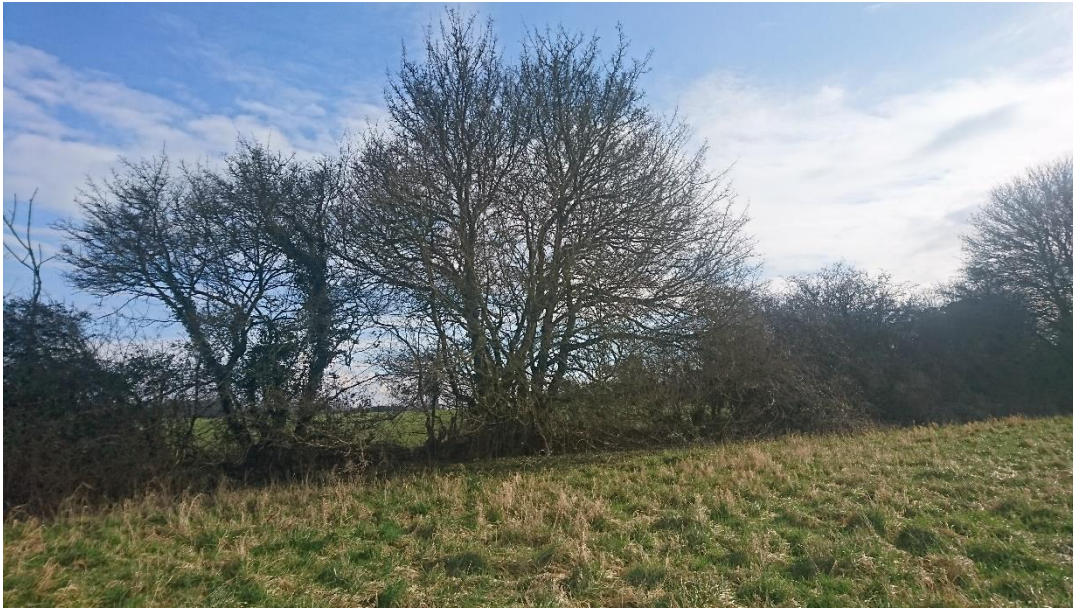
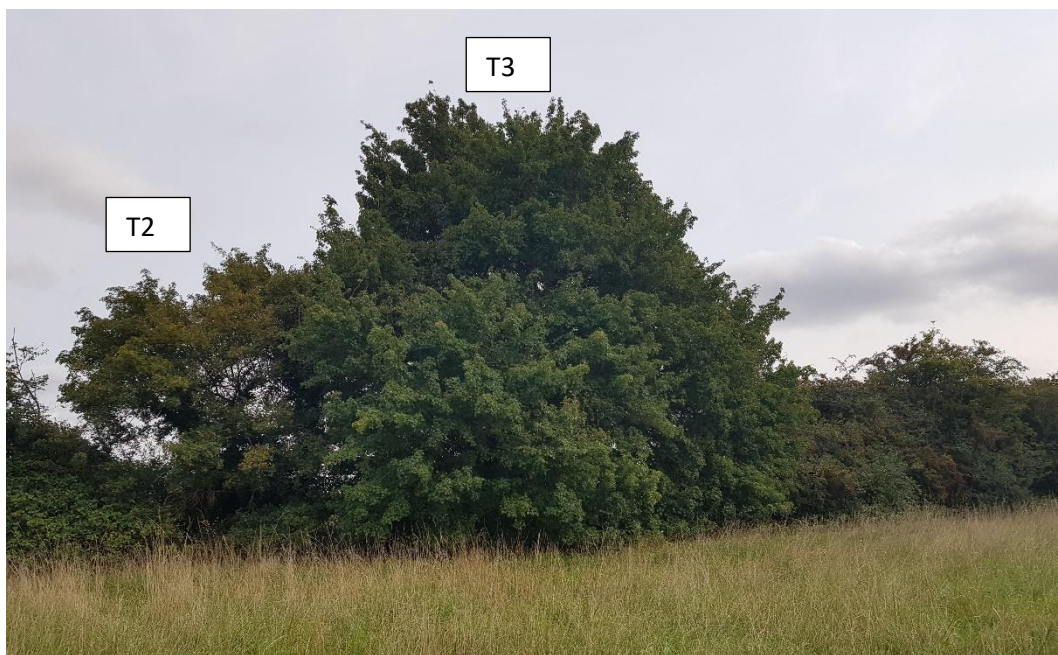
Photo 3 of T2 and T3 field maple February 2020

Photo 4 of T2 and T3 looking east in September 2020

T2 field maple is in reasonable form and condition, although rather suppressed by the multi stemmed veteran field maple T3, which has grown in crown diameter considerably since 2018. The tree forms a dense screen between the site and open countryside to the east and there is scope to crown lift the canopy to ease use of the footpath. T5 field maple has a cavity at the base and there is a risk of shear failure at the top of the cavity, although it is sheltered by adjacent trees protecting it from windthrow. Its removal is recommended for safety reasons.

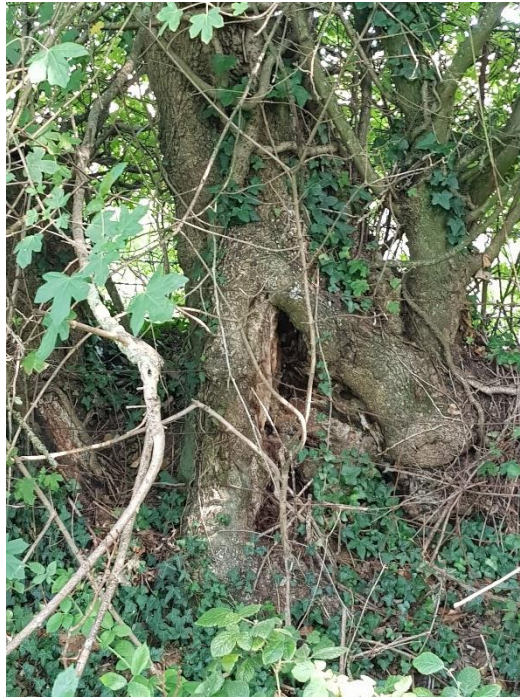
Photo 5 of the cavity at the base of T5

Tree Number	Botanical Name (Common name)	Age	Dia (mm)	Stems	Height (crown height)	Ult ht (m)	N	E	S	W	Cond	Life Exp	BS Cat	RPR (m)	RPA (m ²)	Comments	Recommendations
T5	Acer campestre (Field Maple)	M	350	1	18(1)	8	1	2	1	3	Fair	<10	U	4.2	55.42	Spindly. Leaning West. Ivy on tree. Unable to inspect stem due to Ivy. Unable to inspect stem due to undergrowth. Cavity on stem. Unbalanced crown shape. Crown distorted due to group pressure. Major basal cavity accross one quarter of trunk and deep. Risk of shear failure at the top of the cavity.	Remove tree and root.
T6	Acer campestre (Field Maple)	M	600	1	18(2)	18	4	5	1	5	Good	40+	B2	7.2	162.88	Ivy on tree. Unable to inspect stem due to Ivy. Unable to inspect stem due to undergrowth. Major deadwood in crown. Unbalanced crown shape. Crown distorted due to group pressure. Skyline feature.	Sever Ivy. Remove Ivy. Inspect stem/basal area. Remove dead wood

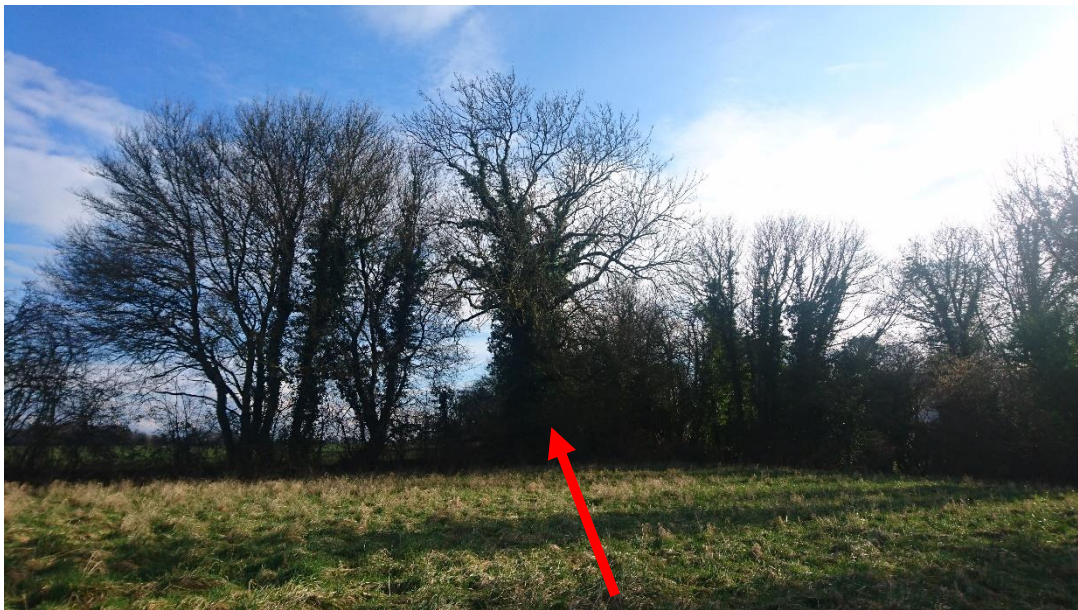
Photo 6 of trees in the south-eastern corner. The ash with fungus (T7) is shown arrowed. February 2018

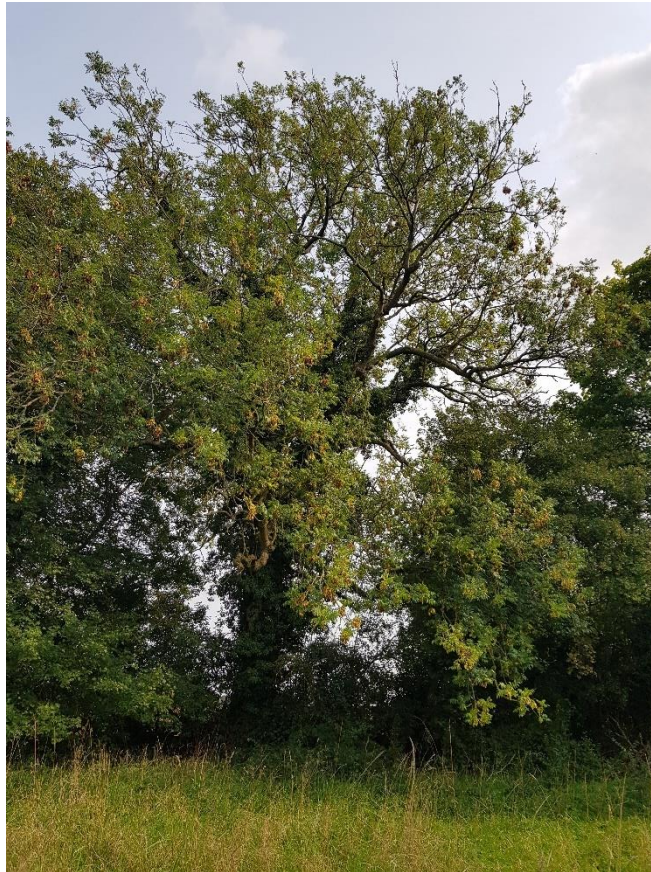
Photo 7 of the ash tree T7 looking east. September 2020

The large ash T7 is in decline with a marked loss of vitality. Dead wood removal, ivy severance and re-inspection is recommended.

Tree Number	Botanical Name (Common name)	Age	Dia (mm)	Stems	Height (crown height)	Ult ht (m)	N	E	S	W	Cond	Life Exp	BS Cat	RPR (m)	RPA (m ²)	Comments	Recommendations
T7	Fraxinus excelsior (Ash)	M	700	1	21(2)	22	9	9	9	9	Fair	10+	C2	8.4	221.7	Ivy on tree. Unable to inspect stem due to ivy. Unable to inspect stem due to undergrowth. Fungal brackets visible on stem. Broken branches in crown. Major deadwood in crown. This is a prominent tree with a large spreading crown. Dense ivy clothes the trunk and the scaffold limbs. Inonotus hispidus bracket on the ground. Old stubs. Some branches have linear wounds. Likely to be decaying due to fungus. In notable decline since 2018 survey with only 50% vitality and retrenchment.	Carry out further inspection. Sever Ivy. Remove Ivy. Inspect stem/basal area. Carry out further inspection. Remove dead wood.
T8	Acer campestre (Field Maple)	EM	308	3	10(2)	15	2	2	2	5	Good	40+	C2	3.7	43.01	Ivy on tree. Unable to inspect stem due to undergrowth. Multiple stems at ground level. Broken branches in crown. Major deadwood in crown. Unbalanced crown shape. Leans west.

8.13. That, irrespective of the application, the landowner is made aware of the potentially hazardous condition of the large ash tree near the footpath (T7) as the tree has a decay fungi and large dead branches. I recommend an investigation using internal decay detection equipment to see if the fungus is causing loss of strength. If the tree is unsafe, it should be felled. If the fungus has caused little loss of strength, then the dead branches should be removed and a full climbing inspection carried out, and the tree annually monitored. I also recommend that T5, and a hazardous stem from T22, be removed for safety reasons irrespective of the application.

T7	Ash	Carry out further inspection. Sever Ivy. Remove Ivy. Inspect stem/basal area. Carry out further Inspection using Arbortom, PICUS or Resistograph.	Major dead wood and dense ivy. Infected with the decay fungi <i>Inonotus hispidus</i> . For safety reasons.

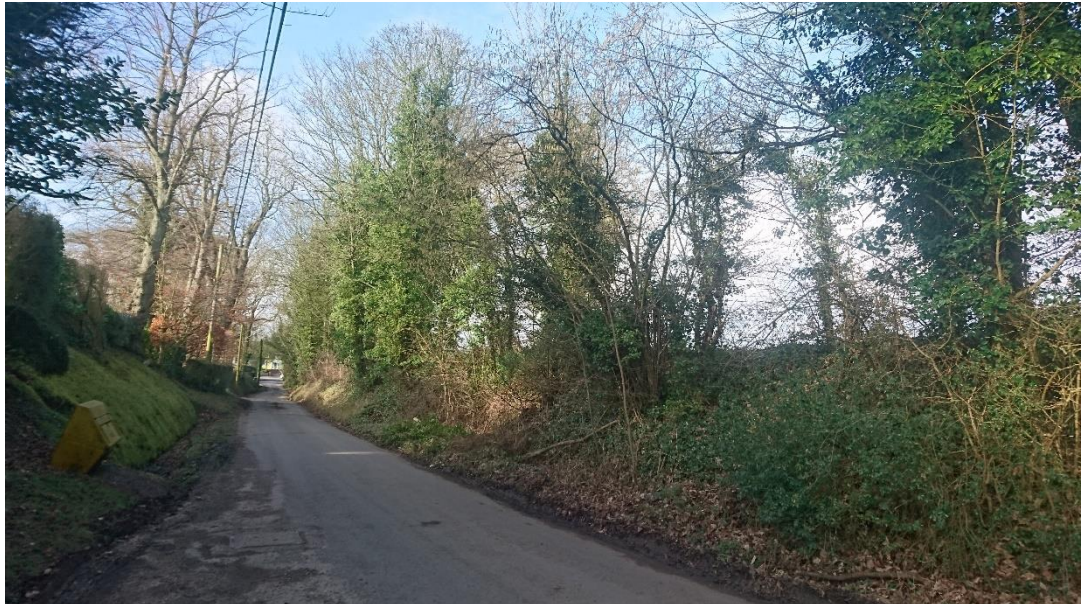
Photo 8 of trees on the southern boundary. February 2018. There will be new planting within the gaps with native species

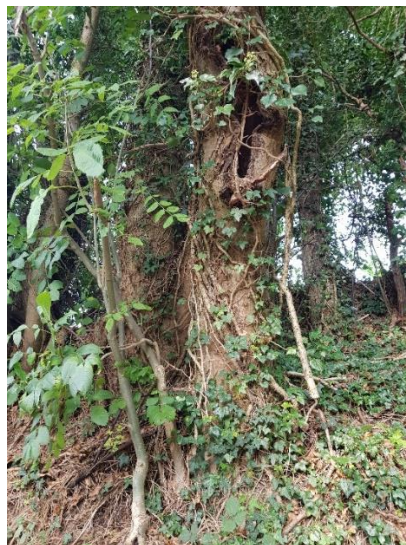
Photo 11 of a cavity on T22 that could lead to the arrowed stem above failing. The tree surgery schedule at appendix 4 recommends the removal of this stem.

Tree Number	Botanical Name (Common name)	Age	Dia (mm)	Stems	Height (crown height)	Ult ht (m)	N	E	S	W	Cond	Life Exp	BS Cat	RPR (m)	RPA (m ²)	Comments	Recommendations
T22	Fraxinus excelsior (Ash)	M	663	6	20(13)	20	9	7	7	10	Fair	20+	C2	7.96	199.08	Coppice. Ivy on tree. Unable to inspect stem due to Ivy. Dieback in crown. Broken branches in crown. Major deadwood in crown. Unable to fully examine due to the steepness of the slope. Cavity on eastern stem which leans north at 1m. This could lead to stem failure over the road.	Sever Ivy. Remove Ivy. Inspect stem/basal area. Carry out further Inspection. Remove major deadwood. Remove broken/damaged branches. Remove eastern stem on road side within 2 months.
T23	Crataegus monogyna (Hawthorn)	M	200	1	8(0)	11	1	1	2	5	Poor	<10	U	2.4	18.1	Poor shape & form. Leaning West. Ivy on tree. Unable to inspect stem due to Ivy. Unable to inspect stem due to undergrowth. Major deadwood in crown. Unbalanced crown shape. Crown distorted due to group pressure.	Remove tree and root.

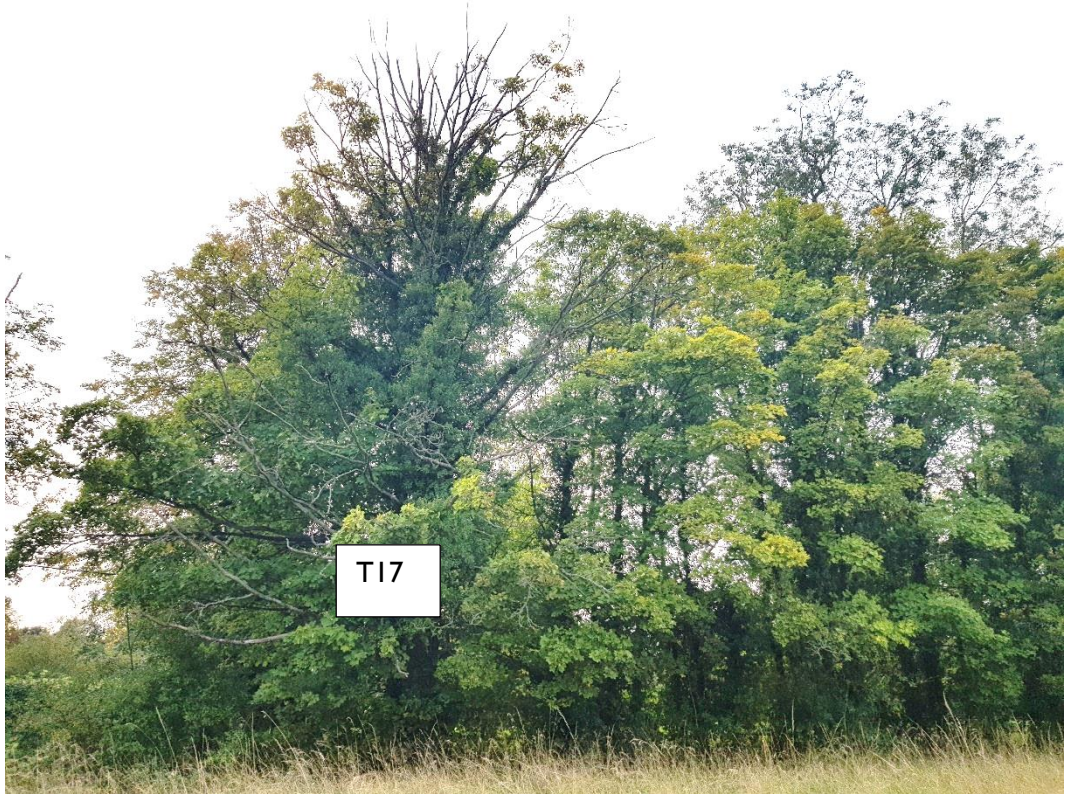
Photo 12 of T17 sycamore with conspicuous dead wood and in terminal decline and will be removed for safety reasons and replaced. September 2020

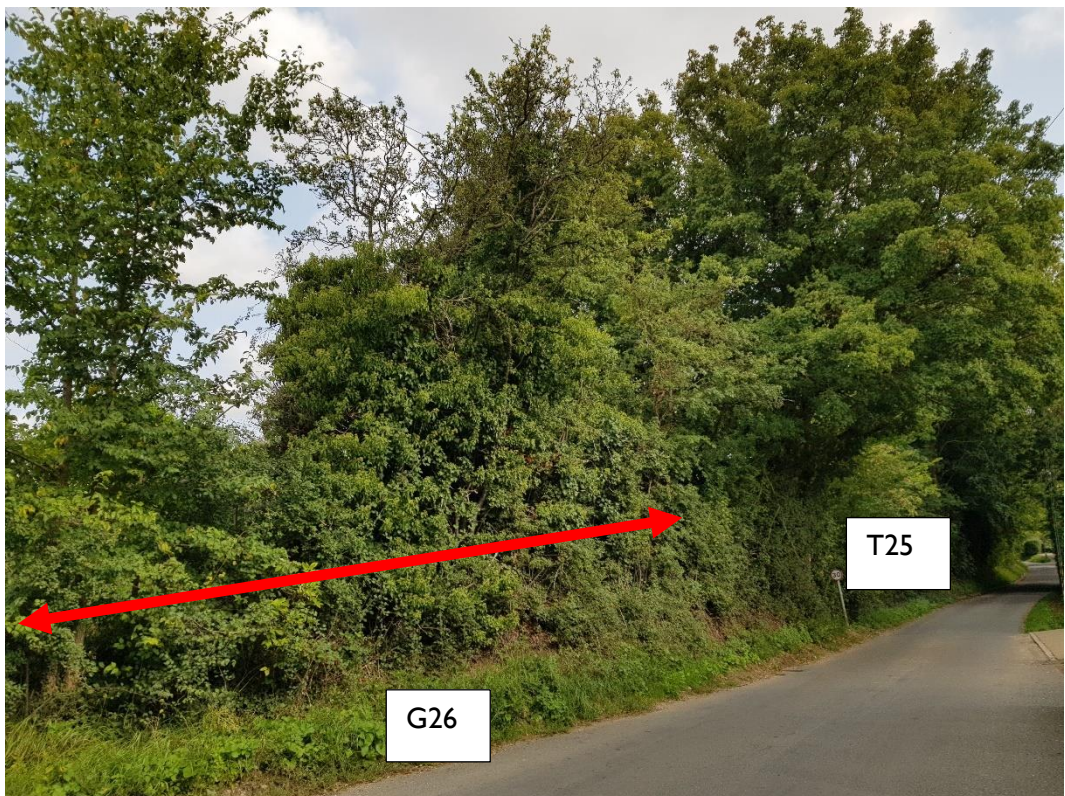
Photo 13 of the low quality scrubby elm and hawthorn G26. T25 field maple is in a good condition and. September 2020.

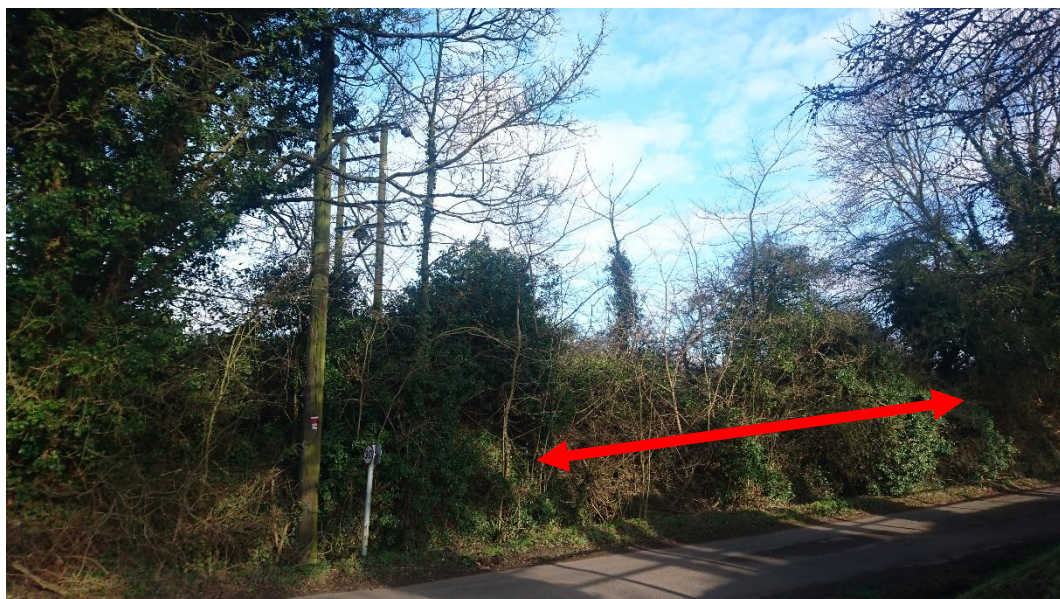
Photo 15 of G24 showing extent of bellmouth entrance. Photo February 2018. This a patchy group of elm, blackthorn and elder with dense bramble.

G24	English Elm Blackthorn and elder	Fell to ground level and grub out stumps of most of the area, retaining some with opportunities taken to review improvements to the remaining section with replacement species	Low quality and or dead and dying trees.
T25	Field Maple	Sever Ivy. Remove Ivy. Inspect stem/basal area. Carry out further Inspection. Remove major deadwood. Prune to clear overhead wires Ensure 5m clearance of heigh over the road	For safety reasons. For site splay reasons
G26	English Elm, Hawthorn	Selective removal of weaker specimens which will be marked up with spray paint. Remove some of the ivy.	Dead and dying trees.

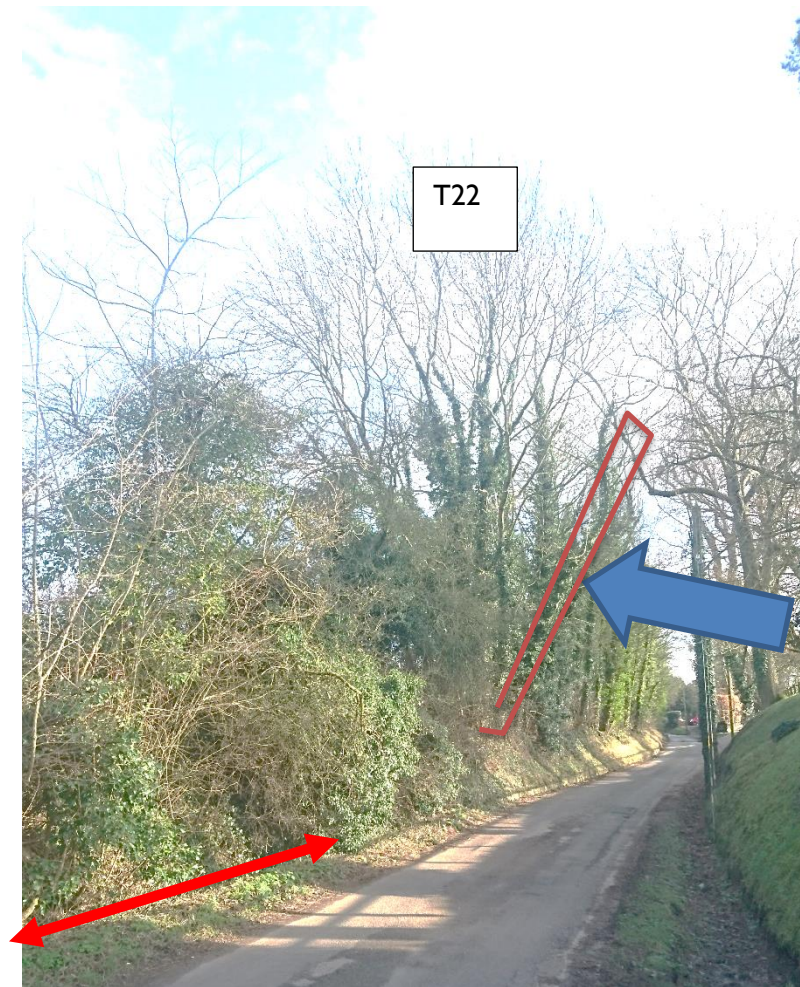
Photo 16 of G24 showing extent of bellmouth entrance. T22 ash shown in background.

Photo February 2018 Stem to be removed shown by the arrow and red outline
