HERITAGE/DESIGN AND ACCESS STATEMENT

Apple Trees, Bradfield St.George

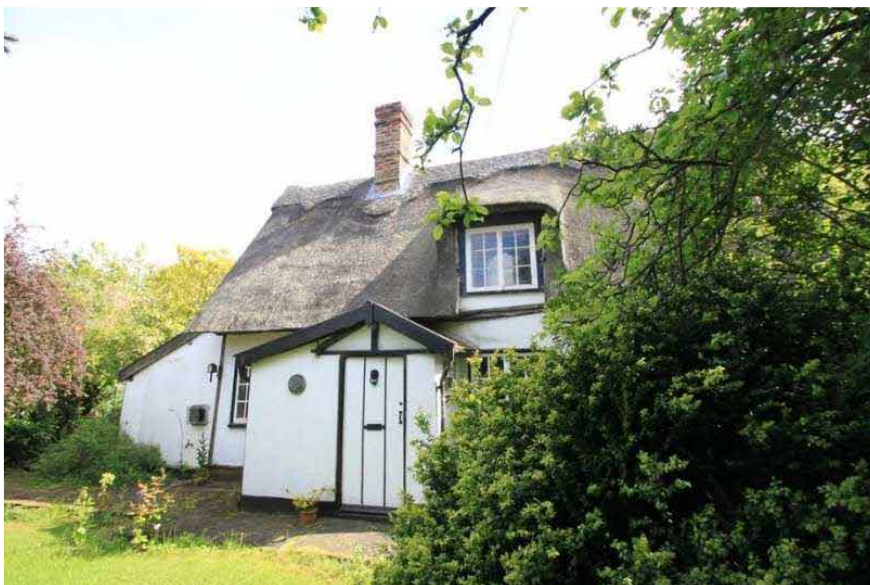
Fig.1 - Front Elevation of Apple Trees in its former condition prior to the commencement of the works.
