**Brief Design Statement for Removal of Thatch To Mill Barn, Mill Lane, RG20 4UD**

**PRESENT SITUATION**

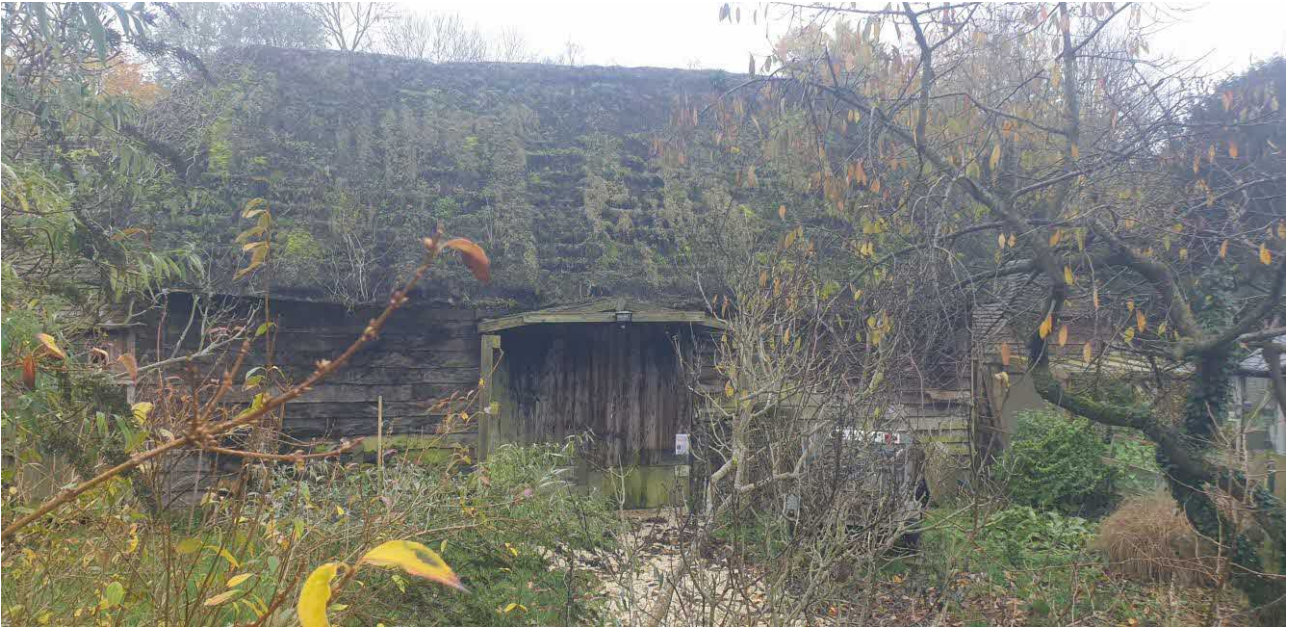
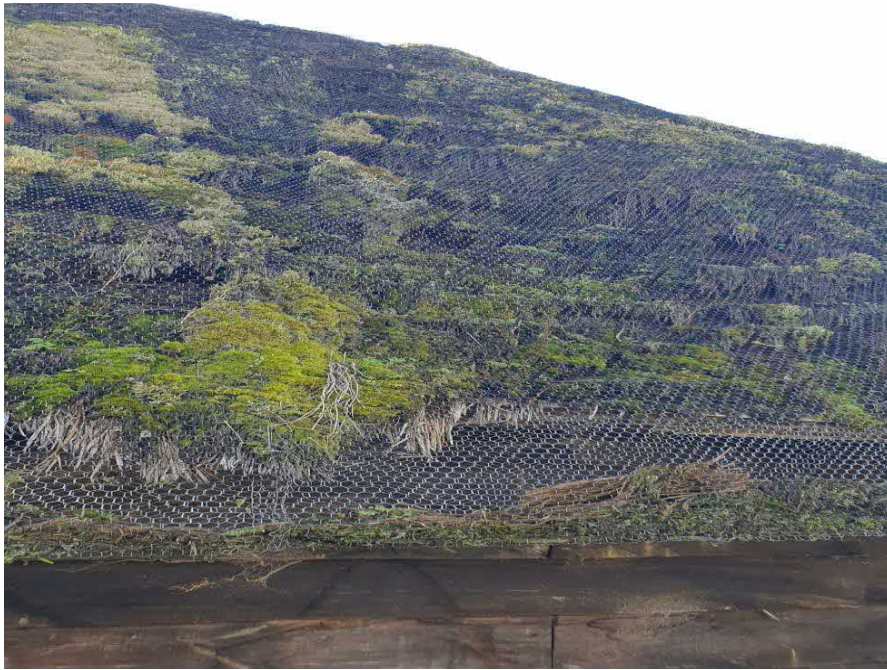
FRONT THATCH

The 30 year old thatch has now deteriorated, exposing fixing battens and under roof allowing water penetration through the fixings. The thatch is slipping and rotting and potential vermin infestation.

Whatever happens to the roof the rotten thatch needs removing and fixing holes repaired. The original corrugated iron roof is still in place below the thatch. This was retained for rigidity, not to disturb the original timbers and as a short term fire barrier. The barn was listed with this iron roof.
