**HERITAGE ASSESSMENT  
for  
RENOVATION & REPAIR WORKS  
to  
SOUTH of BUILDING**

Chart Place,  
Church Road,  
Chart Sutton,  
Maidstone,  
Kent,  
ME17 3RE

**COUNTRY HOUSE  
HOMES**

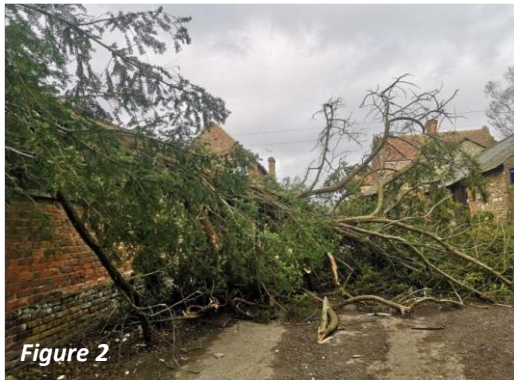
**Figure 2 – Tree Fallen Over Wall**

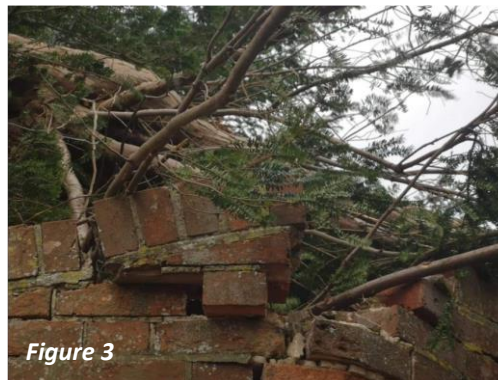
**Figure 3 – Damage to Wall**

- 8.4** The repair of the boundary walling to the east of the entrance gates following the tree damage seeks to reinstate the walling, using bricks reclaimed from the damage and laid in the same style and Flemish bond. Given that these works seek to reinstate and repair damage with works of the same style and quality there is no significant harm to the heritage asset or its legibility.

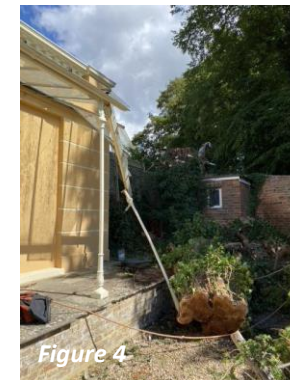
**Figure 4 – Damage to Glass Canopy**

- 8.7 As established at Paras 7.35 to 7.40, the existing glazed veranda canopy is a modern structure erected in the 1989 to 1992 period and is glazed in Georgian-wire glass, which is visually detracting from the overall quality of the frontage. The reinstatement of this structure following the tree damage and the reglazing of the structure using toughened safety glass will serve to improve the visual appearance and does not result in any harm to the surrounding Heritage structures.

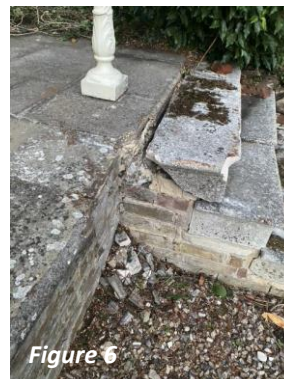
**Figure 6 – Frost Damage to Steps**

- 8.5** The raised terrace was first introduced around 1880 which is consistent with its current appearance, formed in red stock facing bricks with Flemish bond brickworks. However the existing structure is crumbling and decaying with frost damage and requires rebuilding in order to continue to provide structural support to the raised terrace. Given that the works will be carried out with reclaimed red stock facing bricks, lime mortar pointing and in Flemish bond, the reinstatement will continue to represent the same heritage detail of the original structure, therefore minimising harm to the Heritage asset and its future understating.

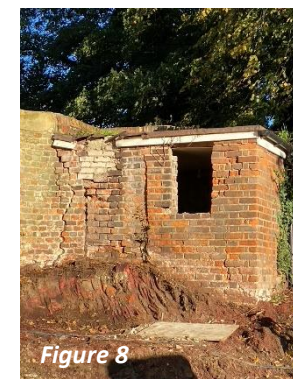
**Figure 8 – Damaged Storage Building.**

- 8.3** To take each item in turn; The renovation and repair of the storage building damaged by the fallen tree would appear to affect a building that has origins to the 1708 creation by Sir Christopher Desbouverie, given that the 1719 etching by Thomas Badeslade shows a single storey flat roof building in a similar location to the existing structure. However, as can be seen at Figure 8, this existing structure has Flemish bond brickwork of a later period and has a modern flat roof structure, indicating that the building has been subject to rebuilding and renovation several times over the years. Indeed there is no evidence that the building is the same structure as that shown in the 1719 etching. Therefore the works to repair the building following the tree damage, using bricks reclaimed from the damage and building in the same style/bond, does not harm the heritage of the property and does not result in any loss of legibility.
