Pre-Development BS5837 Arboricultural Implications Assessment Haggerston Castle Landscaping

Produced for Haven – Haggerston Castle

By Jim Richardson BSc For. HND Arb.

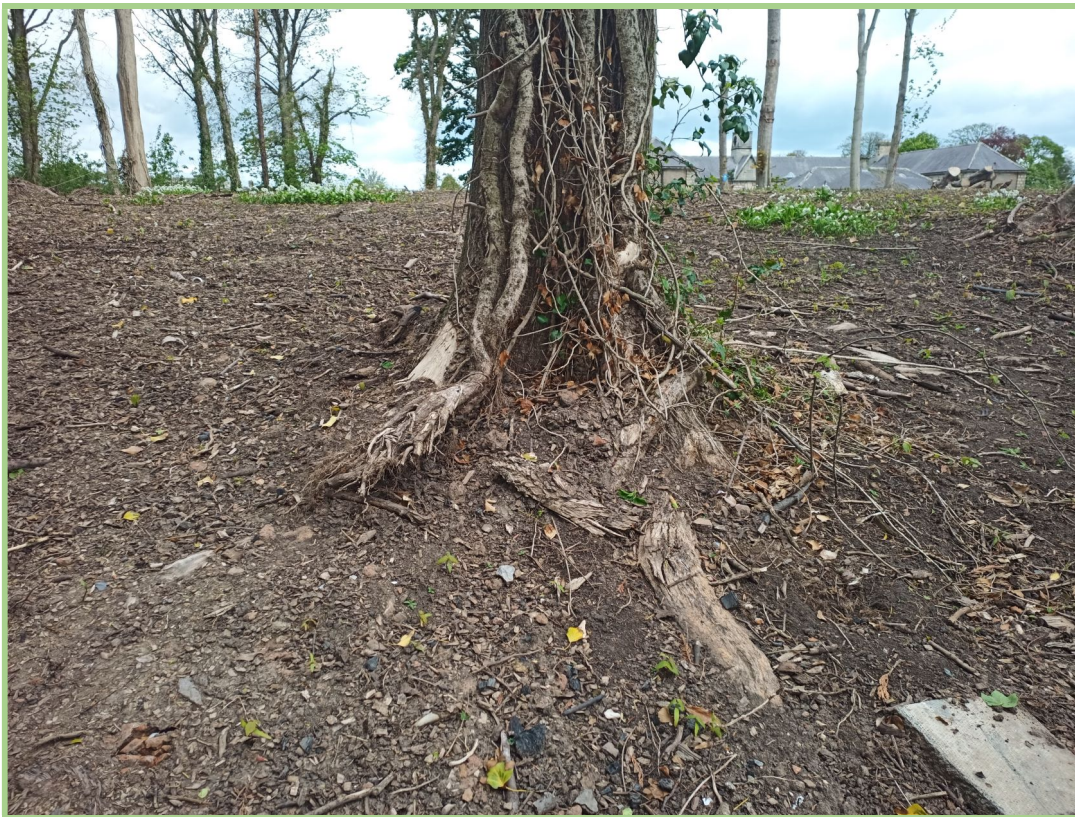
The area was devastated by Storm Arwen in November 2021 when most of the trees in the area were windblown. Following the storm, the site was used as an emergency storage facility for other storm damaged timber, brash and chippings, causing significant ground disturbance. Most of the remaining trees are now in poor condition due to a combination of factors.

- Ground Disturbance – Throughout Site.

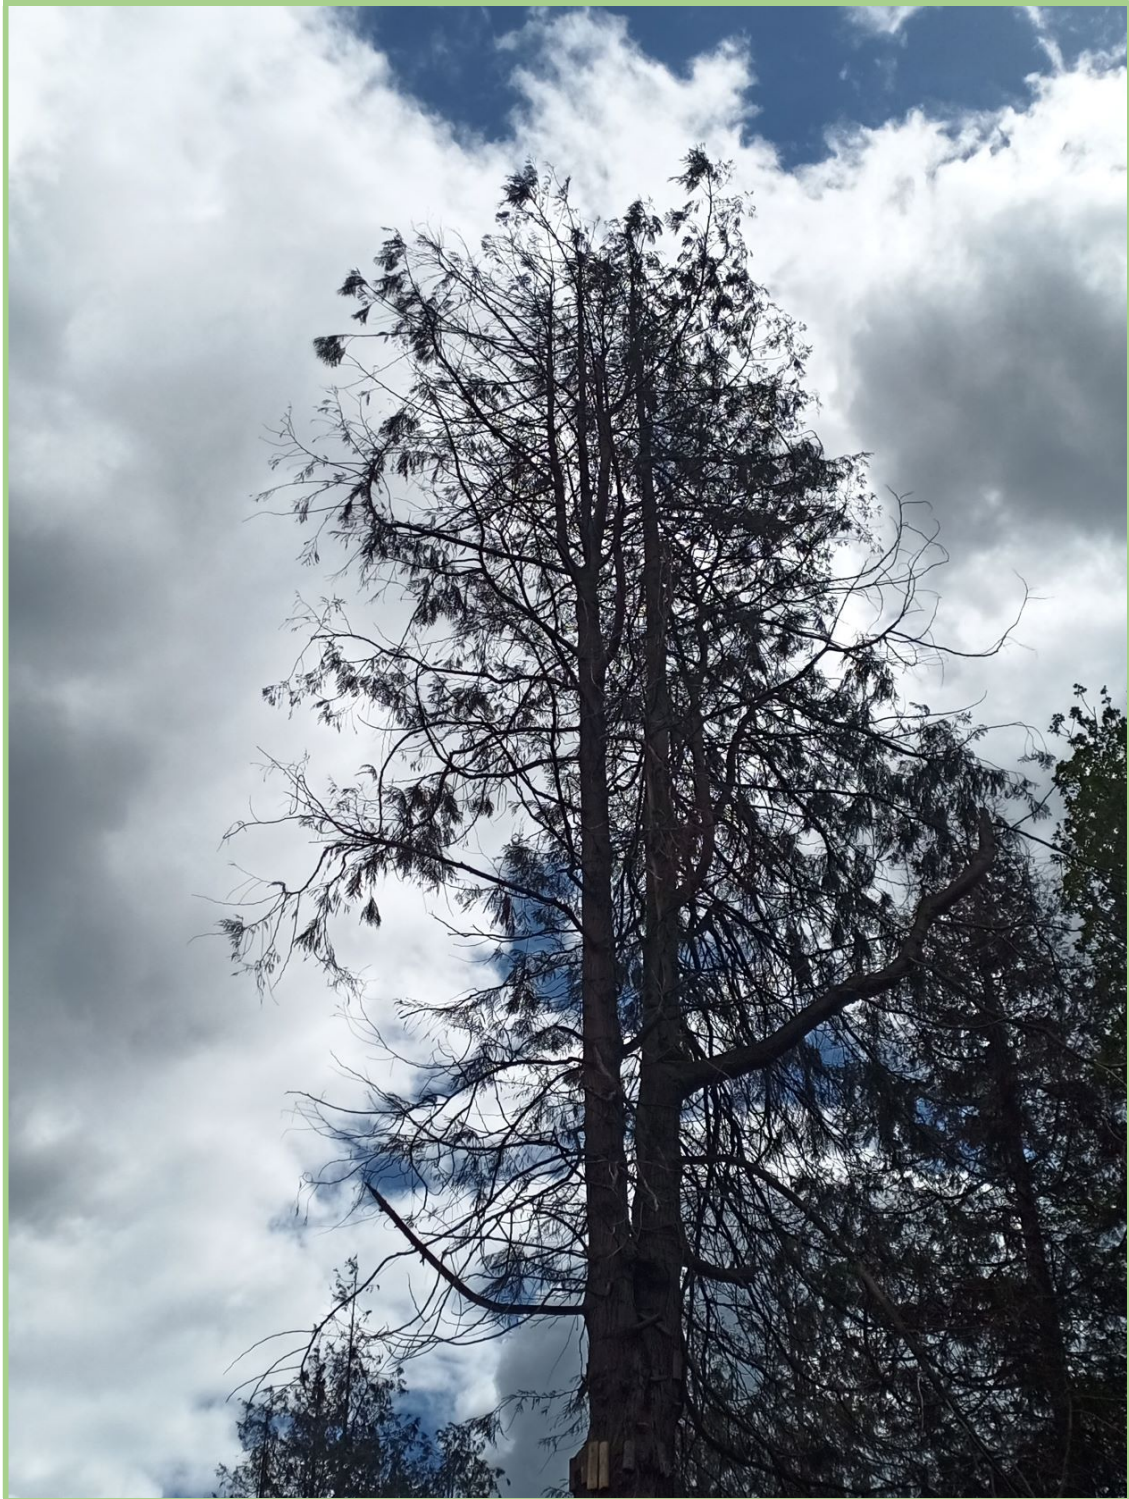
- Crown Dieback Example

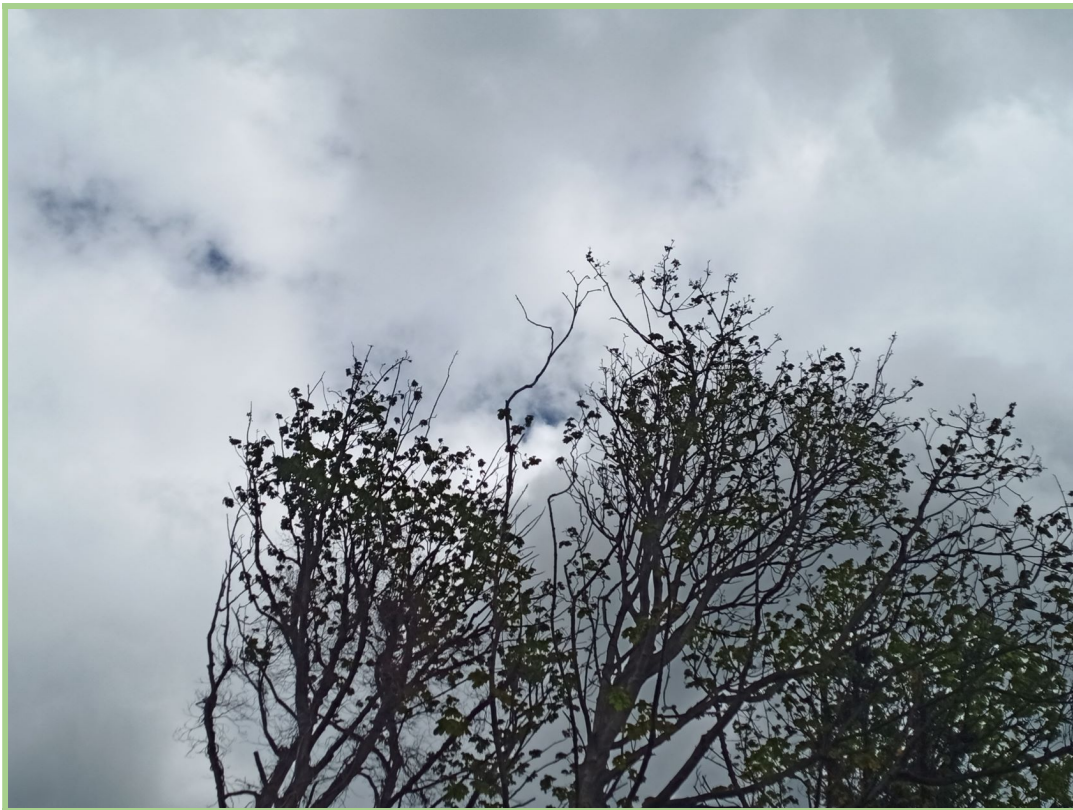
- Crown Dieback Example
