ARBORICULTURAL REPORT

to BS 5837:2012 at:

***Hodsock Woodhouse,
Hodsock Lane,
Worksop,
S81 0TF***

Reference: *AWA5189*

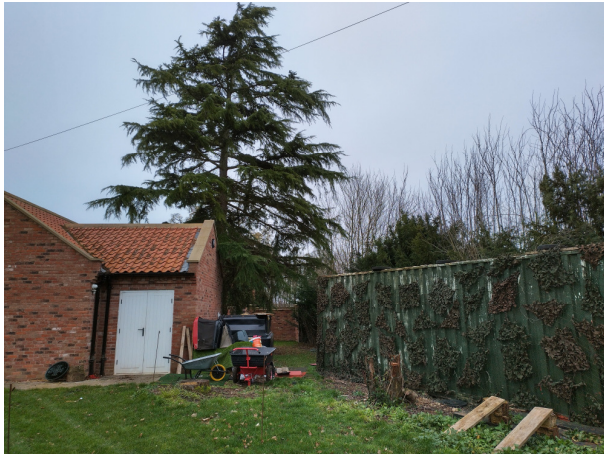
Photo 1: T5 from north

- 3.2.8 Trees T5, T26, T30, and T36 are significant trees on site with moderate amenity value and good visual value. All are early-mature except T30 which is a mature Weeping Willow. T30 has a prominent position in the landscape and is in good condition, though its age will limit its long-term value.

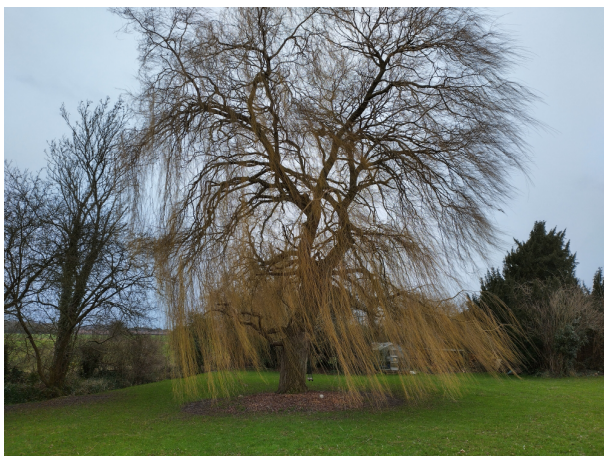
Photo 5: T6 and T8 from east

- 3.2.9 Tree T6 and somewhat T7 have received poor pruning as a result of clearance from the powerline to the south. However, they both are of good visual amenity and are in good structural condition.
