# AllAboutTrees

## Arboricultural Impact Assessment

Eden House,

Stocksfield

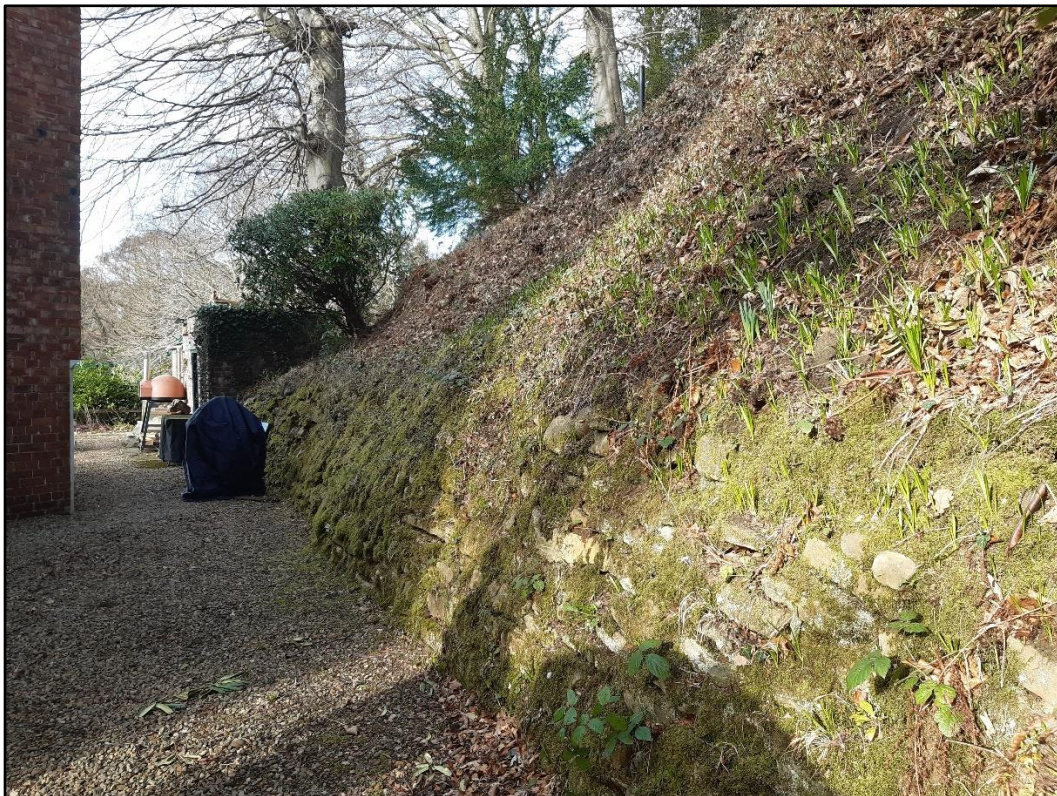
4.6.2 The image below shows the location of the extension to wrap around the existing dwelling. The extension will be placed at the lower level. The topography of the land prevents access to the higher ground, affording the trees natural protection. There is no requirement for access onto the higher ground and therefore protective barriers are not be required for the extension to the dwelling. Tree 8 is extremely close to the development area – as tree protection cannot be installed here it is imperative that site operatives take utmost care to avoid any inadvertent damage to this tree.

*Figure 3 – The flat ground adjacent to the steep slope east of the dwelling*

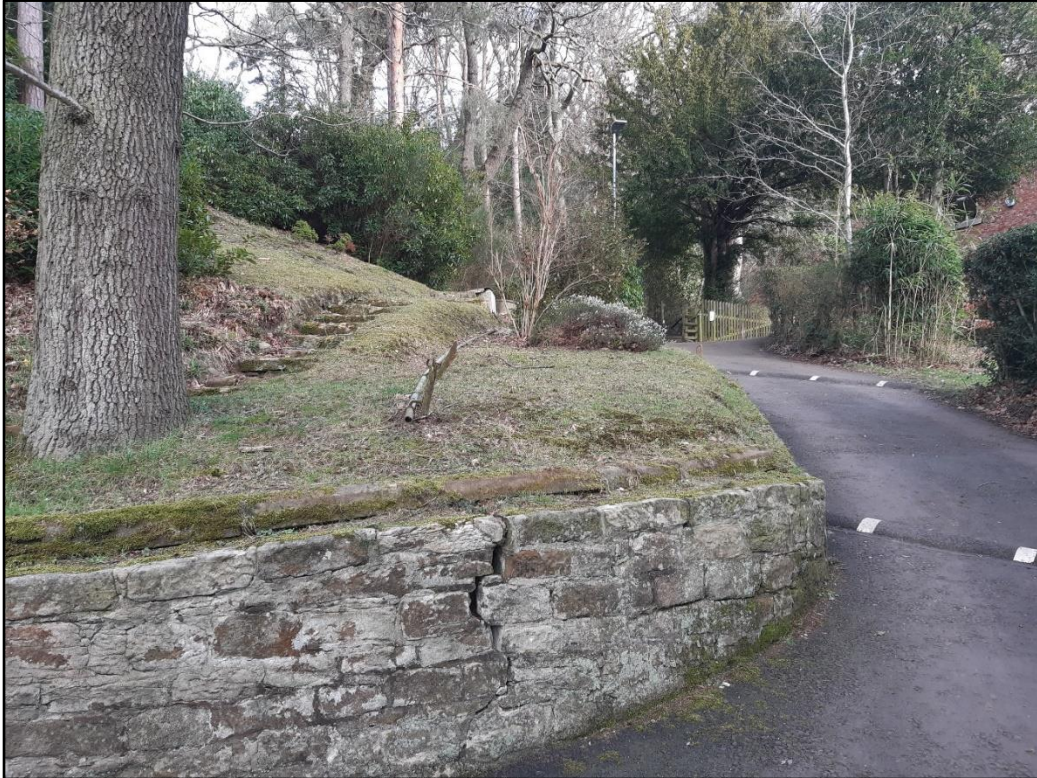
4.6.3 The area identified for construction of the detached garage is more open and a protective barrier will be erected here. The position for the protective barrier is indicated by the blue line on the Tree Protection Plan (TPP) and a specification for its erection is provided in section 5.1 of this document.

*Figure 4 – The proposed location of the detached garage, to the rear of the oak in the foreground*

4.6.4 Due to the slope of the site it will not be possible to install ground protection measures in the locations where the RPAs cannot be excluded with the use of protective barriers. As such, access to the space between the protective barrier and proposed garage footprint must be limited to pedestrian only.

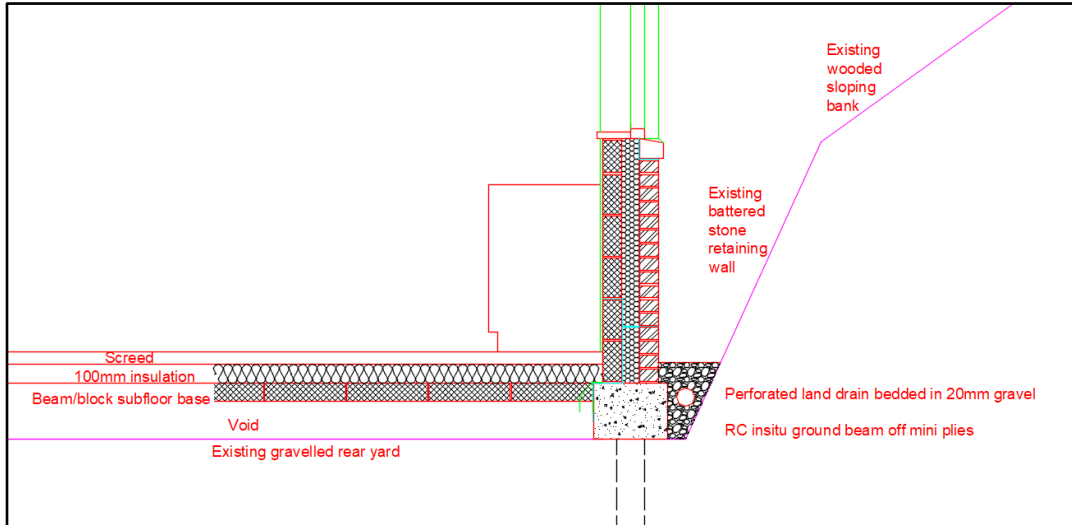
Figure 5 – The proposed extension has been designed to sit on mini piles to limit disturbance to any roots which may have penetrated down into the flat plateau

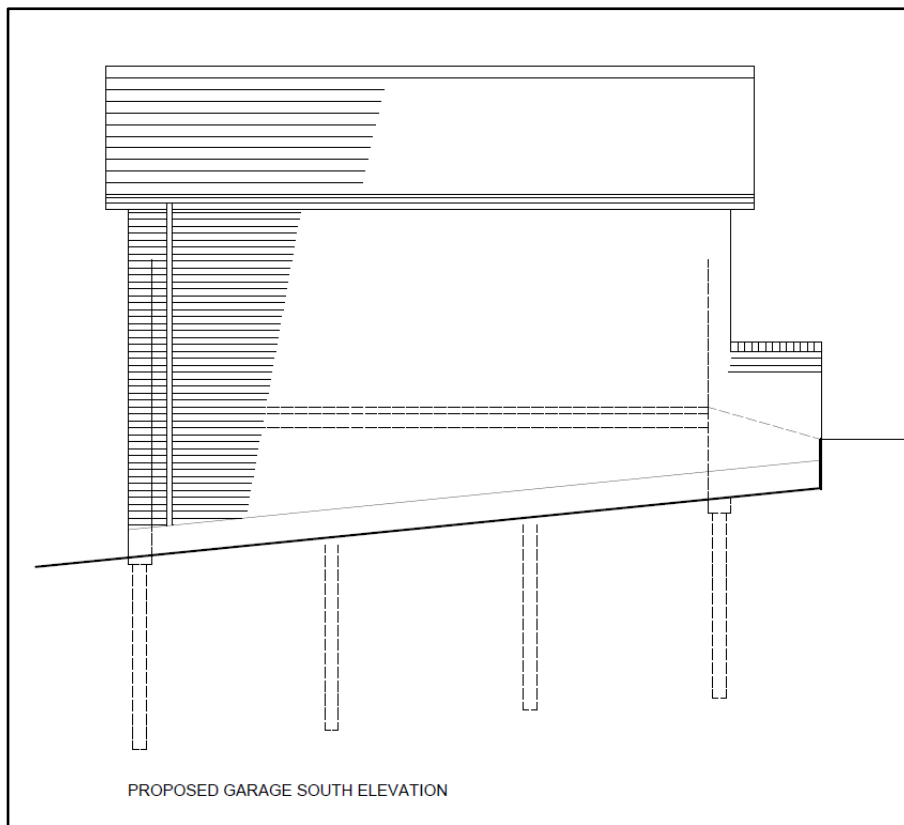
Figure 6 – The garage has also been designed to sit on pile foundations to limit disturbance to below-ground portions of adjacent trees.
