# Arboricultural Impact Assessment

## **Wood Edge Cottage, Aukside, Middleton in Teesdale**

August 2021

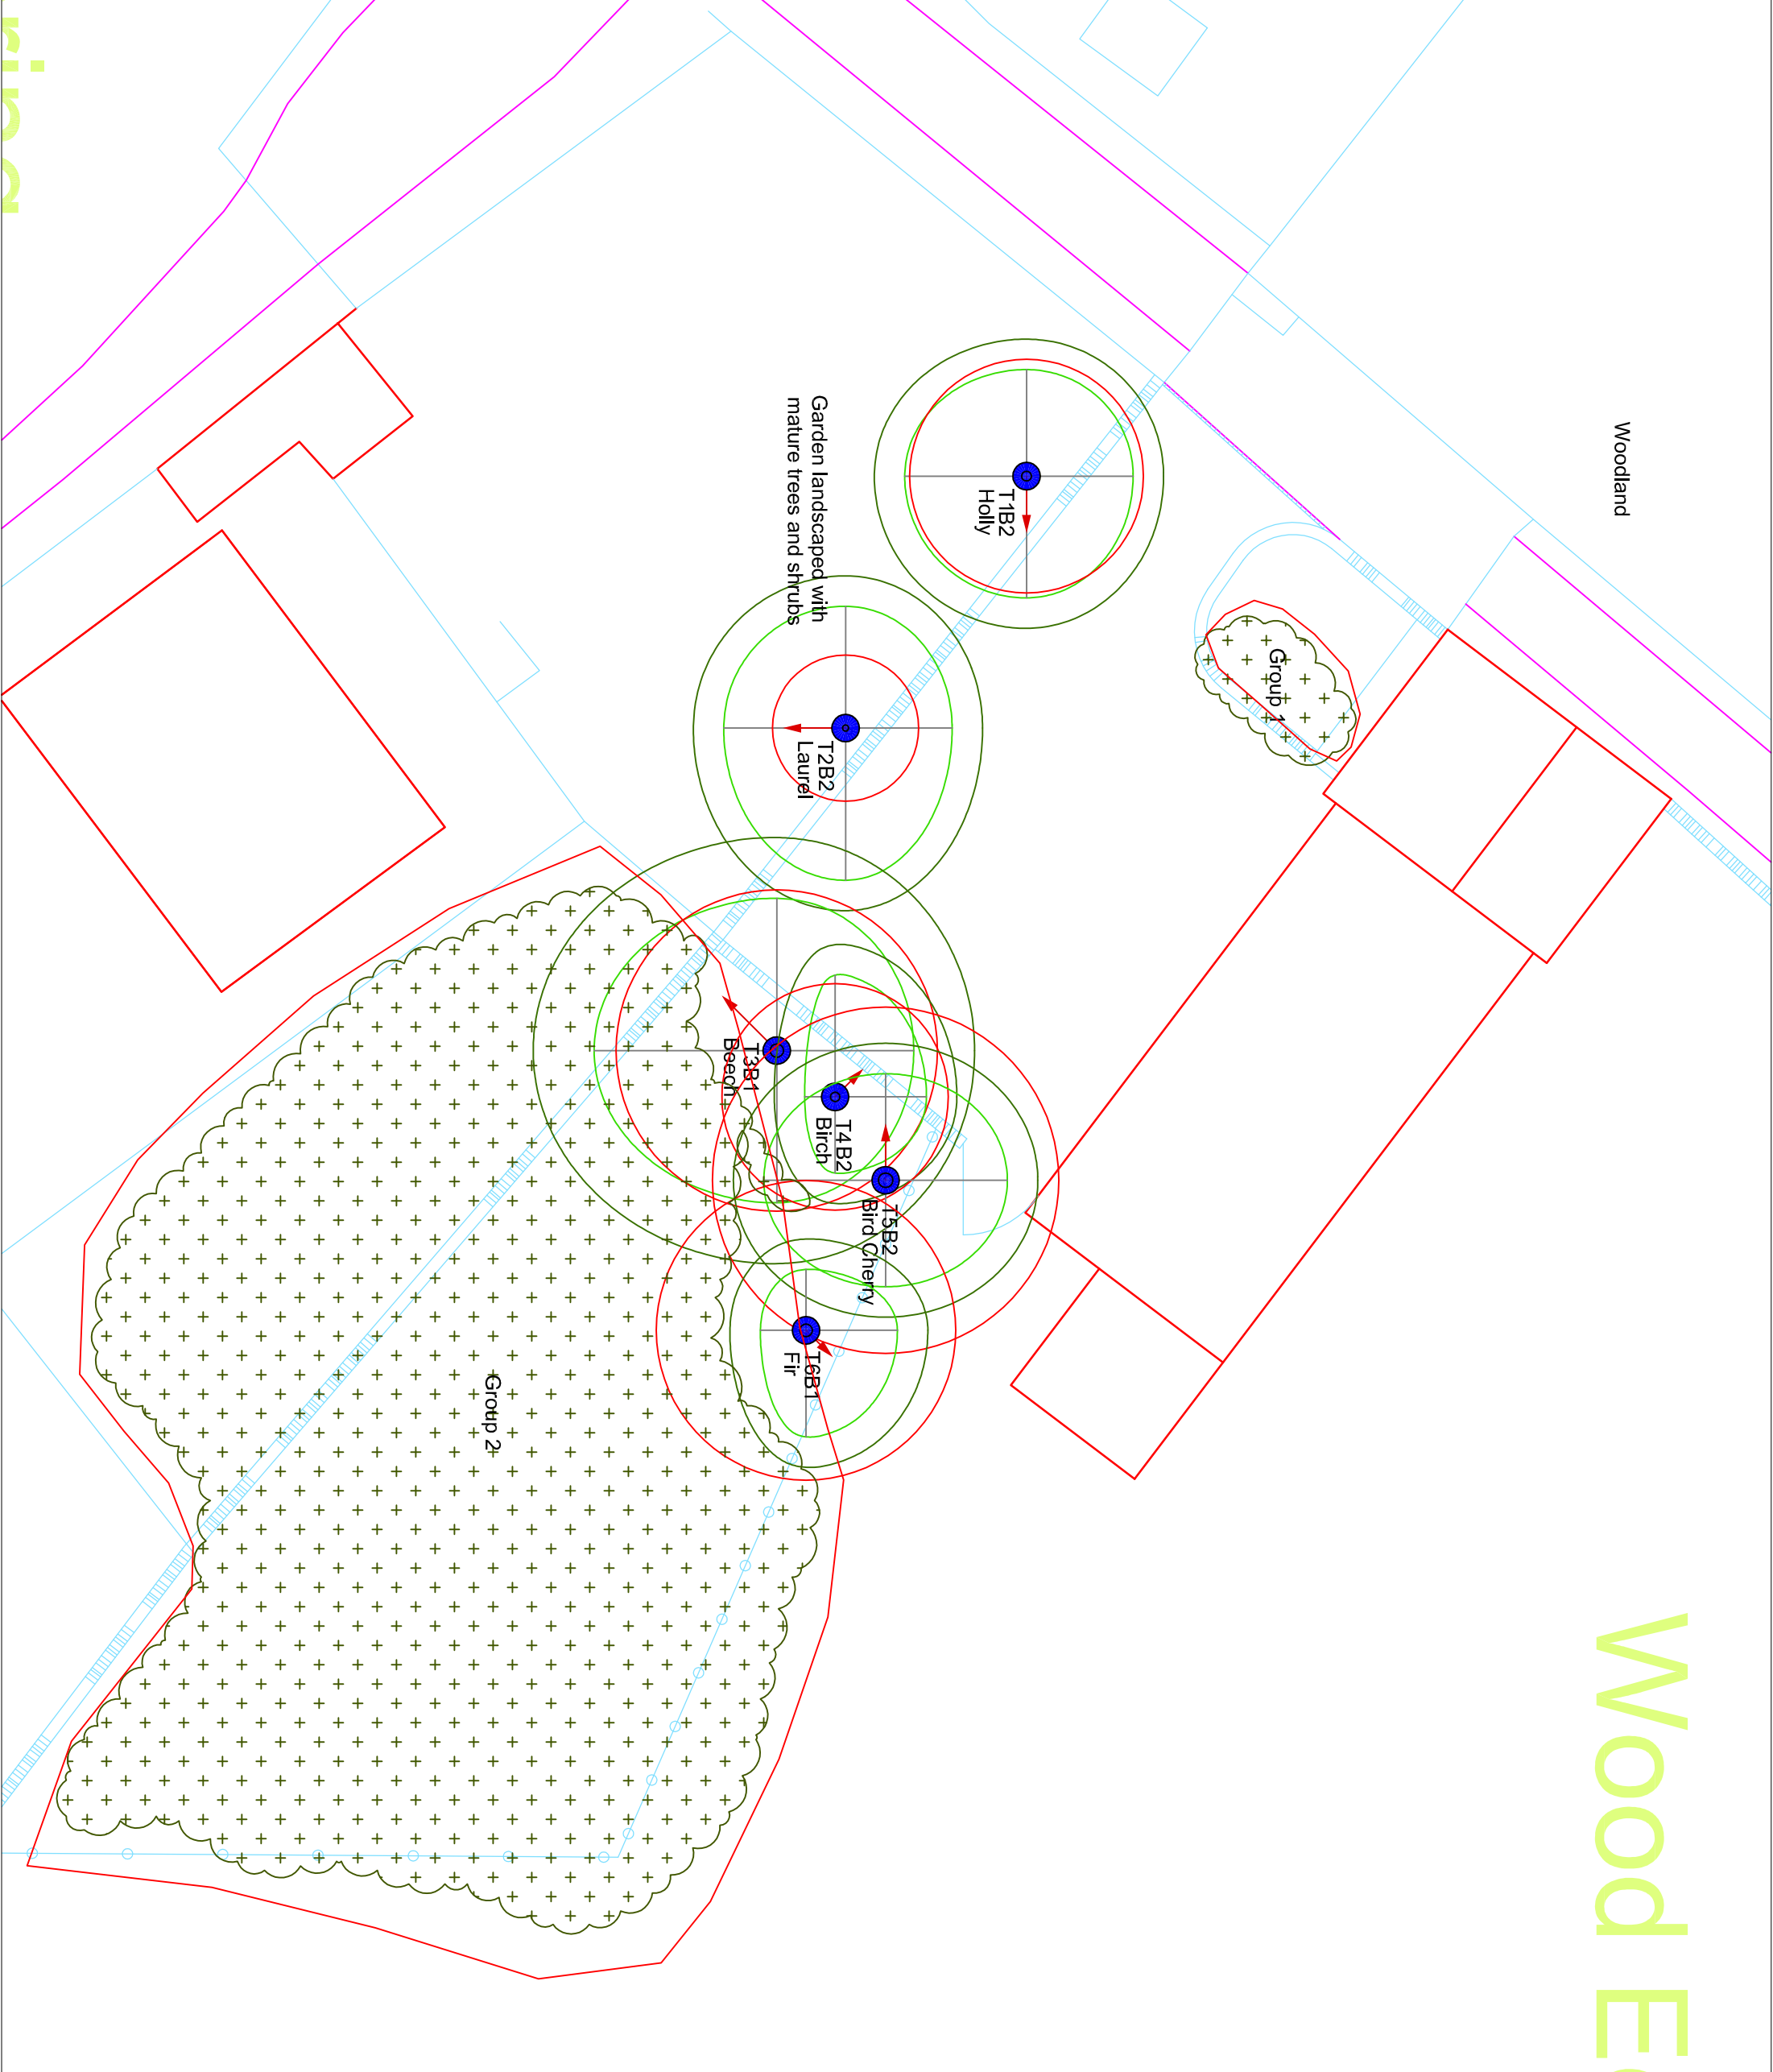
Existing Tree Location Plan  
Wood Edge Cottage, Aukside  
Middleton in Teesdale

2.1.1 There were 6 individual trees surveyed. All of the trees have been given a B category rating (2 B1 and 4 B2). In addition to the individual trees 2 groups were surveyed.

2.2.1 The root protection area is indicated for each tree, group and hedge on each of the plans. The red circles around the trunks indicated the root protection areas as calculated in accordance with the British Standard (BS5837:2012). They are indicative only and do not take into account site specific condition such as topography and underground land forms, built structures and underground services.

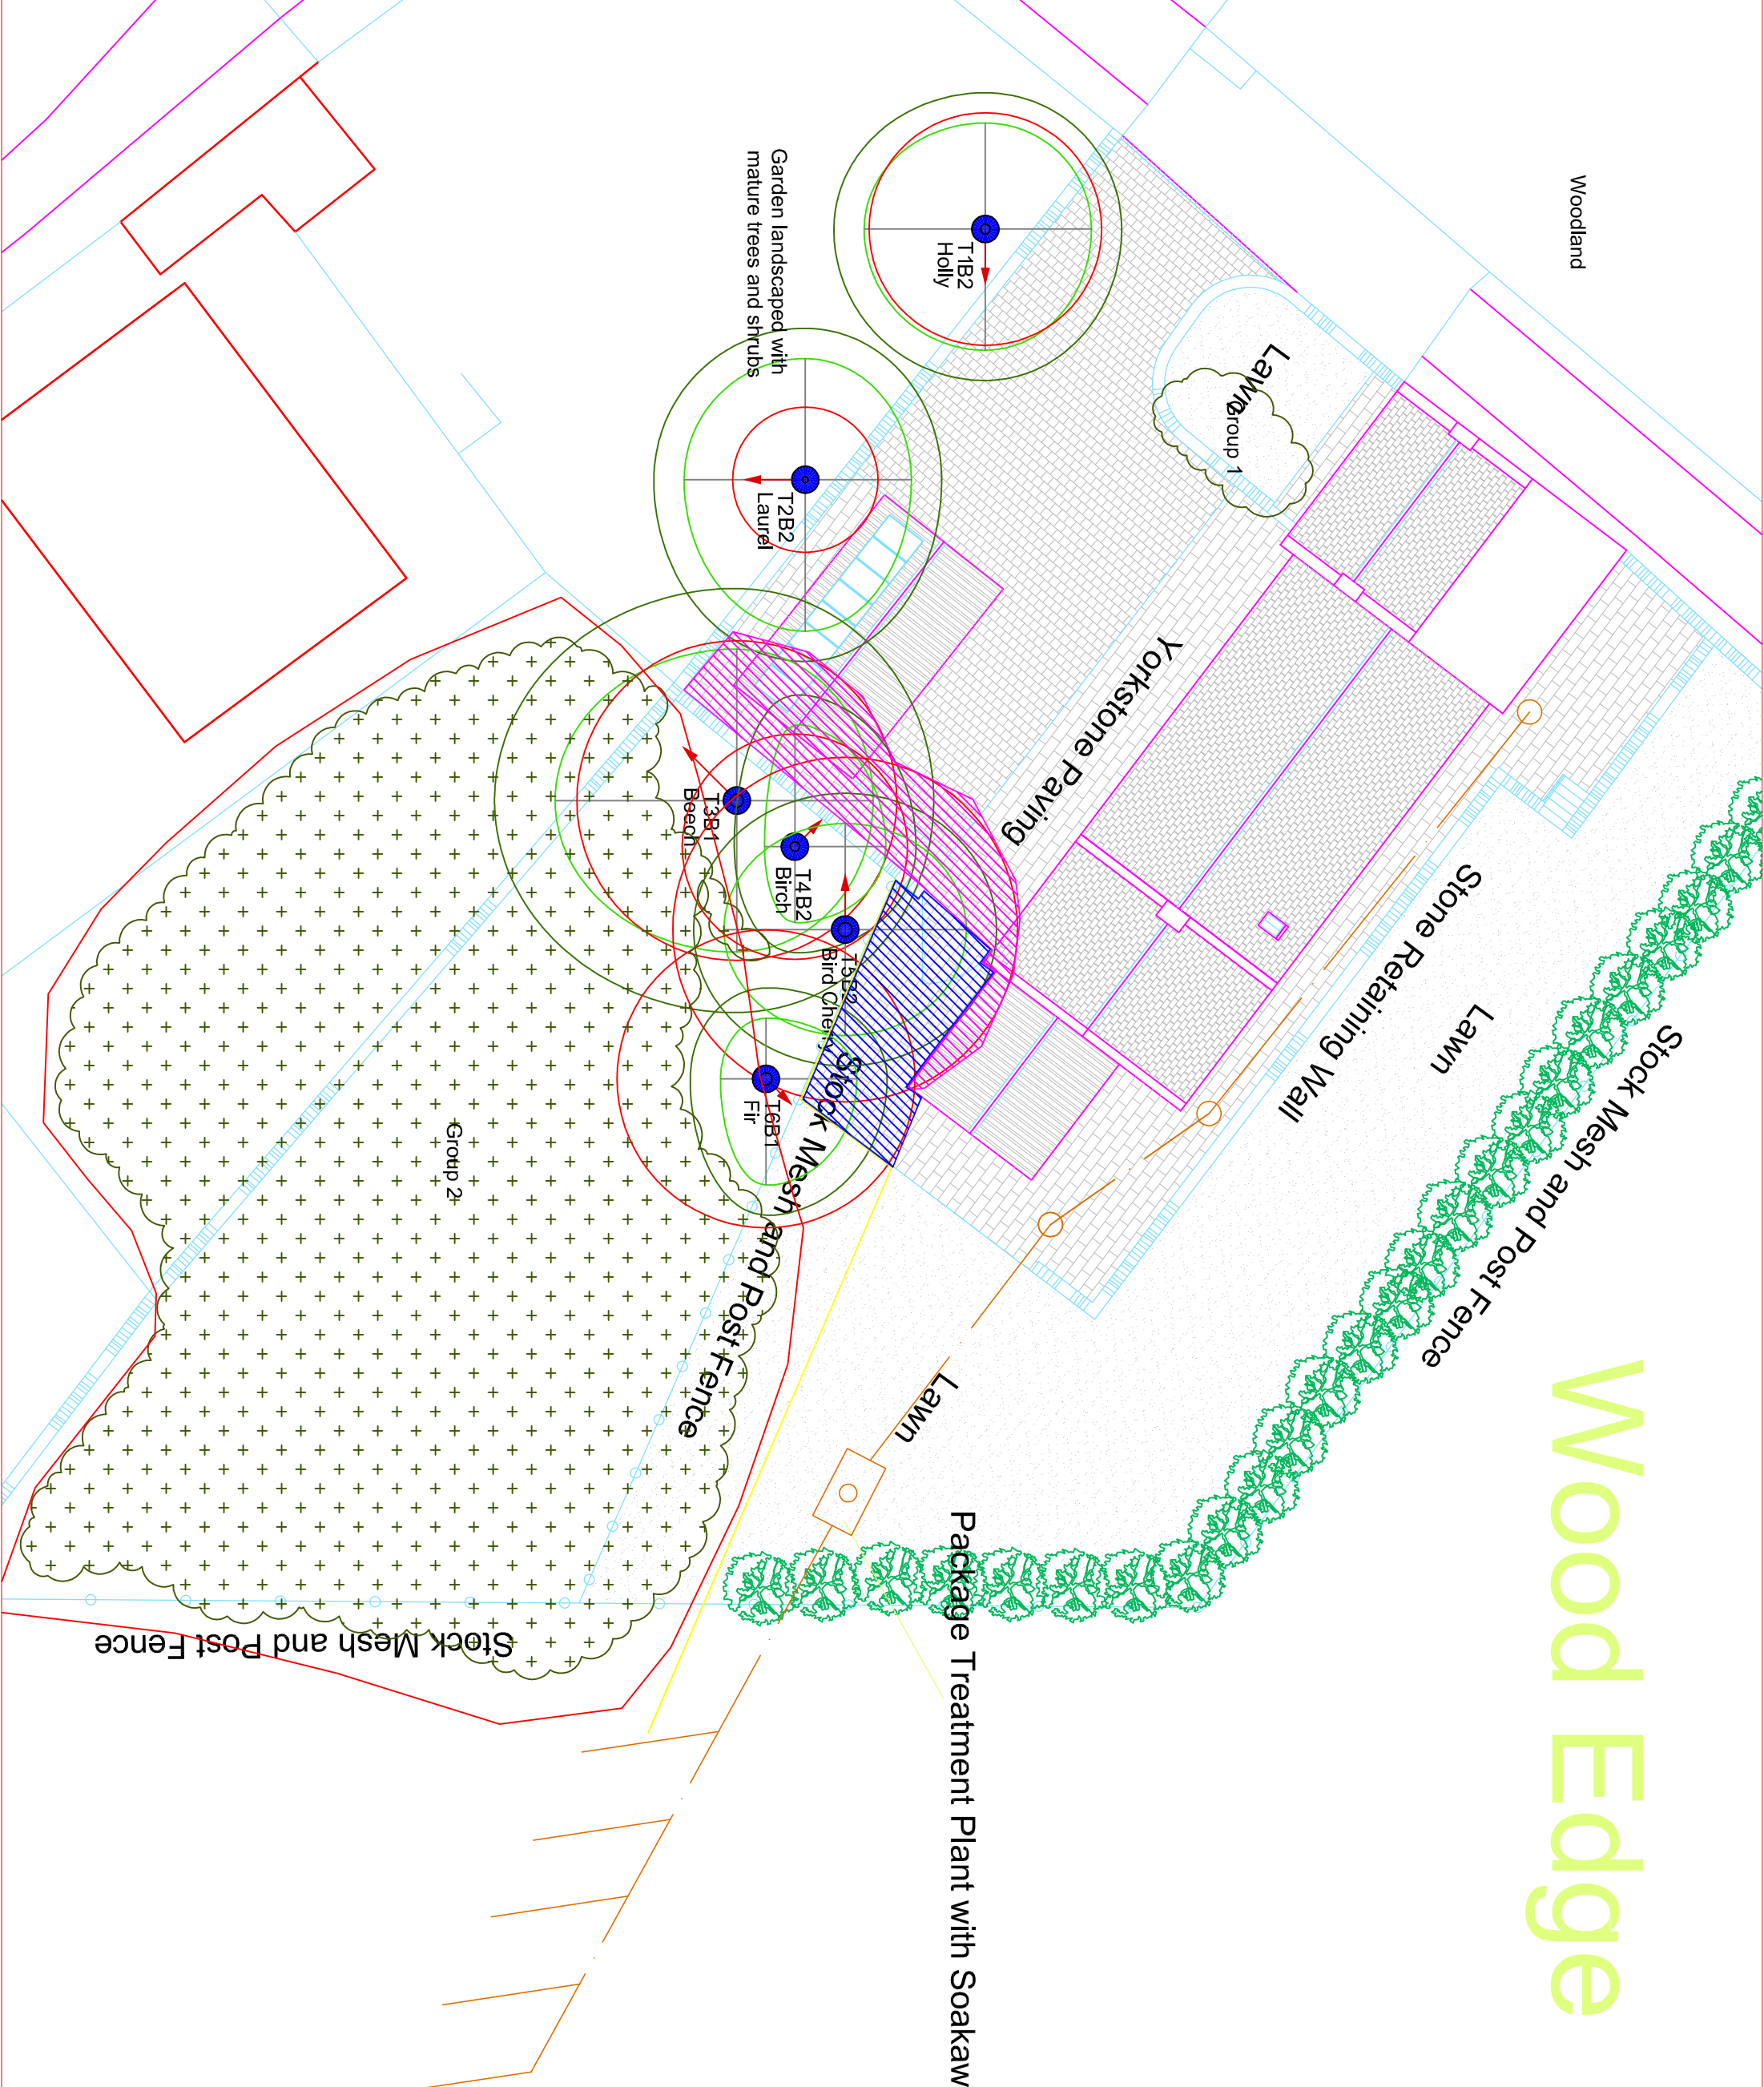
Tree Protection Plan  
Wood Edge Cottage, Auckside,  
Middleton in Teesdale

2.2.3 For this site the root protection areas of most trees are shown to extend into the cobbled yard area. This surface has been in place for decades and may have resulted in root protection areas differing to those as indicated on the plan. As a precaution the area marked on the Tree Protection Plan as magenta hatching is designated a hand dig area only. There should be no digging down in these areas only the removal of the top surfacing, if no roots are encountered digging may be permitted. (See notes on tree 5 for the exception to this.)

3.3.1 Ground protection will be required to provide a working space in the root protection area of tree 5 throughout the development as indicated by the blue hatching on the tree protection plan. Once the existing surfacing is lifted ground protection measure will be required to provide working space around the garage within the root protection areas of trees 2, 3 and 4.

3.2.1 Protective barriers will need to be erected in the position as indicated on the Tree Protection Plan by the thick yellow line to ensure minimal impact on retained trees adjacent to the working area. Barrier position protects both underground and aerial portions of the tree where possible.

4.1.1 For tree 3 where the roots are shown extend into the existing yard area it has been a cobbled surface for decades therefore given the yard construction and wall separating the tree from the yard it is likely that the roots do not extend as far as indicated. However, as a precaution the cobble stones should be lifted by hand and any roots encountered should be treating in the appropriate way. The area marked on the Tree Protection Plan as magenta hatching is designated a hand dig area only.

4.1.2 It is proposed the garage is constructed on a raft, the existing levels within the root protection area of the tree will need to be worked with and no digging down to take place.
