# Proposed Replacement Joinery at Nelsons

2304.1400.P0 - Planning & Heritage Statement

Theo Arch Tech  
3 House Martin Way  
Stowmarket  
Suffolk  
IP14 5JB

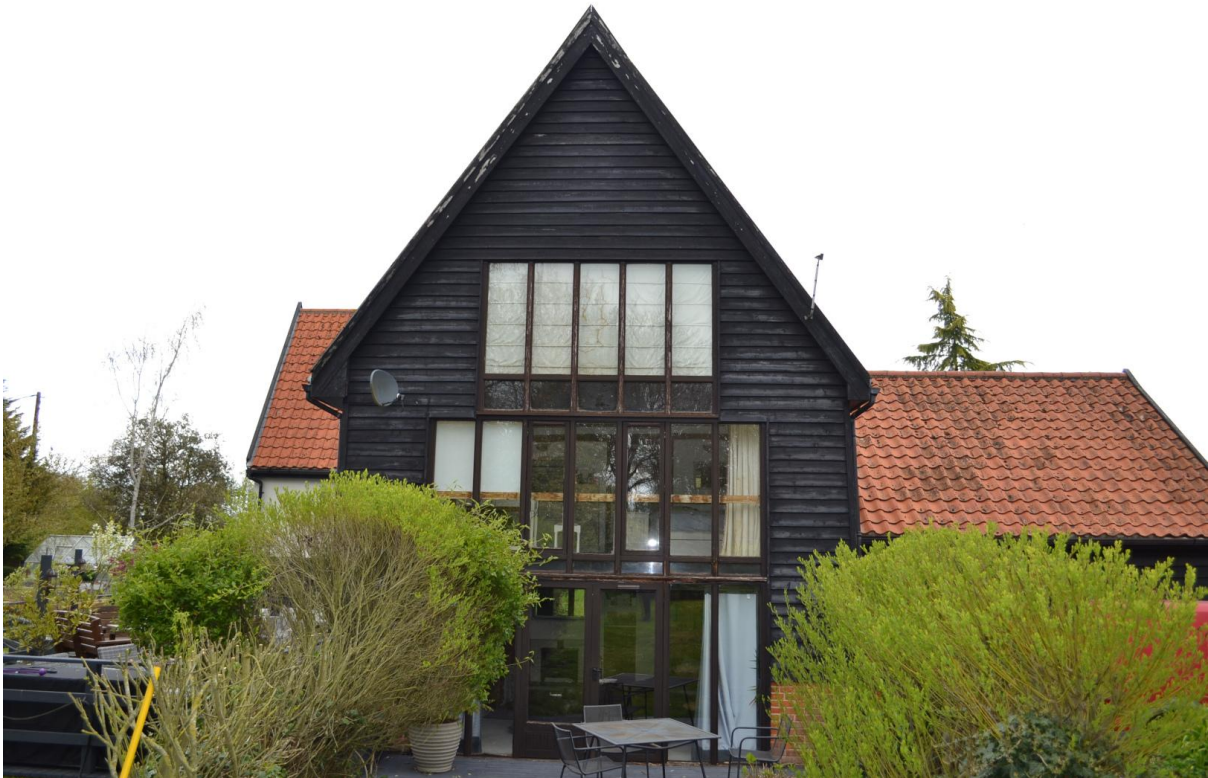
- i. The joinery within the south-west facing glazed gable has failed and requires replacement. Design flaws inherent to the existing arrangement warrant a replacement that is not like for like.

Plate 1 - Gable hosting glazed screens to be replaced

- i. It is proposed to replace the failed softwood joinery in the south-west gable with hardwood joinery that provides functional benefits whilst safeguarding the historic asset.

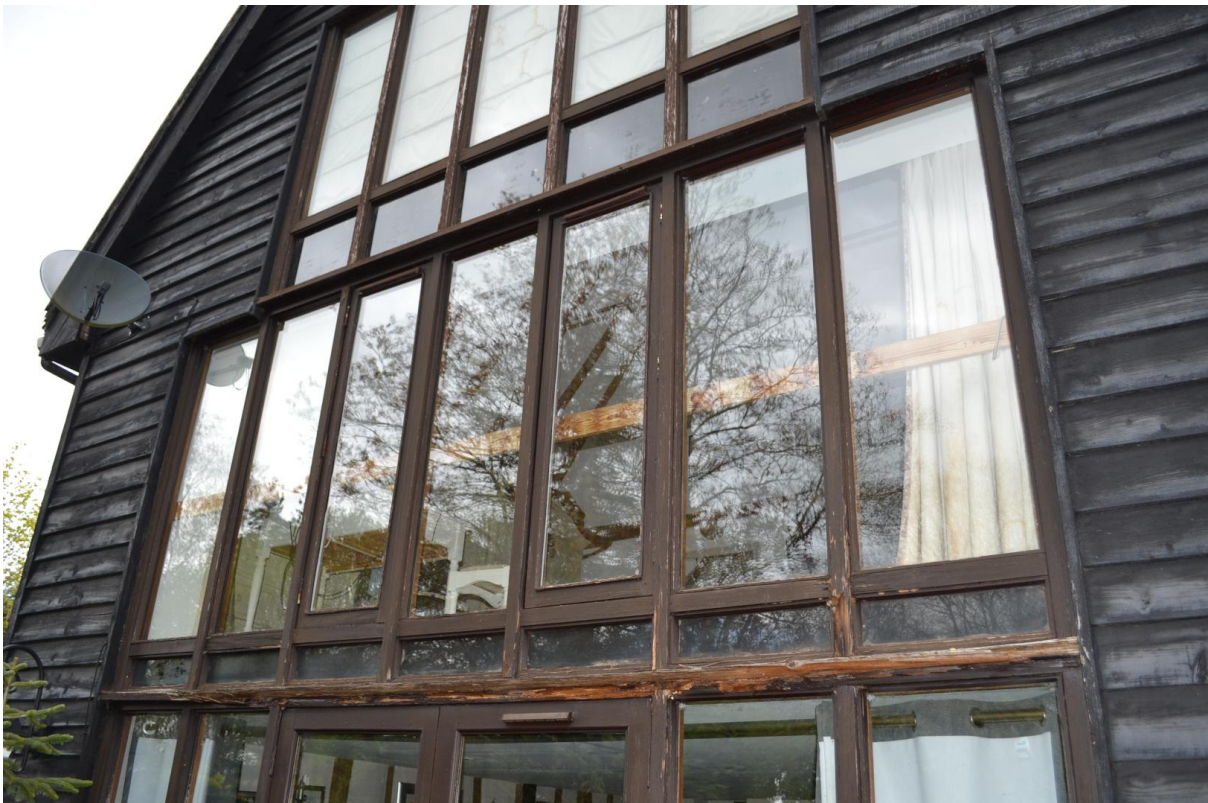
- a. Existing
  - i. The existing joinery to be replaced has failed and is unsafe.
  - ii. The existing joinery in the glazed gable lacks trickle ventilation.
  - iii. The existing joinery in the glazed gable has full height opening lights at first floor, this is a hazard for children and animals.
- b. Proposals
  - i. The proposed joinery will rectify the safety concern posed by the failed joinery.
  - ii. The proposed joinery will include trickle ventilation at ground and first floor levels.
  - iii. The proposed joinery has the opening lights raised to a safe level.

Plate 2 - Note the full height windows, with no balustrade to the barrier.

Building regulations require that low level opening windows in habitable rooms be fitted with restrictors or guarding to prevent falls from height. By redesigning the screen with the opening casements 1100mm from the floor, the new glazed screen will negate this requirement while still providing adequate ventilation.

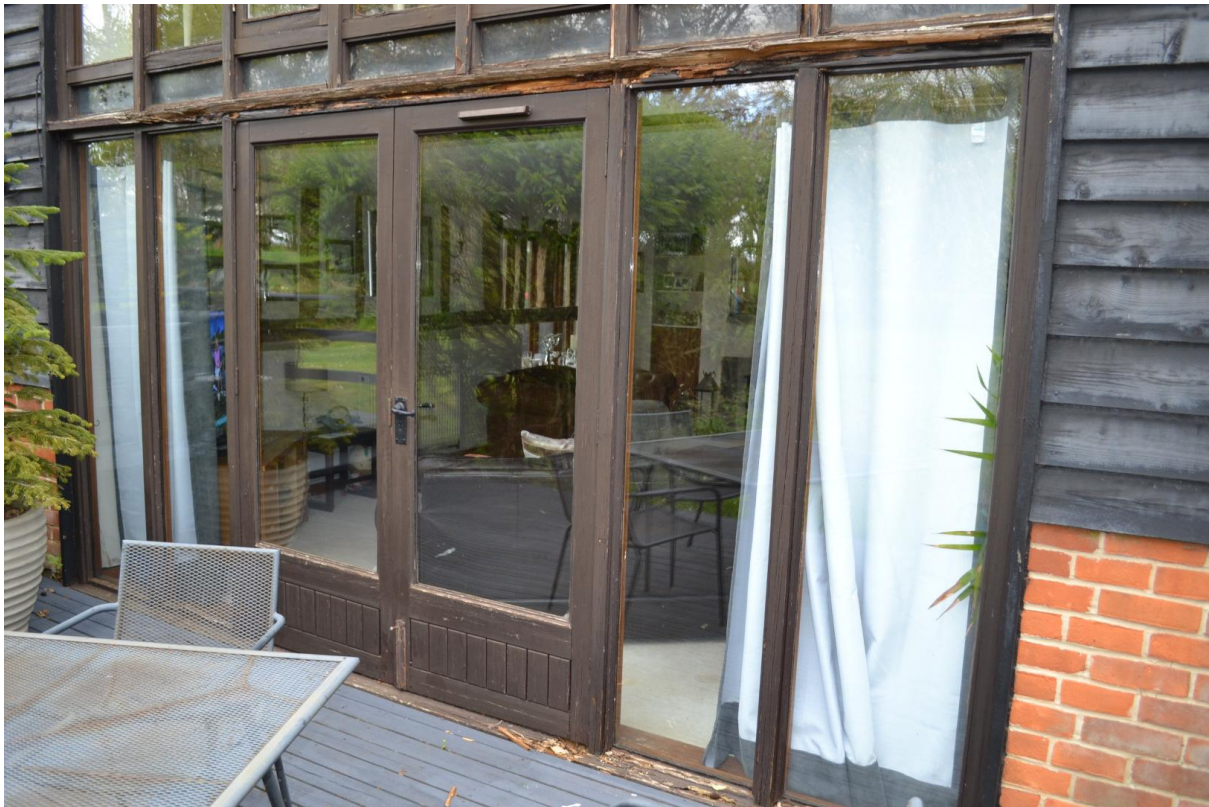
The existing joinery has failed and will result in damage to the heritage asset if not replaced.

Plate 3 - Note the damaged threshold and significant degradation at the head of the doors and sidelights.

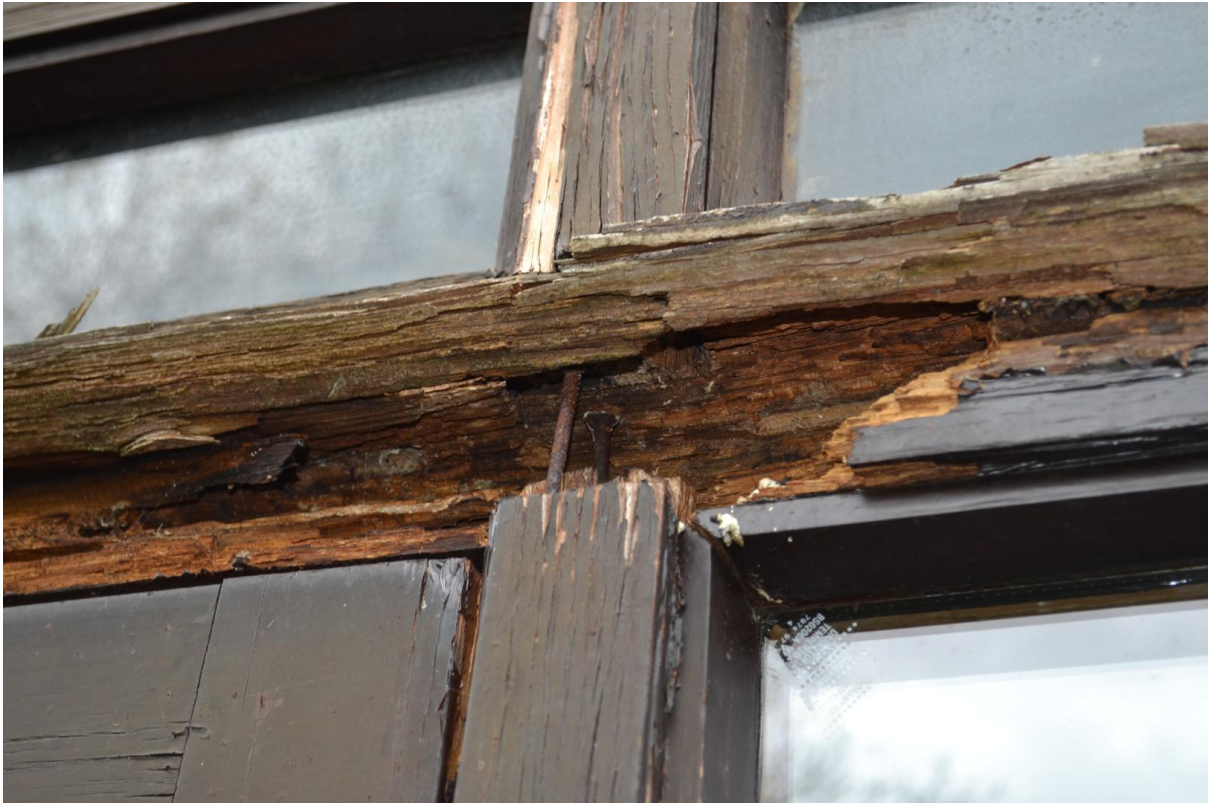
Plate 4 - Extensive Damage - Replacement with hardwood joinery will offer superior lifespan.

- iv. The replacement joinery will be fabricated from hardwood, rather than the softwood that the joinery to be replaced is fabricated from. Using high-quality materials with a long lifespan can help to ensure that the building is protected for the long term, and that future maintenance requirements are minimised. By using hardwood joinery, the proposed changes can help to safeguard the future of the heritage asset.
