27 CHAPEL LANE, LETTY GREEN. SG14 2PA

BS5837 TREE SURVEY, ARBORICULTURAL IMPACT ASSESSMENT AND METHOD STATEMENT.

Proposed construction of single storey property

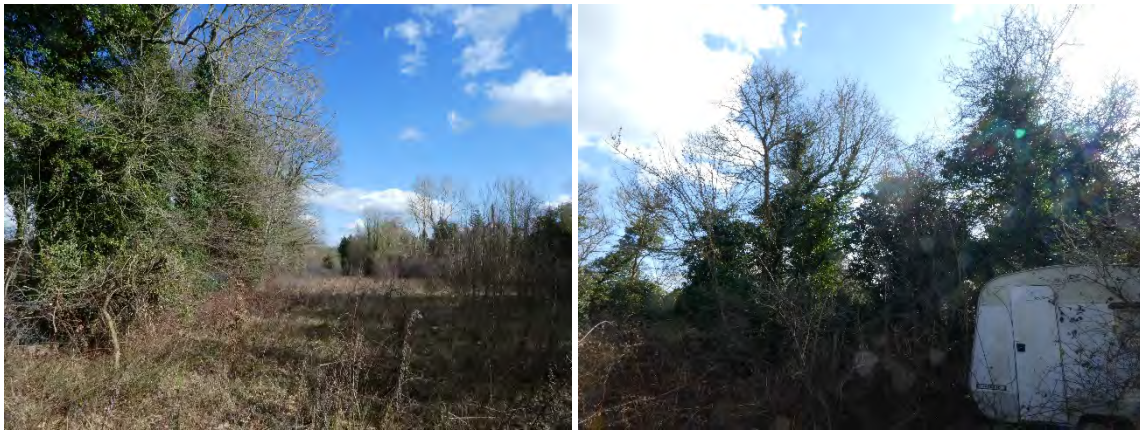
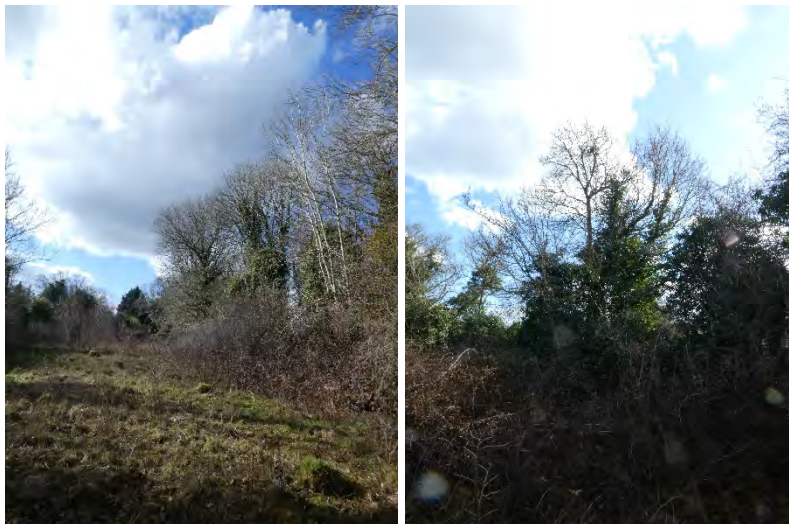
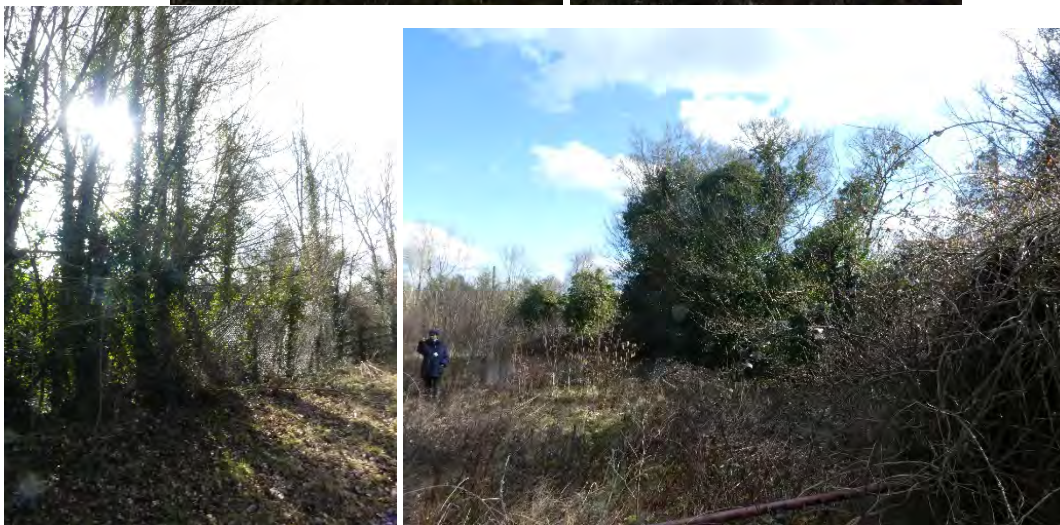
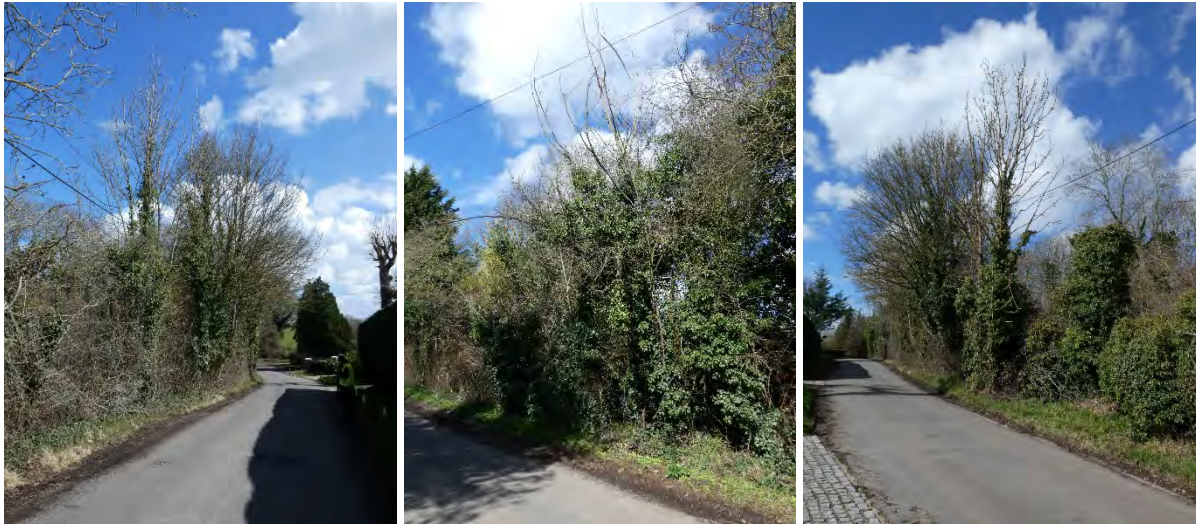
Photographs – photos taken on 14 March from the inside of the site. **Above and below left-** the northern side of the site with tree along Cole Green Way. **Above and bottom right-** the southern side along Chapel Lane

Above and below- overgrown hedging along Chapel Lane with several trees, ash, field maple and hawthorn and dead elm- with some prolific ivy growth consider management of the native hedge if under the client ownership

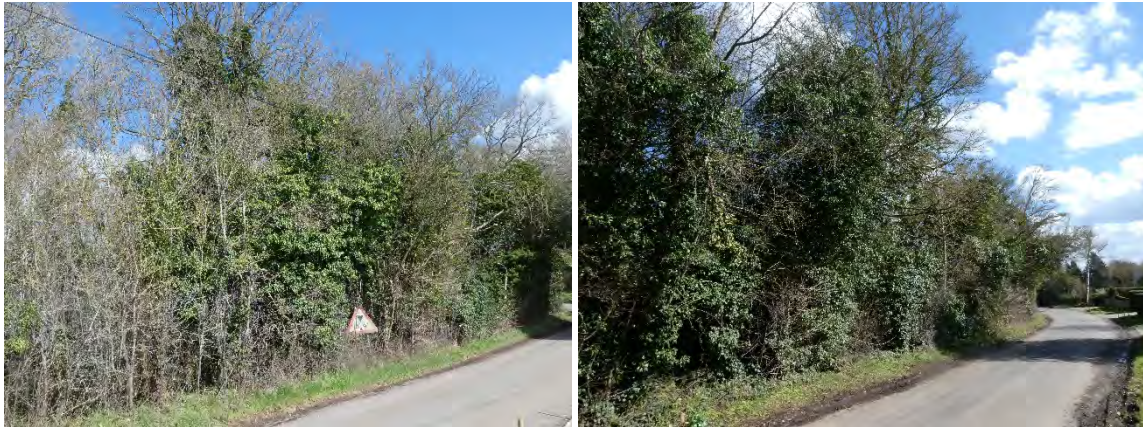
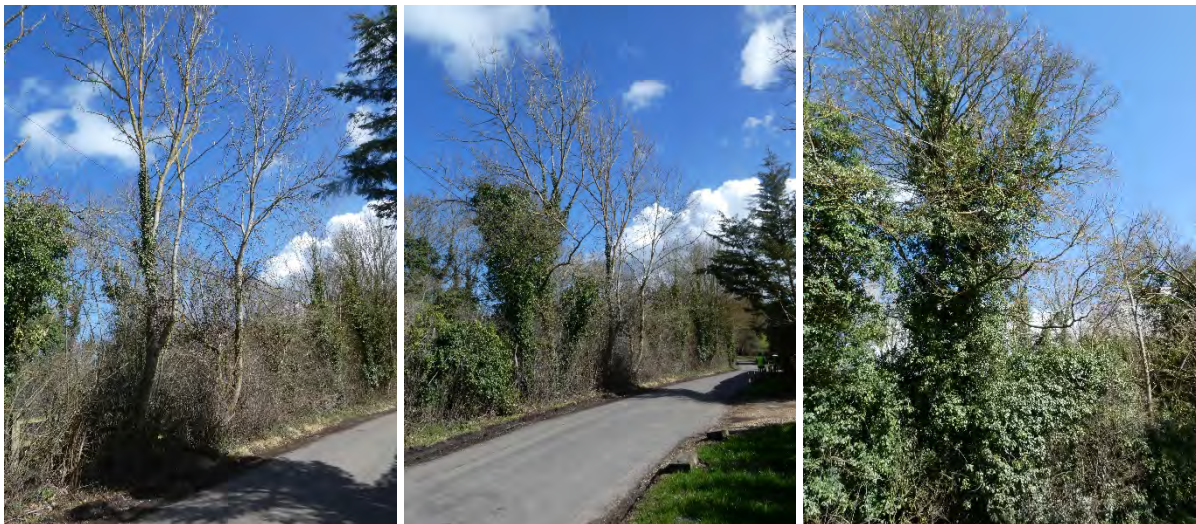
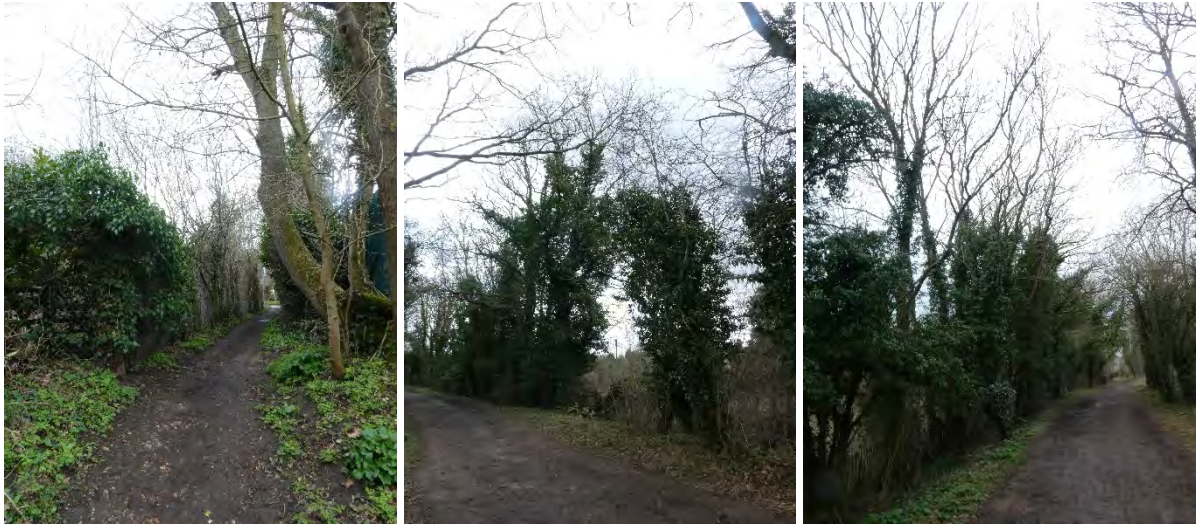
Above and below- trees along the boundary of Cole Green Way, with self seeded trees, several mulberry and with ivy

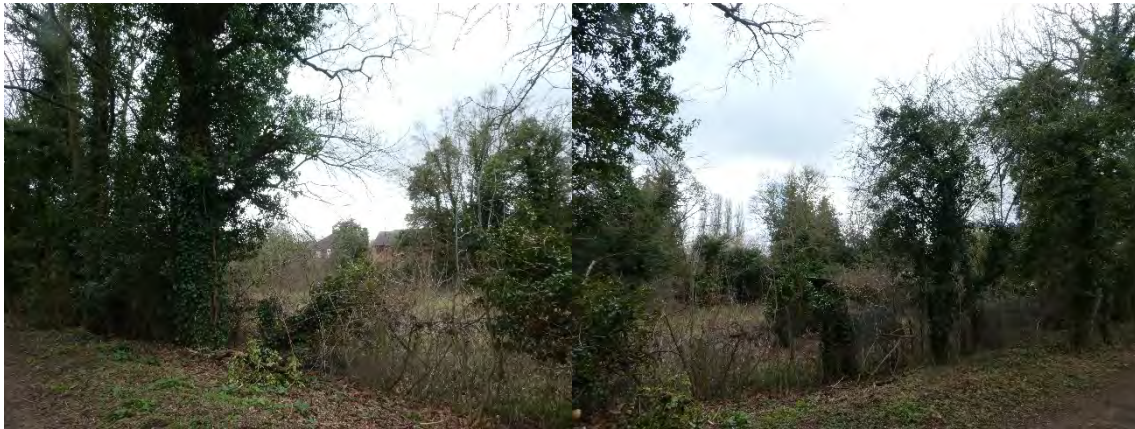
Above - the three oak trees (9T6, T7 and T8) which are adjacent to the entrance and stables

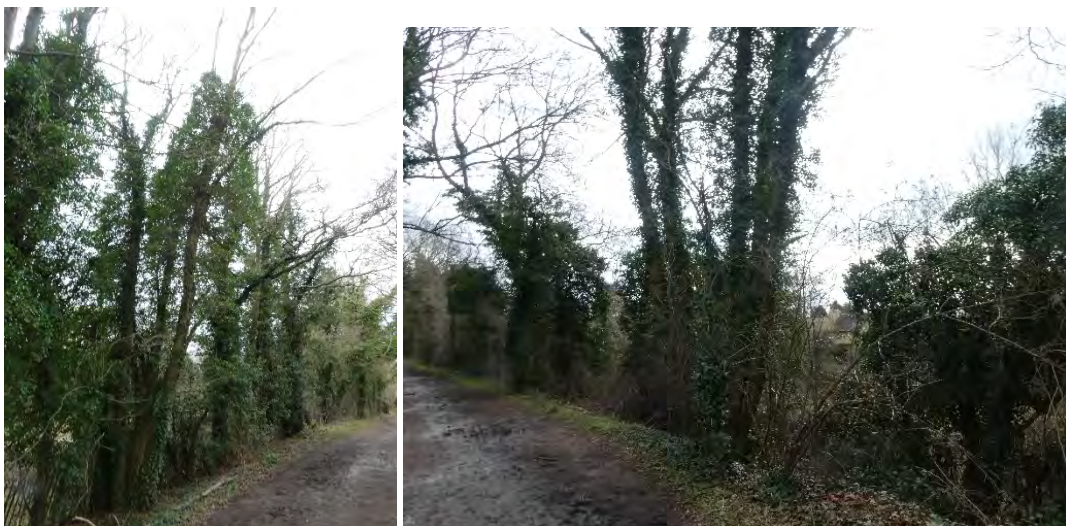
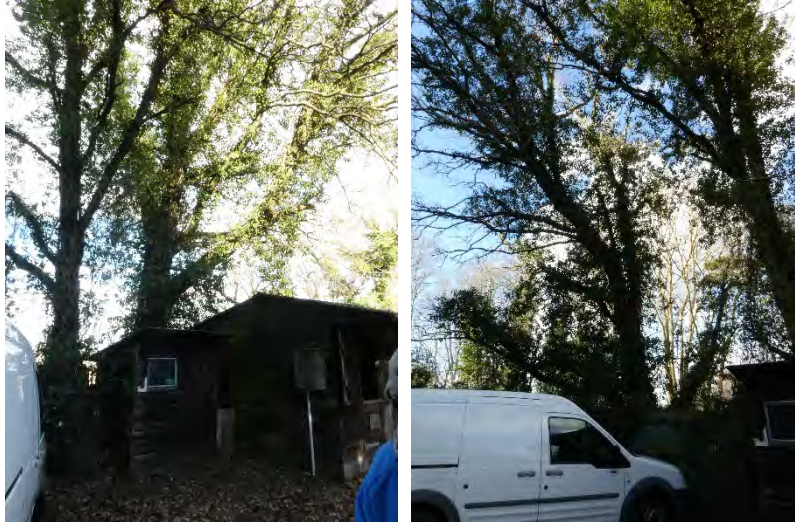
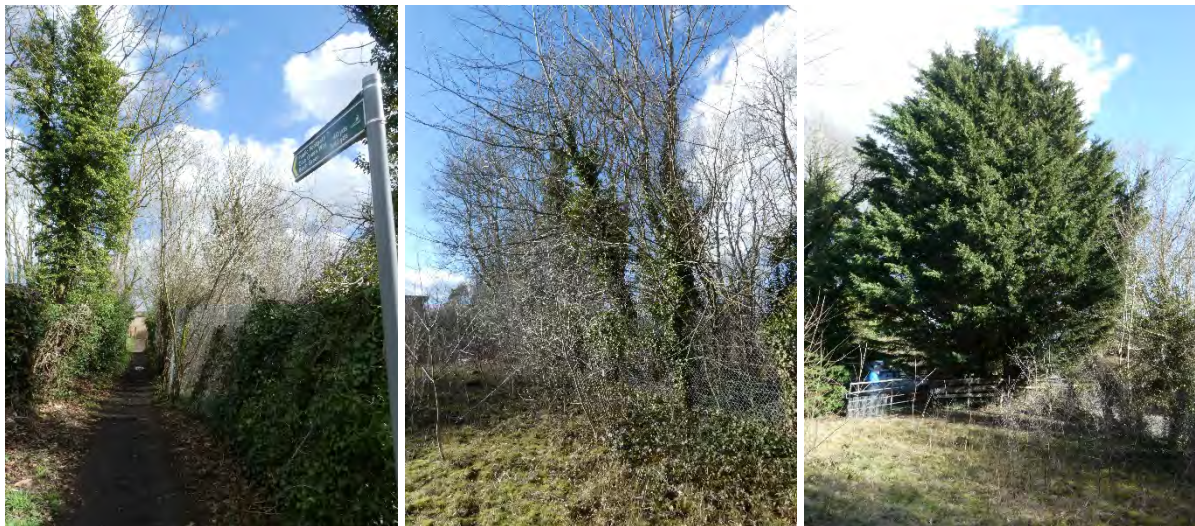
Below left and centre- the footpath between 25 and 27 Chapel Lane with overgrown hedge and suckers. **Below right**- the group of larger leyland cypresses (G1) on the eastern side of the entrance
