Our Ref: IPPS/2621/21.1

Date: 2 December 2021

**Bat and Nesting Bird Assessment:  
House at Oakwood,  
Kerry, Newtown SY16 4PW.**

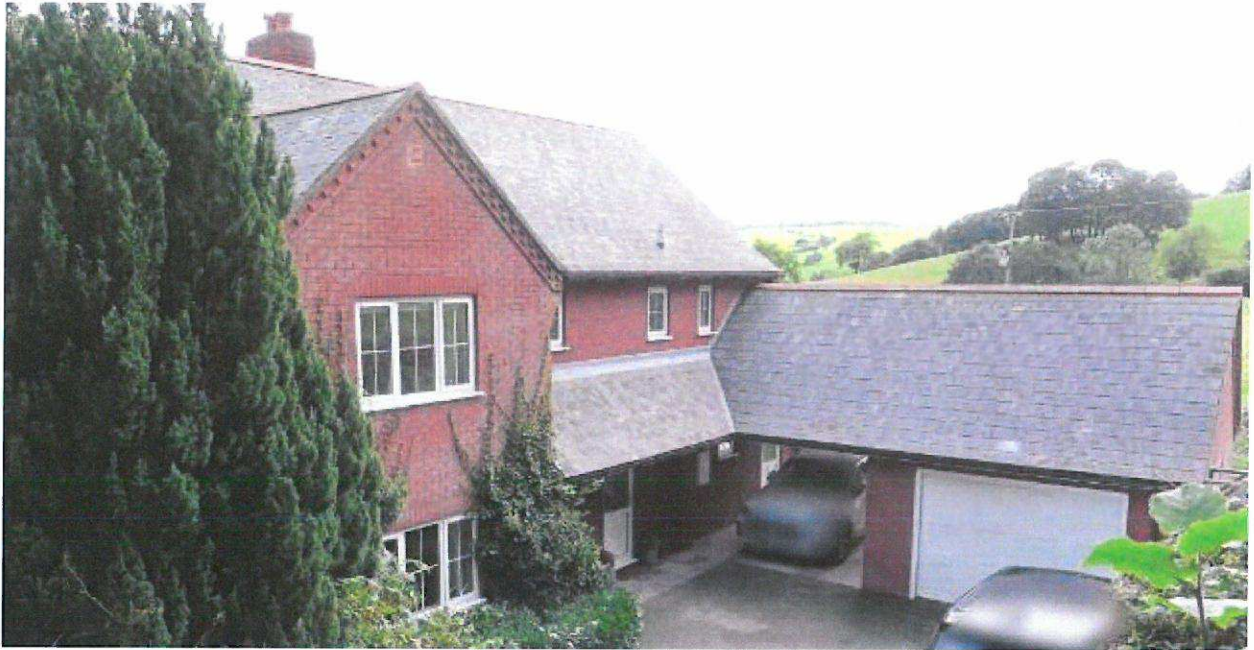
**Photograph 1. Exterior.**  
Left: part of the Northwest elevation.  
Right: Part of the Northeast elevation.

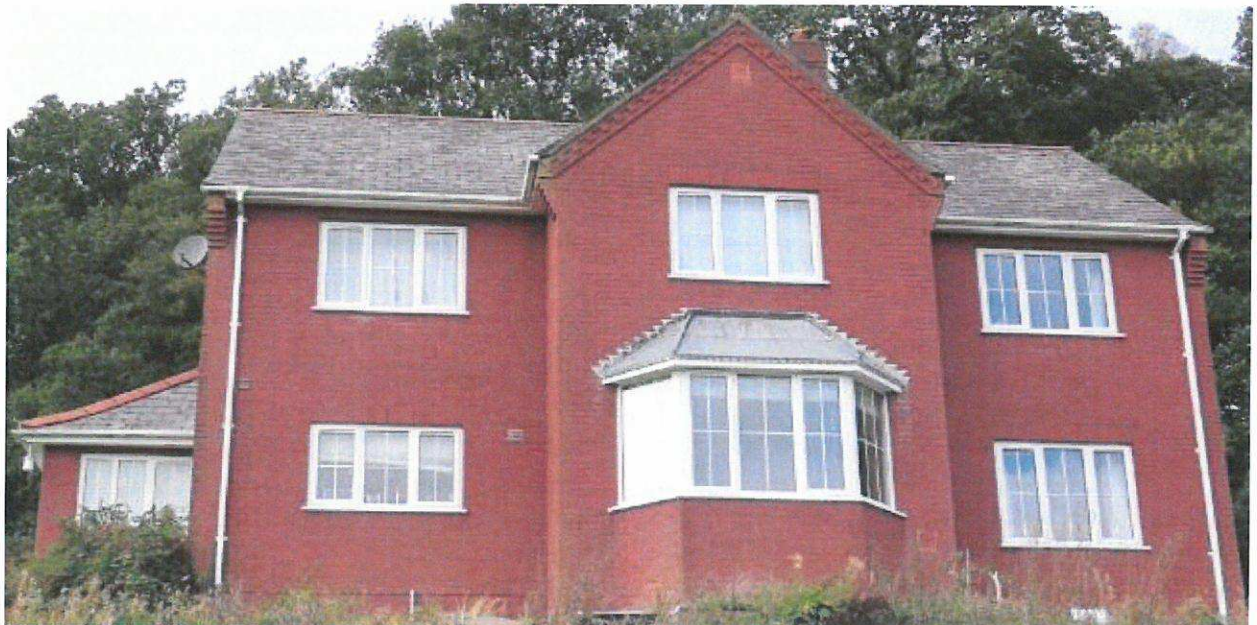
**Photograph 2. Exterior.**  
Southeast elevation.

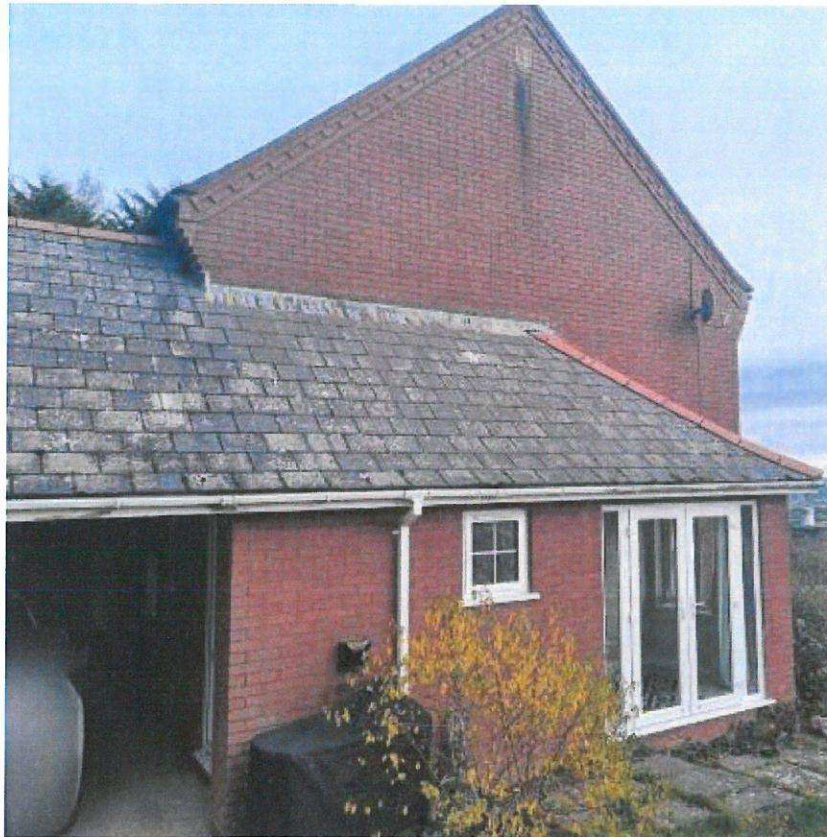
**Photograph 3. Exterior.**  
Part of the Southwest elevation, showing the part of the House to be affected by the proposed development.

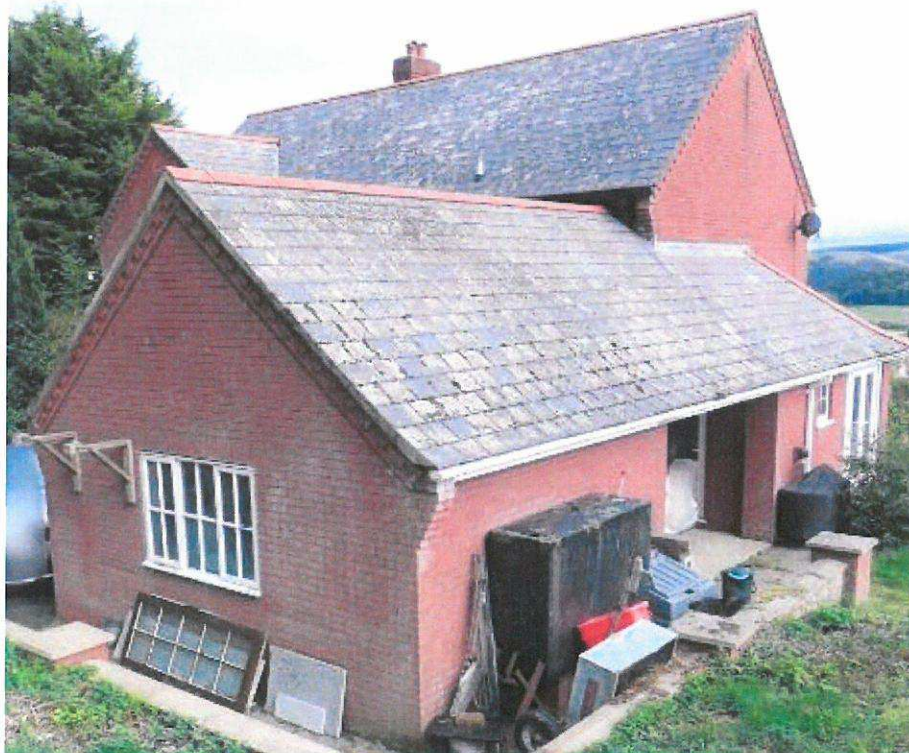
**Photograph 4. Exterior.**  
Left: parts of the Northwest elevation.  
Right: Southwest elevation.

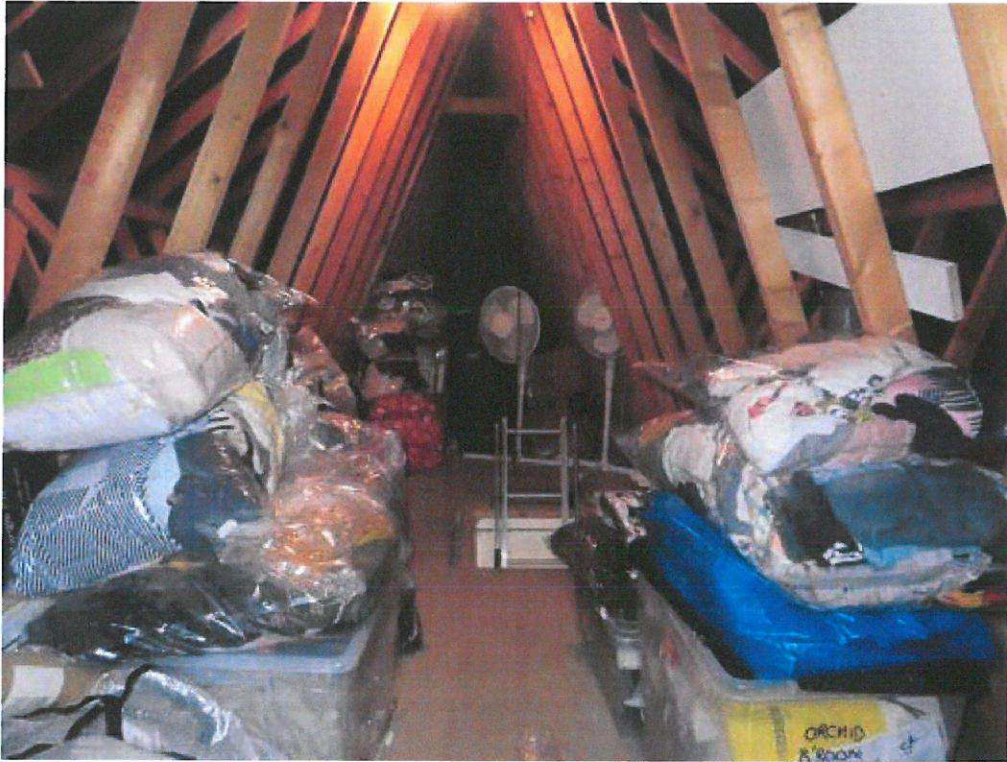
**Photograph 5. Interior.**  
View of part of the roof-space of the main, two-storey, section.  
Looking southwest from northeast.

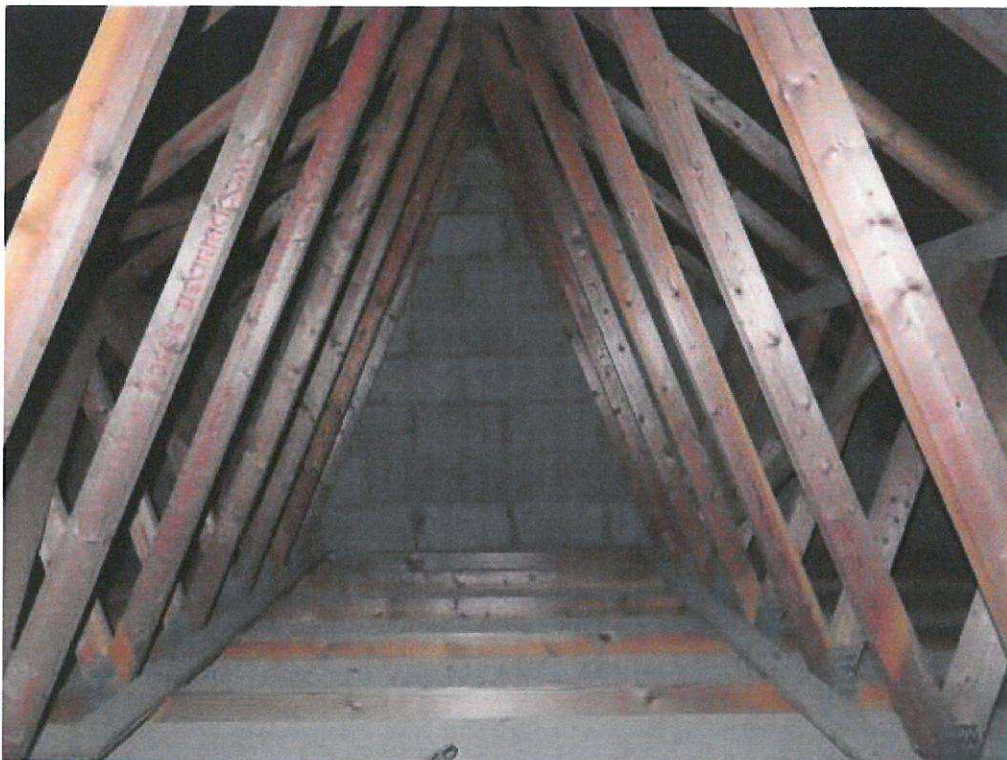
**Photograph 6. Interior.**  
View of party of the roof-space above the car-port.  
Looking northwest from southeast.
