The Moat Farm, The Street, Hinderclay, IP22 1HX

This document is in response to planning enforcement documentation EN/21/00838, received 2022/12/15 regarding the renovation and refurbishment of The Moat Farm. The following information is to outline works done on the above listed property and answer queries/concerns raised by the planning authority. Photo locations can be found in accompanying documents A-1003 and A-1004

Response to request for information received on 2022/12/15

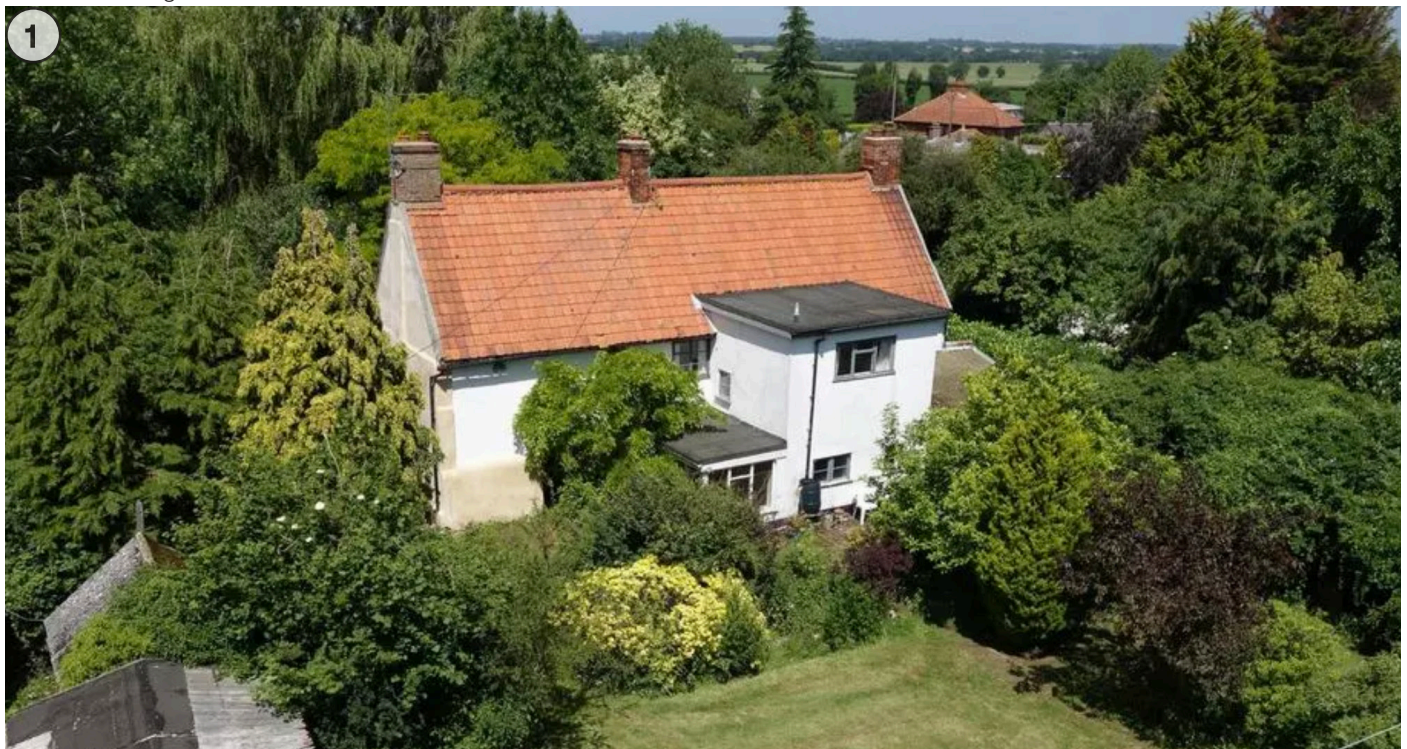
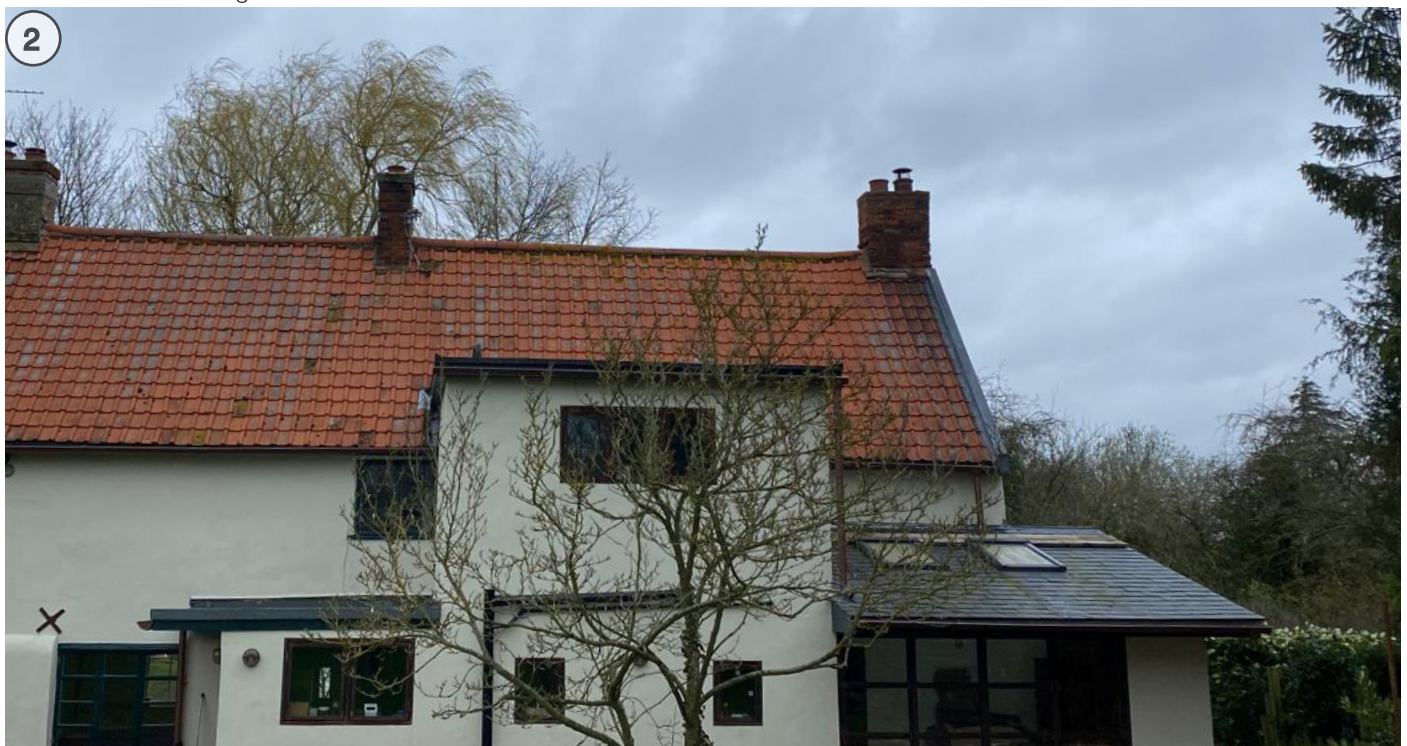
MD photo	LBC needed	support	comment	Summary Response
REAR EXTENSIONS					
Renewal of roof and s/s and 2/s extns	31	Probably not			Tiling was removed and roof repaired

The C20 extension flat roofs were retained, cleaned of debris and repaired, however the SE sloped roof had sustained significant damage resulting in water ingress to the interior. The decision was made to re-roof it using a more aesthetically pleasing and historically sympathetic slate tiling.

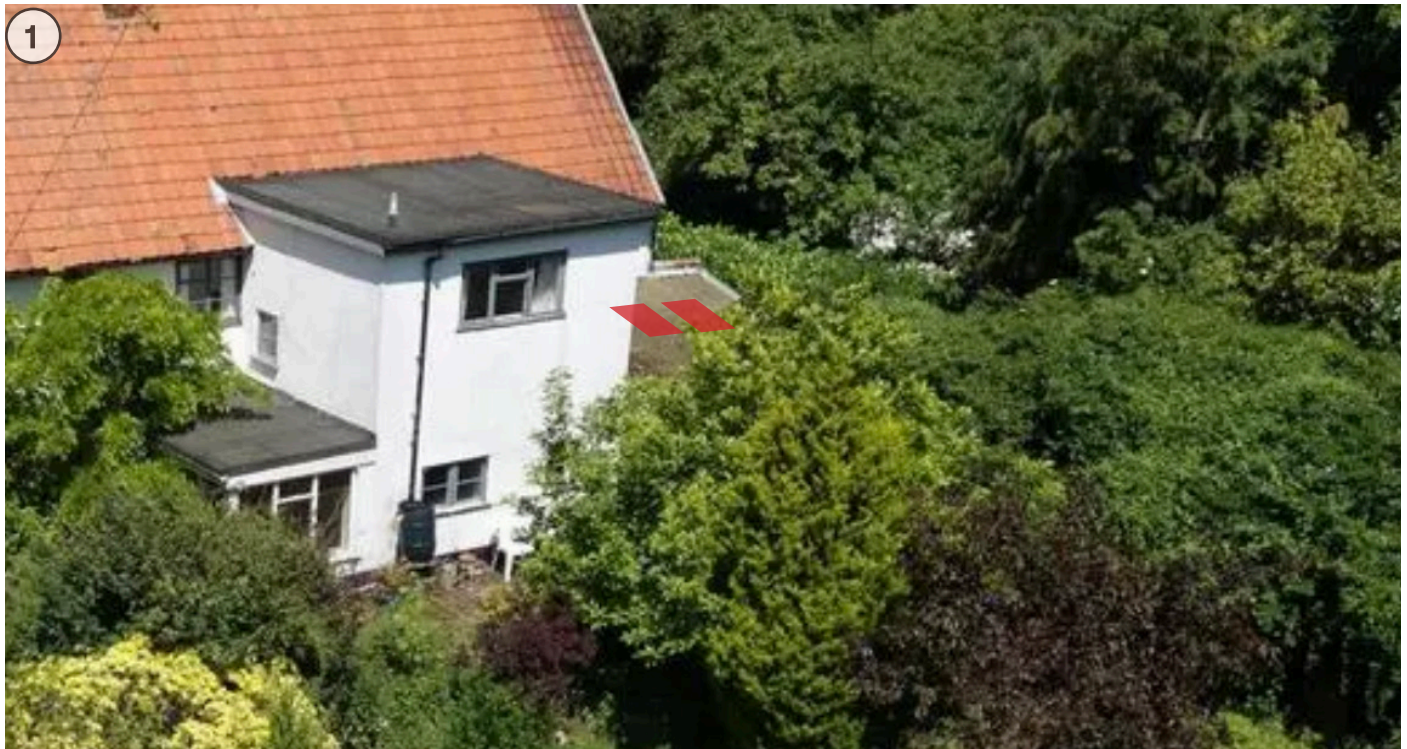
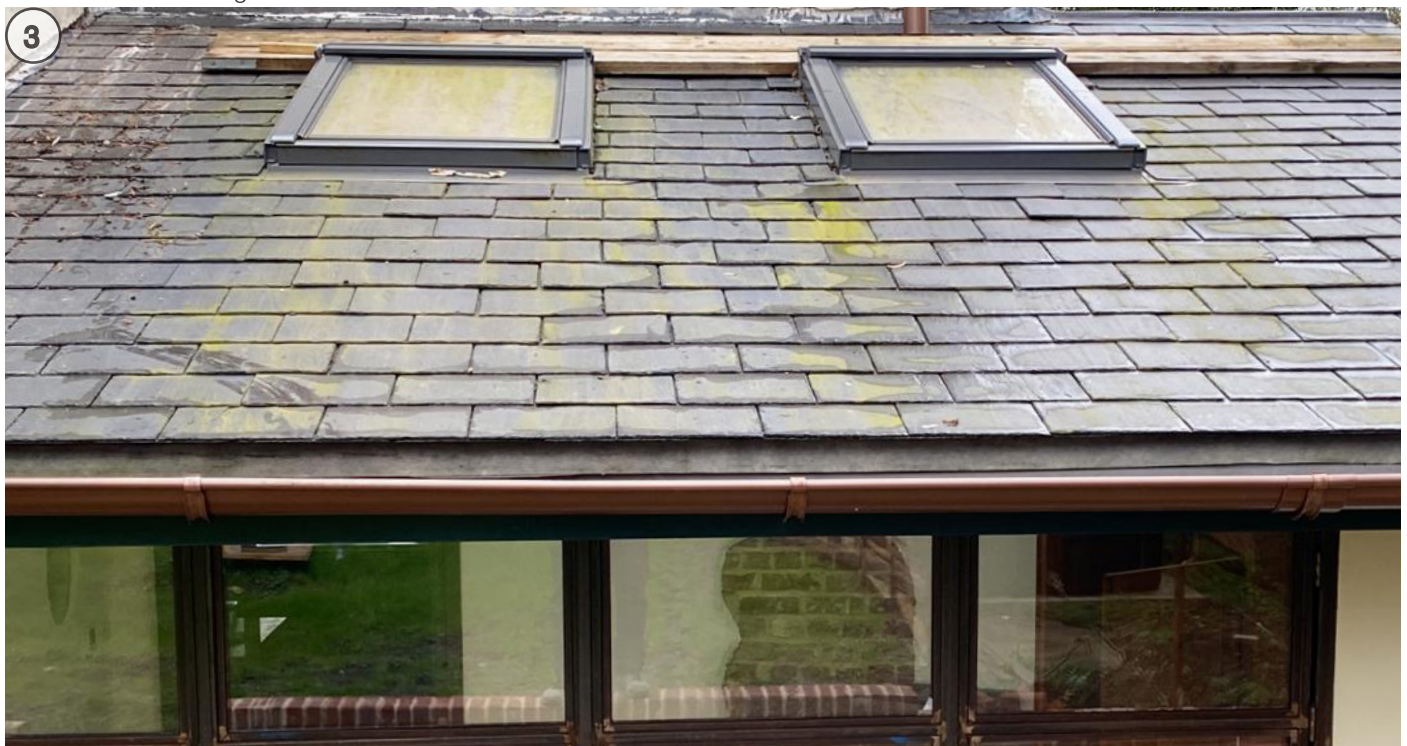
MD photo	LBC needed	support	comment	Summary Response
REAR EXTENSIONS					
insertion of 2 rooflights		Y	Y	Over the 'porch' ?	Installed into modern extensions during roof repairs

During repairs of the SE C20 sloped extension we chose to install 2 rooflights to enhance the interior space and improve natural light penetration to the kitchen situated within the historic part of the property.

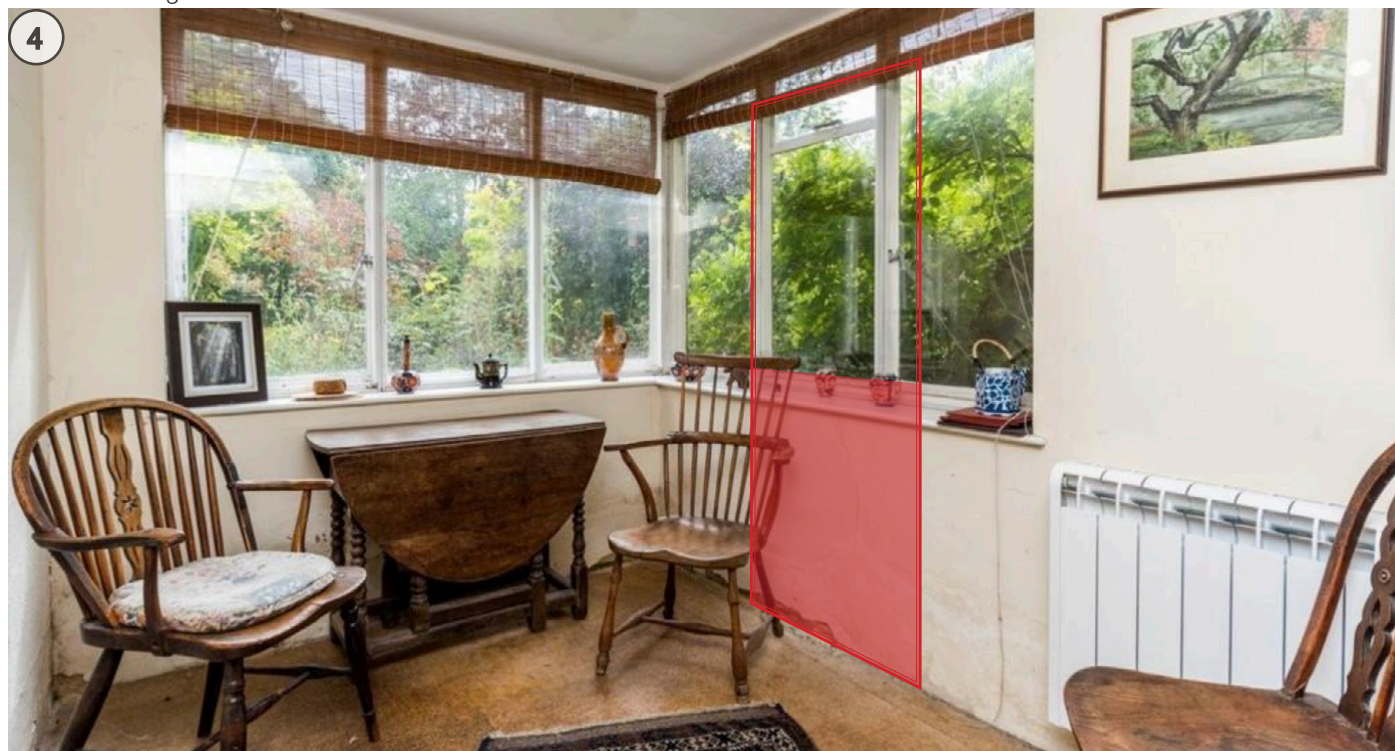
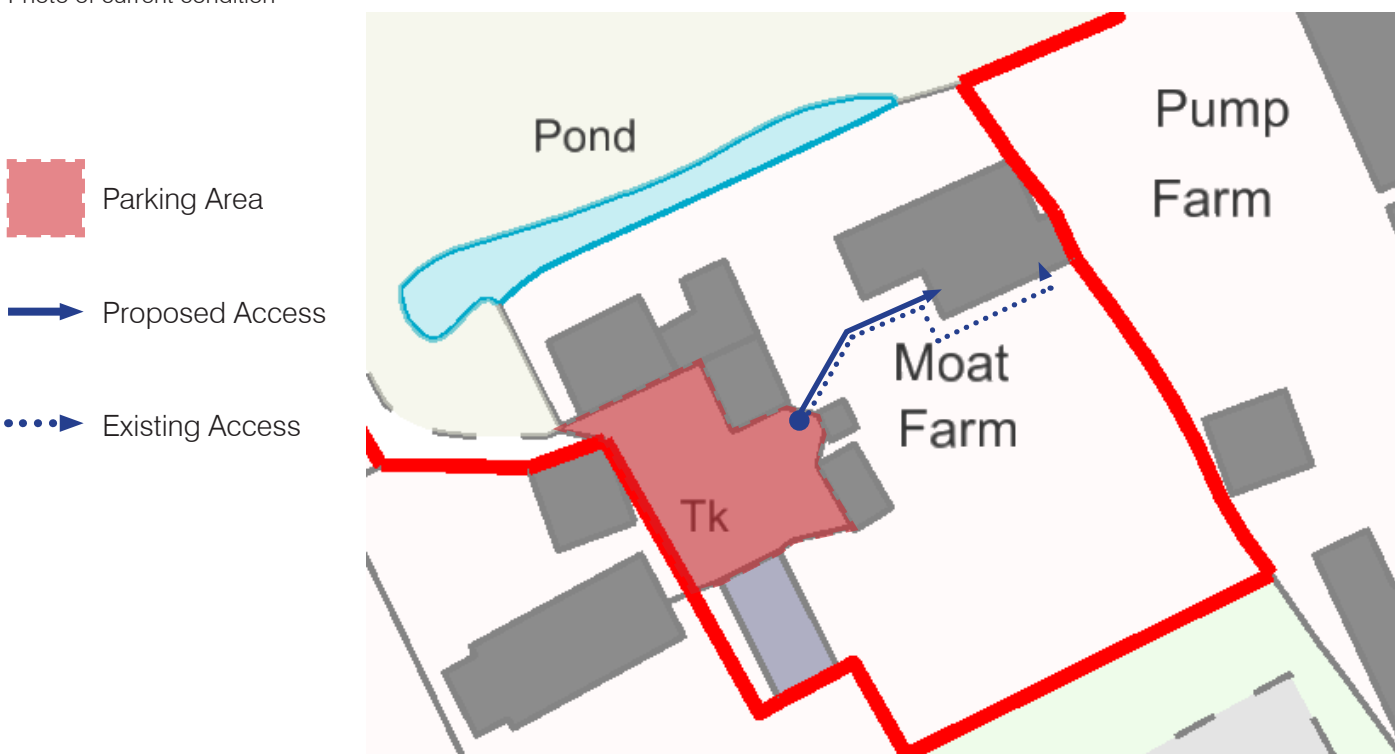
MD photo	LBC needed	support	comment	Summary Response
REAR EXTENSIONS					
Replace corner window extn with door and window	31, 36, 46	Y	Y		Evidence of existing doorway during repairs, decision made to reinstate

During repairs of the C20 SW extension walls and windows evidence was uncovered in the masonry that there had previously been external access. It was decided to restore this route as it created a more direct link to the external parking area and a more natural access point to the property.

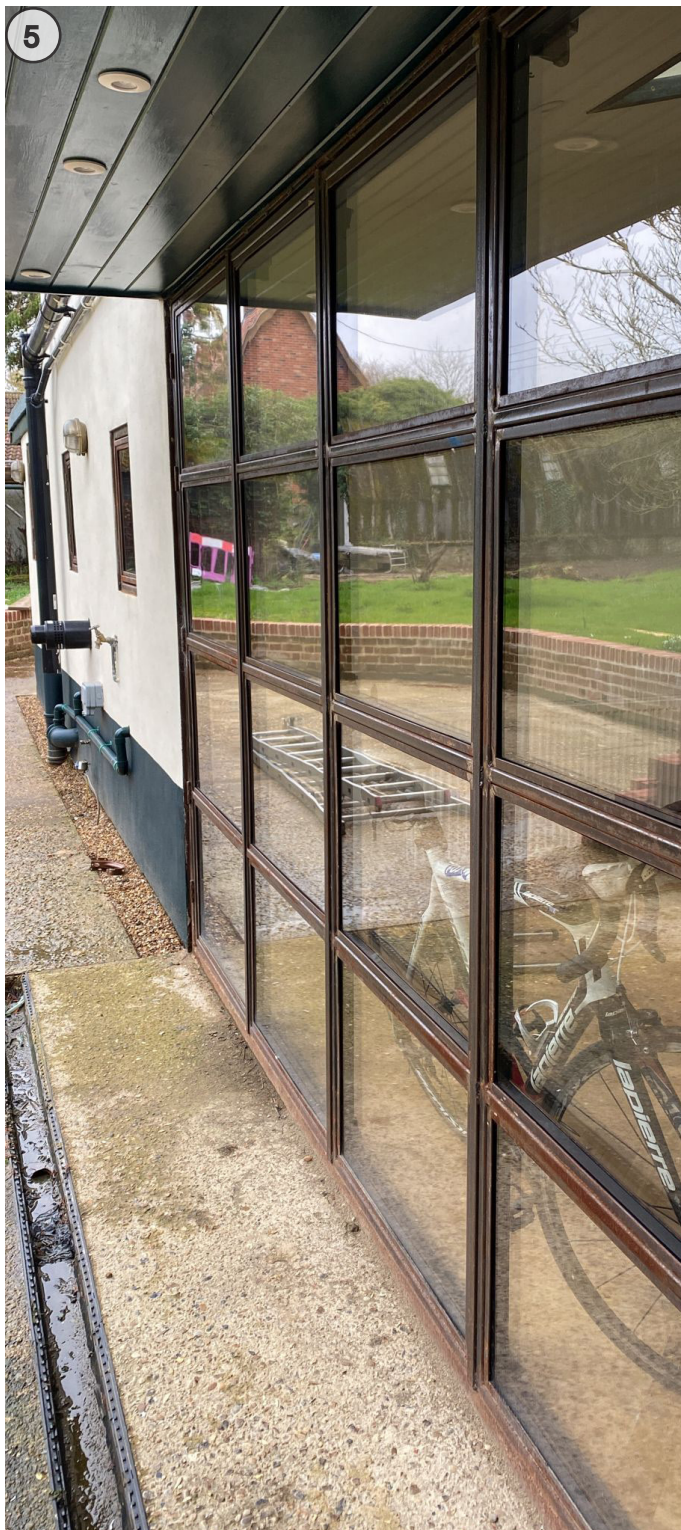
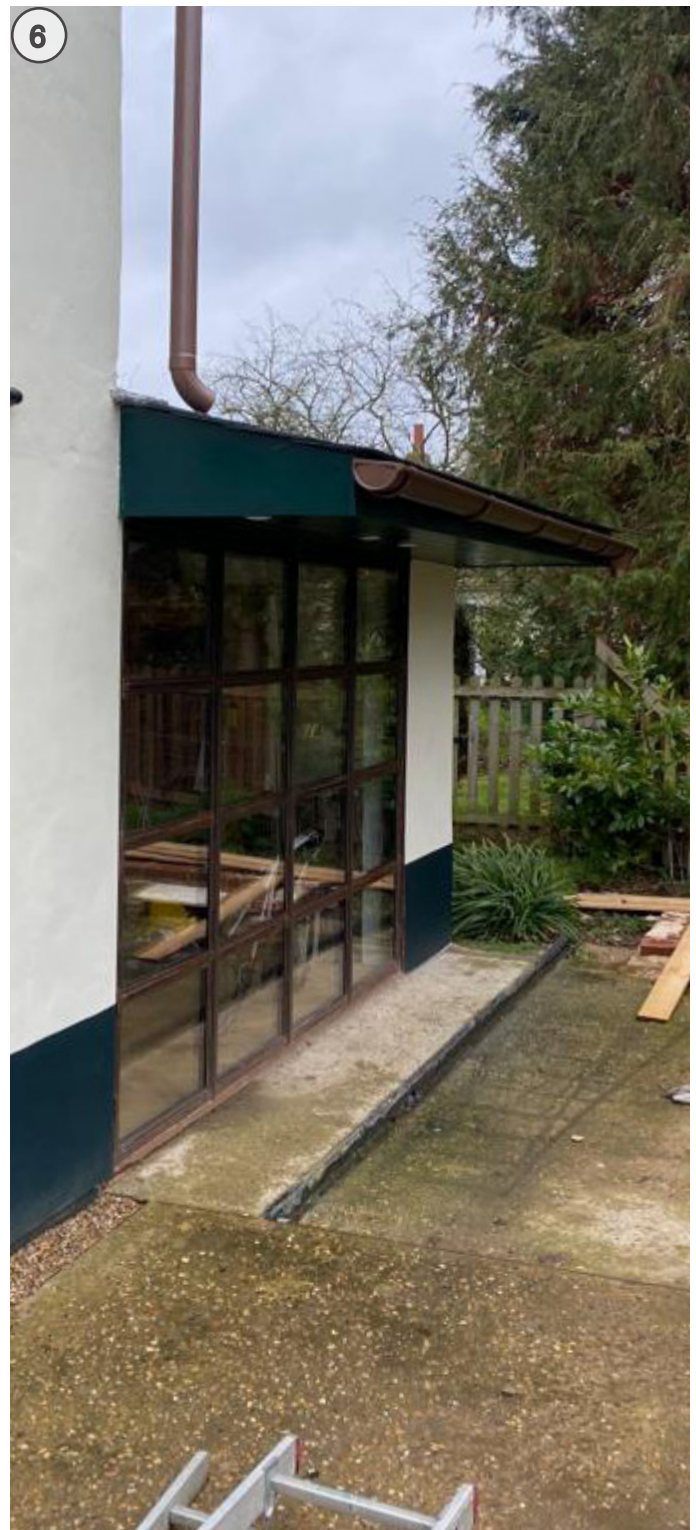
MD photo	LBC needed	support	comment	Summary Response
REAR EXTENSIONS					
Rear porch overhang of s/s roof	31, 49	Y	Y		Installed during roof repair

Installed during the repairs of the SE C20 sloped roof. The overhang was built to provide additional solar shading to the glazed extension as well as protection from the elements when the doors are in use.

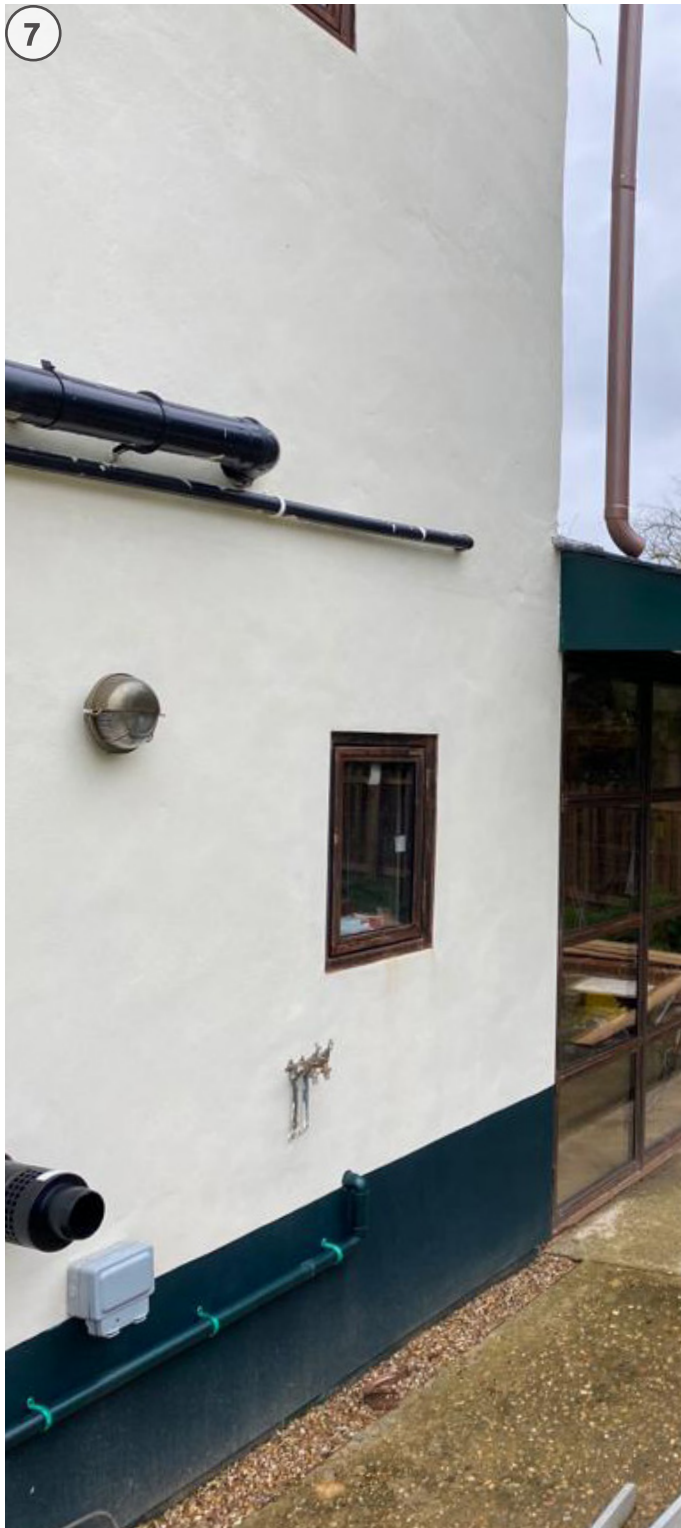
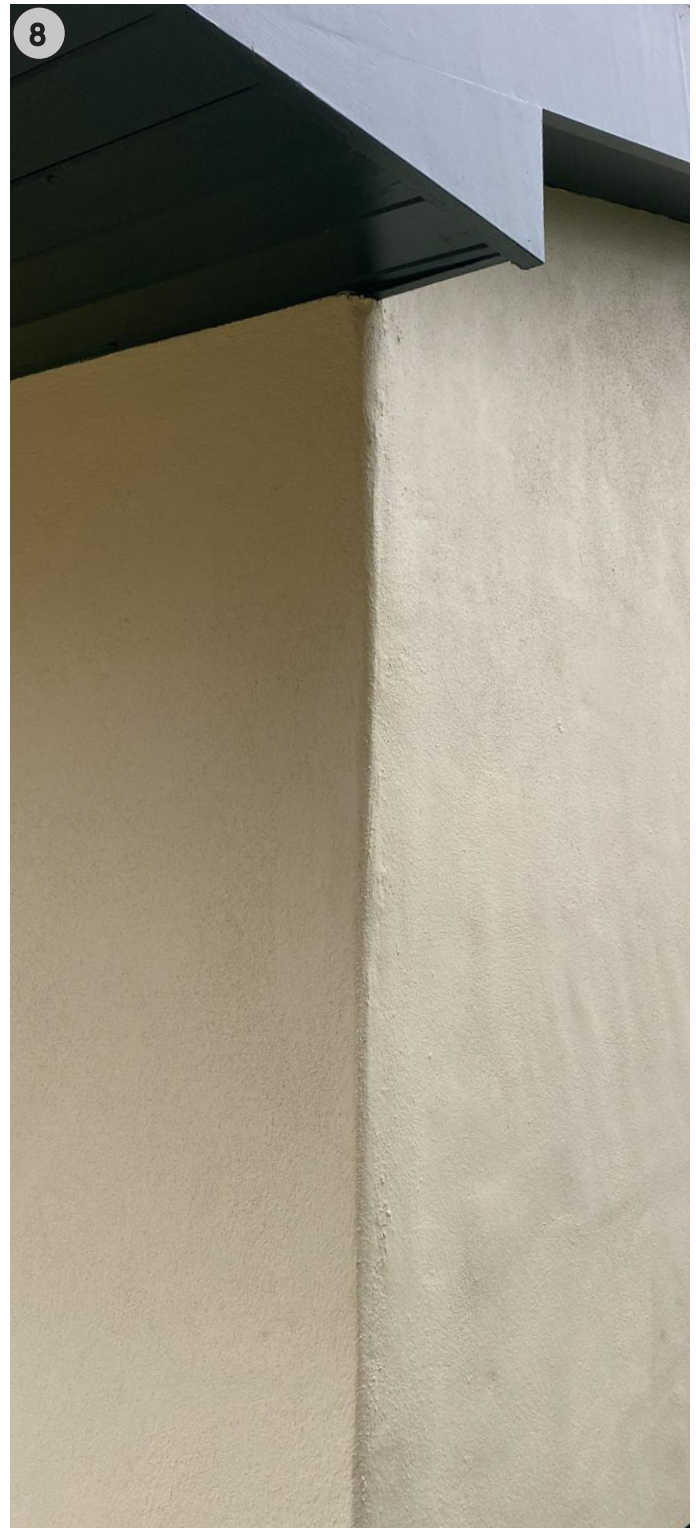
MD photo	LBC needed	support	comment	Summary Response
REAR EXTENSIONS					
Re-render s/s and 2/s extns	31	Prob N		Assume material is same as previous	Repaired due to water damage, materials match existing

Extension's rendering showed signs of water ingress and was beginning to crack and separate from the wall. Repairs were made where possible and re-rendered where necessary using materials to match the existing condition

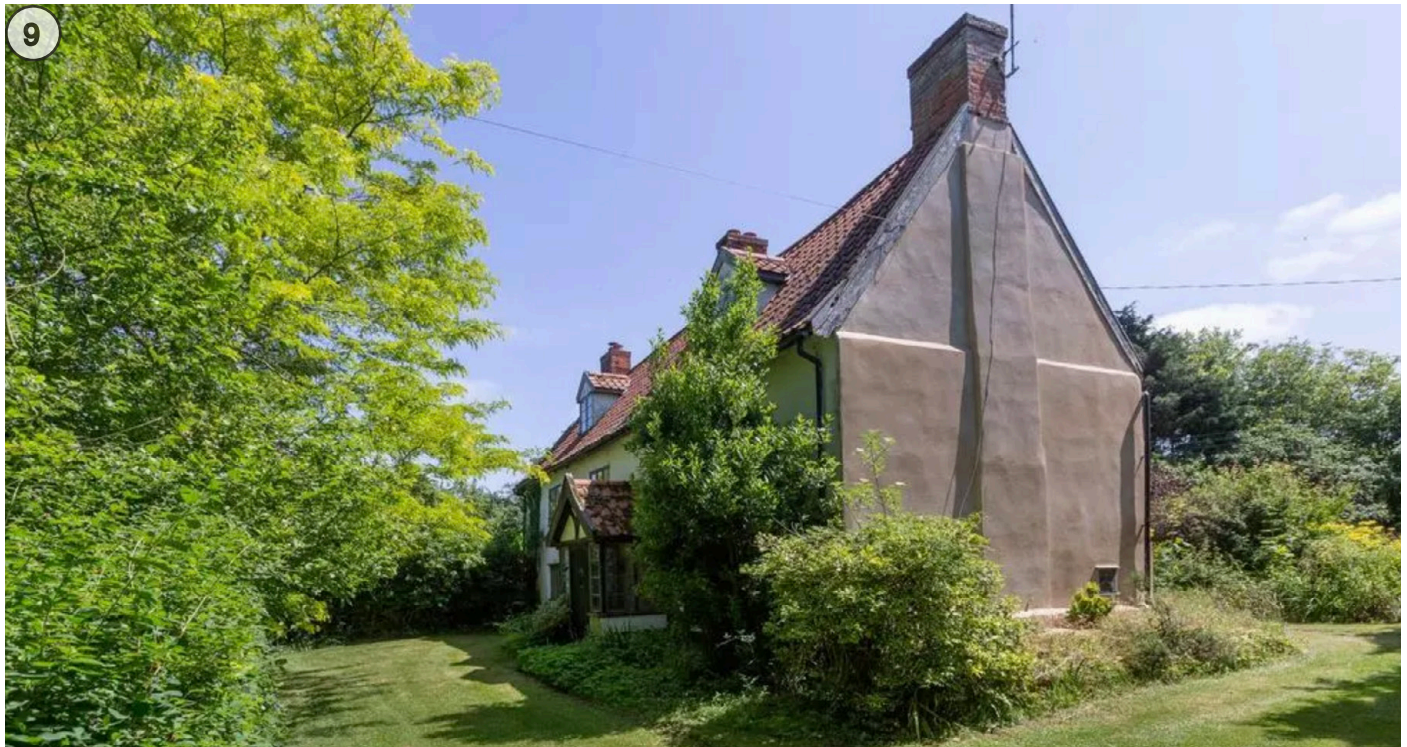
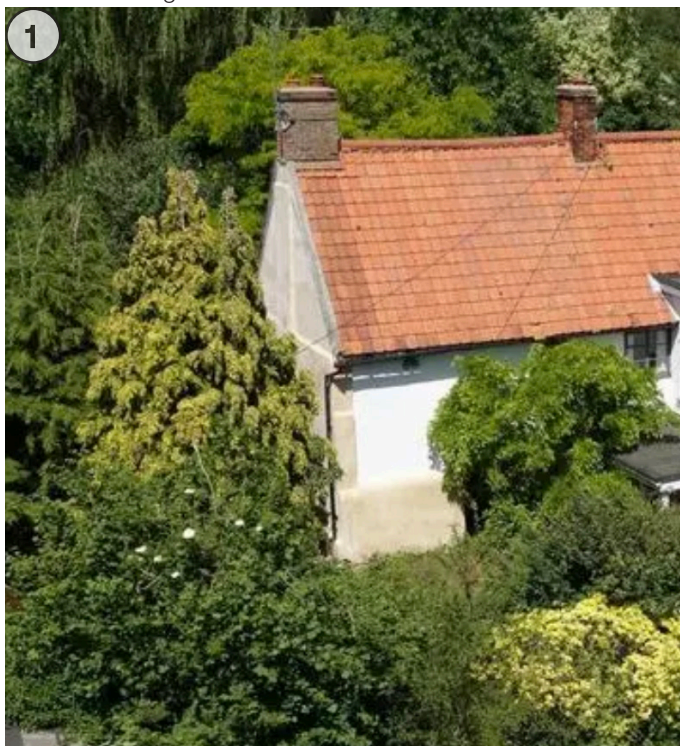
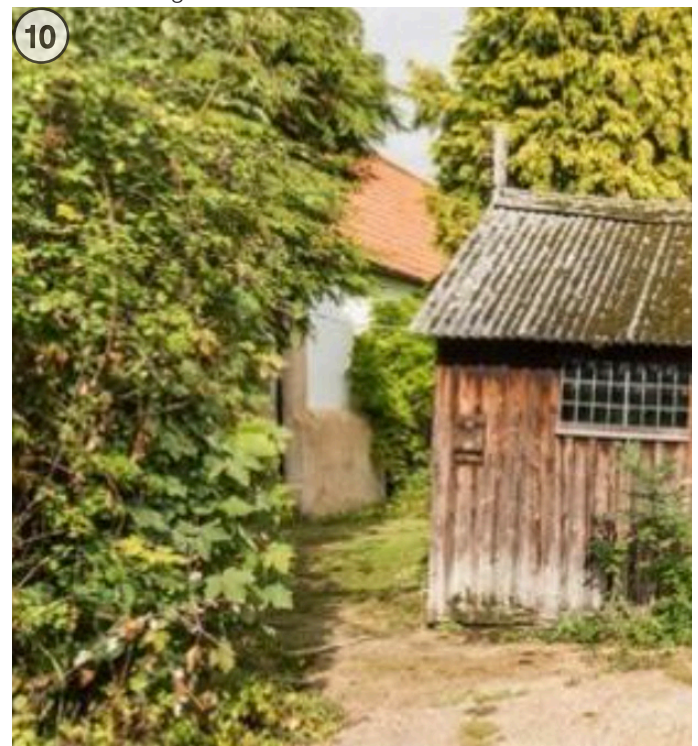
MD photo	LBC needed	support	comment	Summary Response
HISTORIC PART					
Render W gable and SW corner of S elevation; new barge boards and lead capping	31, 68	Y	N – should be lime; also needed for any timber repairs	This is possibly a brick gable, incorporating the large hearth, but the answer is the same.	Gable was rendered prior to ownership, new barge boards and lead capping replaced like for like.

W and SW gable were rendered prior to ownership, the assumption made that all prior works had been done using the correct historically accurate materials and in accordance with the listing.

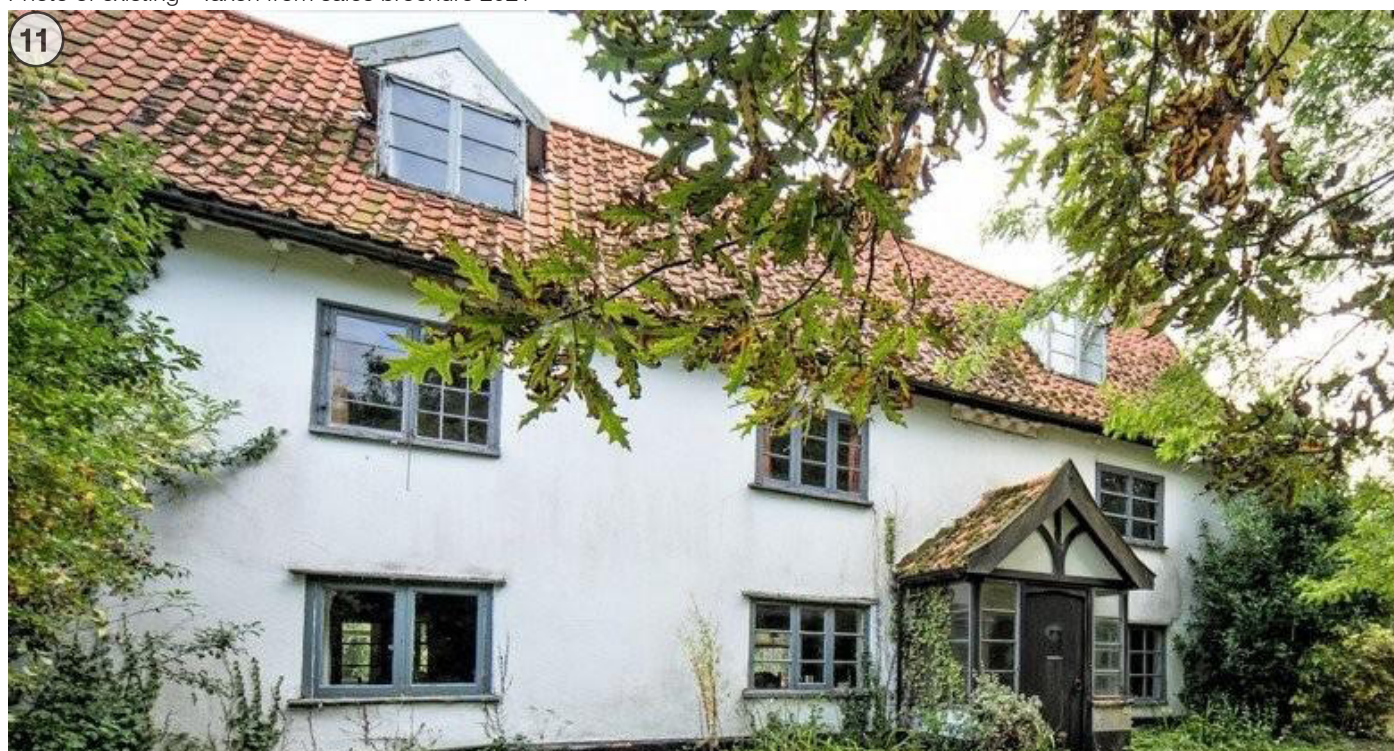
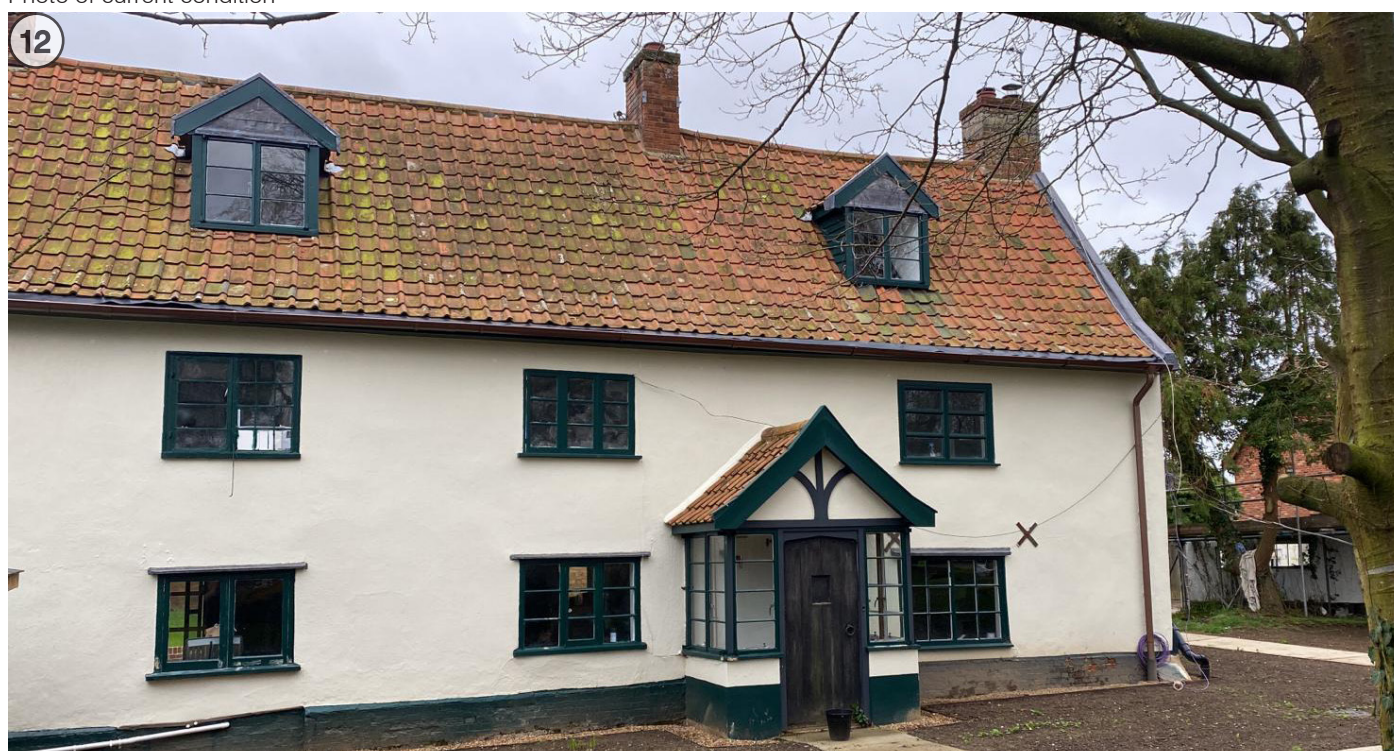
MD photo	LBC needed	support	comment	Summary Response
HISTORIC PART					
Renew pantiles to main roof ?	31, 60, 61			I don't think this was done; the tiles are flat Roman, and photos show defects in the same place	Tiles were cleared and secured

Existing roof atop historic part had loose tiles and extensive moss growth on the N slope. Tiles were secured/relocated and cleaned of moss and debris.

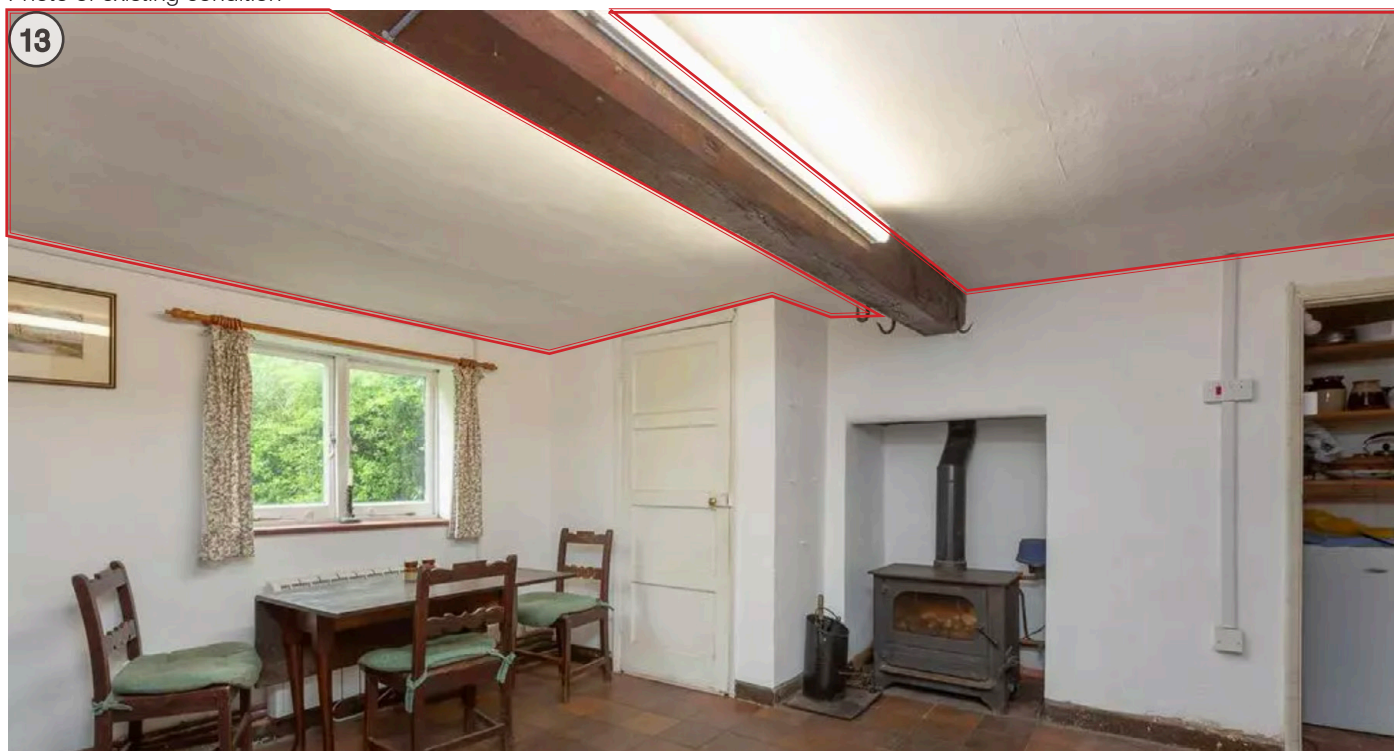
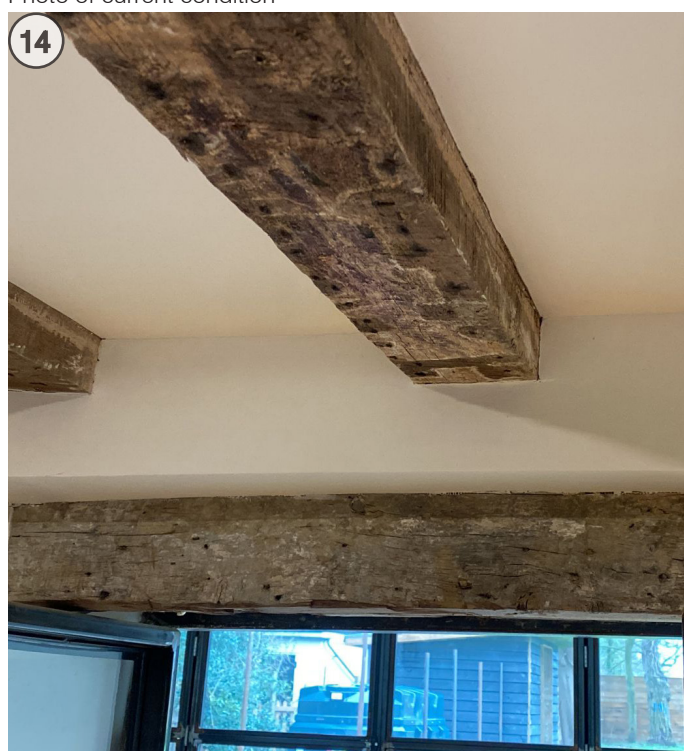
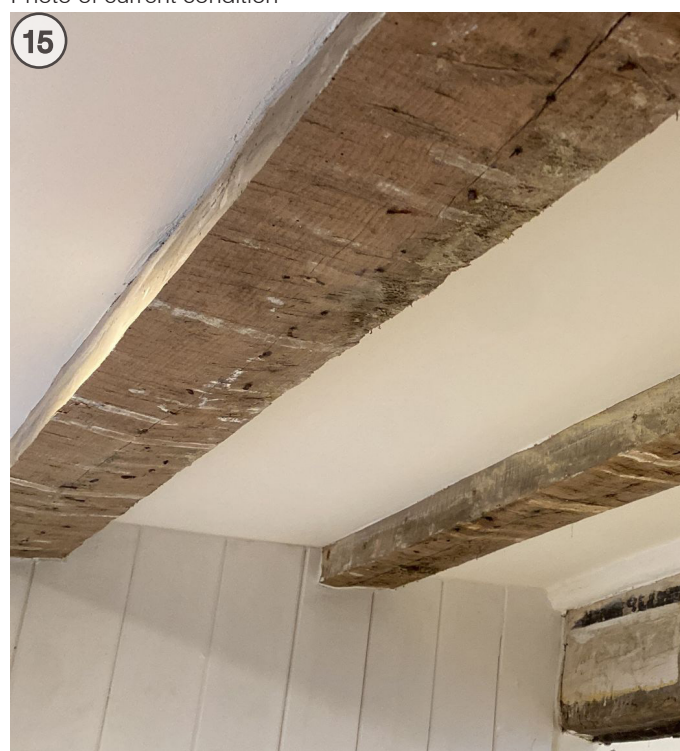
MD photo	LBC needed	support	comment	Summary Response
HISTORIC PART					
Remove ceiling kitchen, expose timbers ?		Y	Possibly; depends on what we lost and what we gained	92ff are sitting room; 108 for kitchen	Plasterboard ceiling removed to expose existing ceiling timbers

Plasterboard ceiling in the kitchen was showing signs of failure. During repairs works existing timber beams were uncovered and the decision was made to expose them due to both their historic and aesthetic appeal.

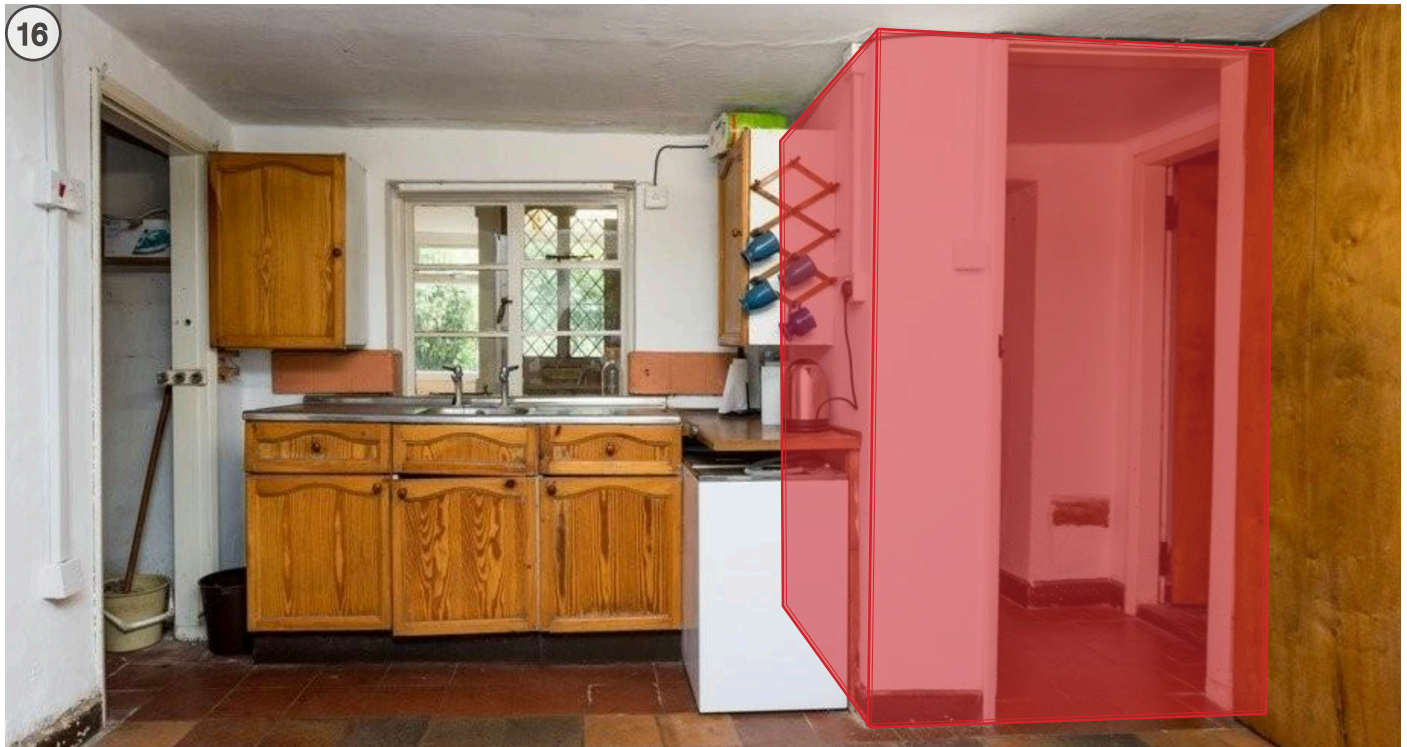
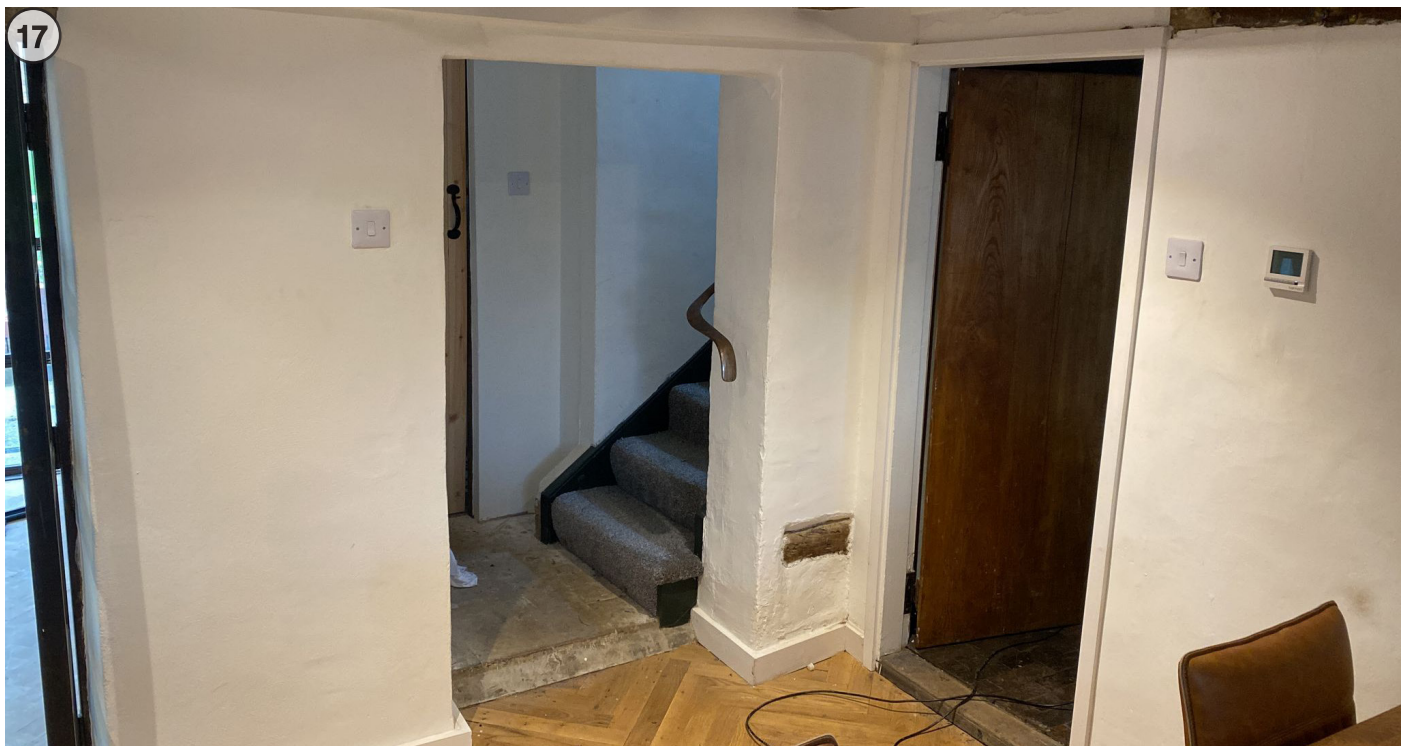
MD photo	LBC needed	support	comment	Summary Response
HISTORIC PART					
Remove internal doorway and wall in kitchen ?		Y	Y	Clearly a modern insertion	Walls were modern stud work, decision made to remove

Investigative works revealed interior dividing wall to be modern timber stud work and plasterboard. These modern interventions were removed to create a better connection between the kitchen and the living room.

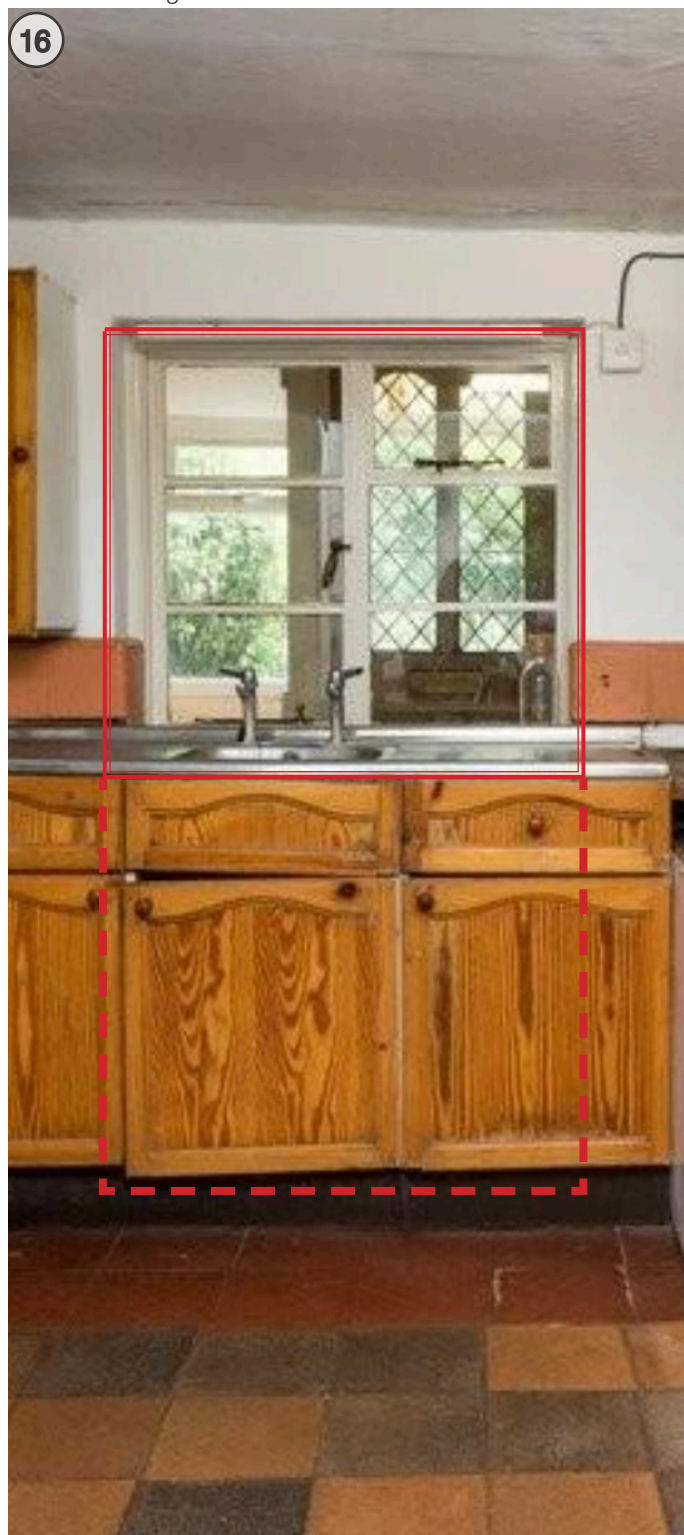
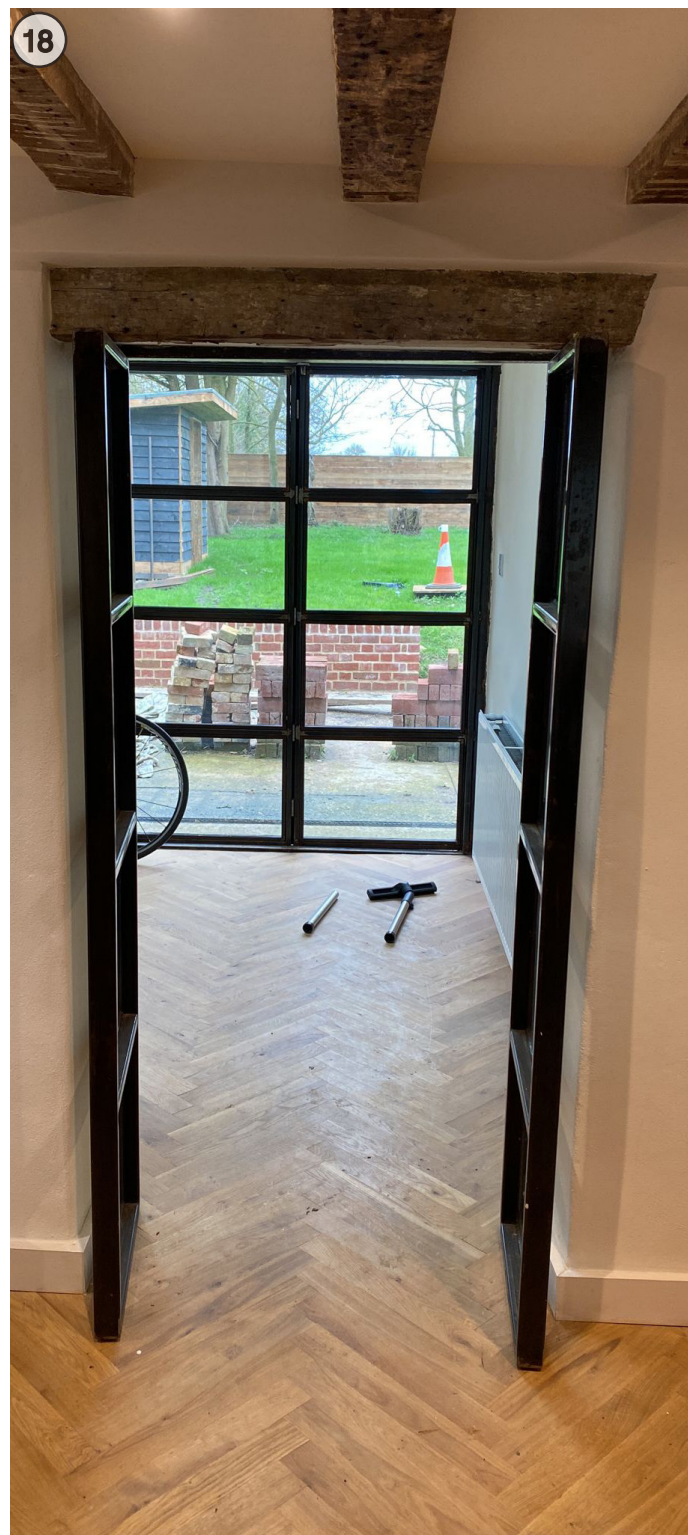
MD photo	LBC needed	support	comment	Summary Response
OTHER					
New door opening from porch to kitchen ?	36, 46, 50, 108	Y	Probably N	potential loss of historic frame; refuse unless clear evidence it was a previous opening; reinstatement might not be desirable.	An existing window, decision to convert to doorway to after uncovering evidence of previous doorway/failing repair

Existing window opening. During reparations to wall multiple masonry infill patches were uncovered, difficult to determine if it was a previous doorway or poorly repaired. Decision was made to remove the failing repair and convert to a doorway to provide a direct link from the kitchen to the extension and improve natural light penetration.
