The Moat Farm, The Street, Hinderclay, IP22 1HX

This document is in response to planning enforcement documentation EN/21/00838, received 2022/12/15 regarding the renovation and refurbishment of The Moat Farm. The following information is to outline works done on the above listed property and answer queries/concerns raised by the planning authority. Photo locations can be found in accompanying documents A-1003 and A-1004

Response to request for information received on 2022/12/15

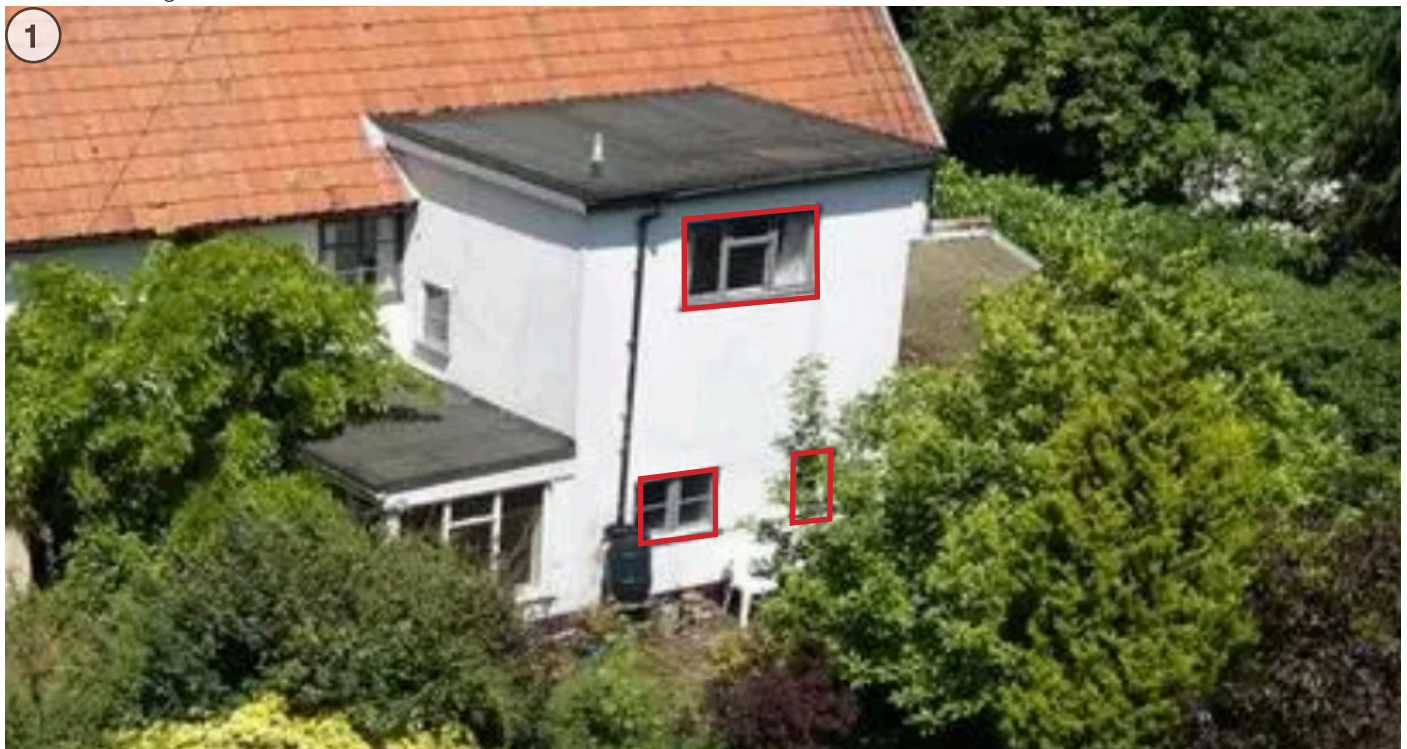
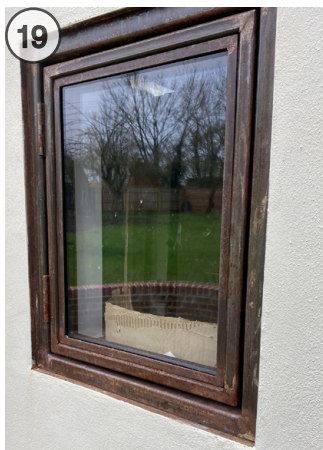
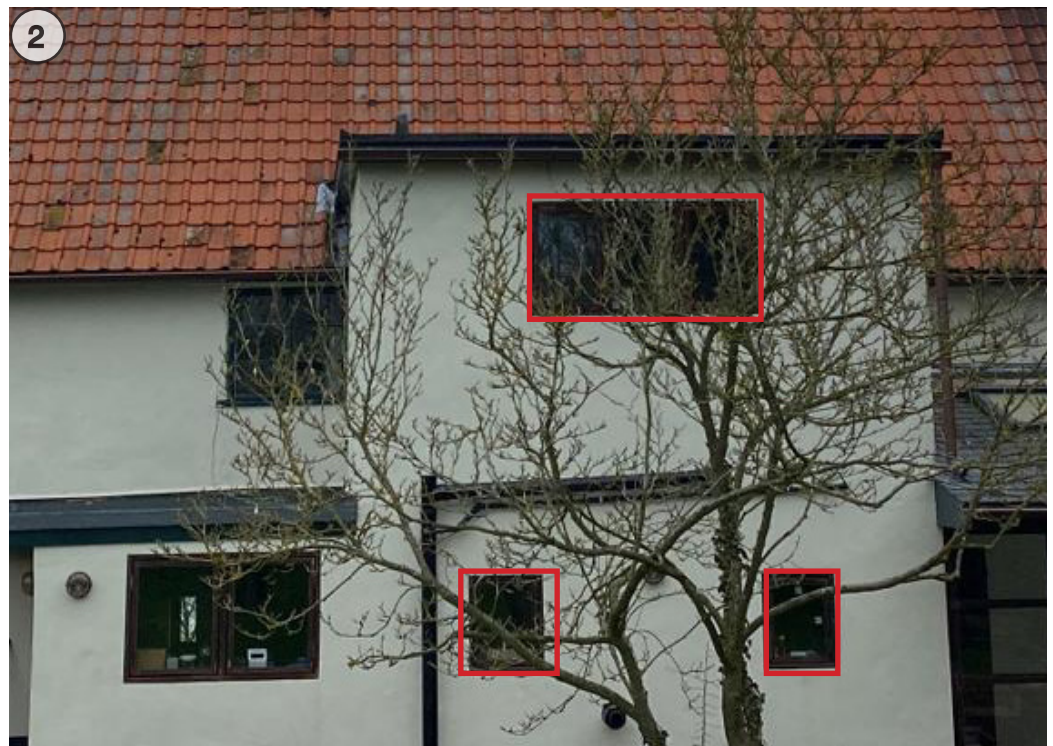
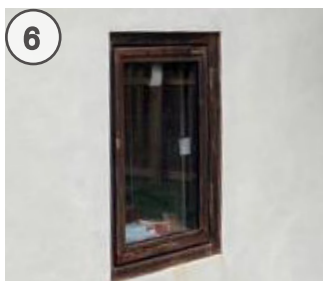
MD photo	LBC needed	support	comment	Summary Response
OTHER					
New rusty windows to extns	57 etc	Y	Y	replacing Crittall, and don't look bad	Existing timber window surrounds damaged, decision made to replace with similar to historic crittall windows

The existing timber surround Crittall windows in the SW and SE extensions had sustained water damage and as a result had extensive rot. The choice was made to replace with similar steel Crittall style windows.

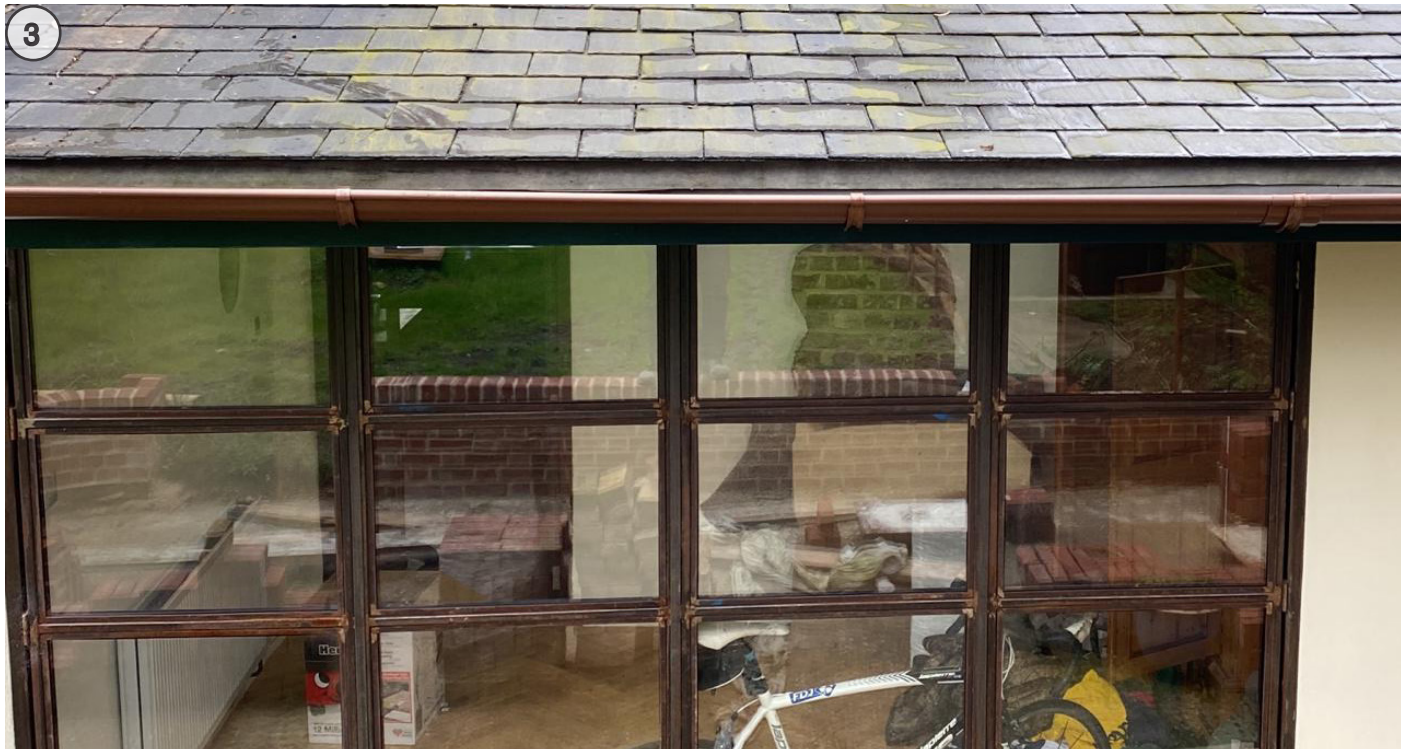
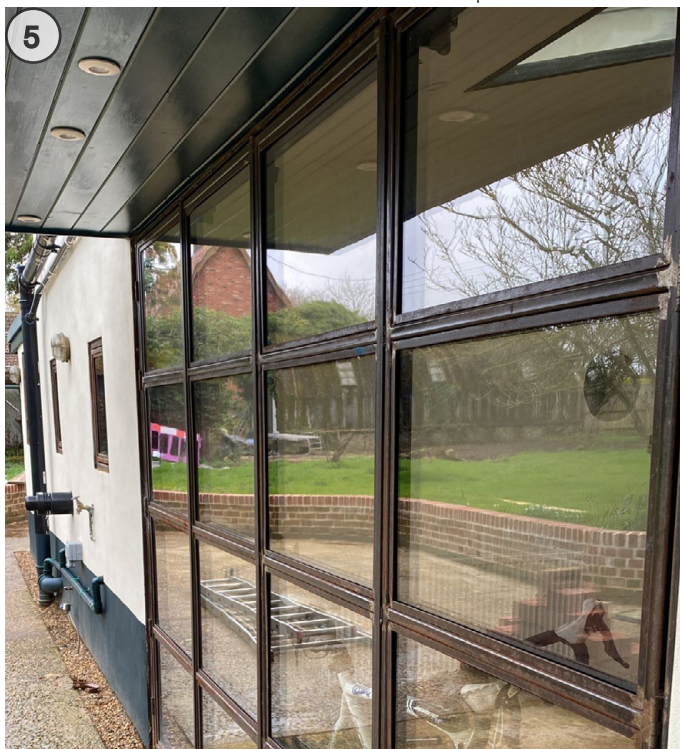
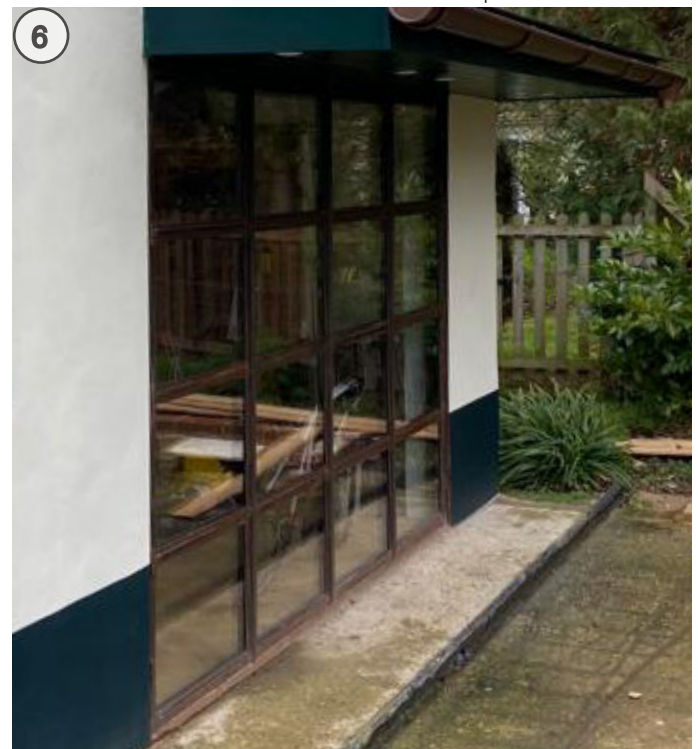
MD photo	LBC needed	support	comment	Summary Response
OTHER					
Ecotherm foil + PIR insulation (at windows)	65		Only in the modern part	Where is that going ? voids in the frame ? definitely not supporting that.	Difficult to answer without photos, modern extensions thermal performance was upgrading with additional insulation.

The thermal performance of the C20 SW and SE extensions was upgraded during the course of the renovation works. Comment is difficult to accurately address without specific photo hi-lighting concern.

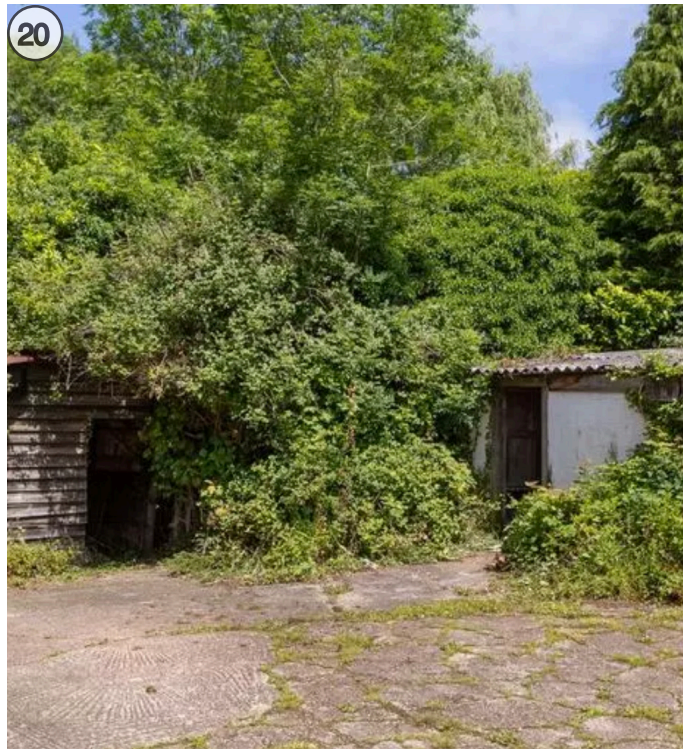
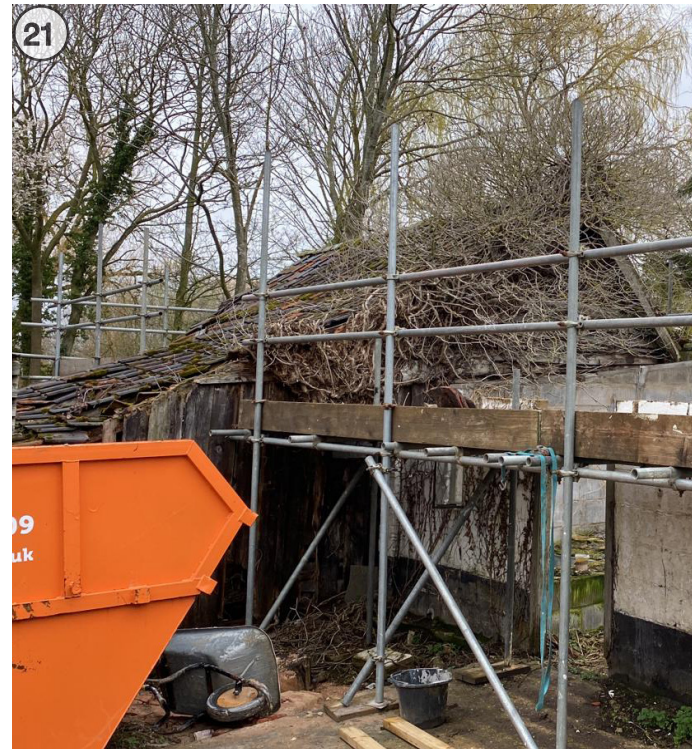
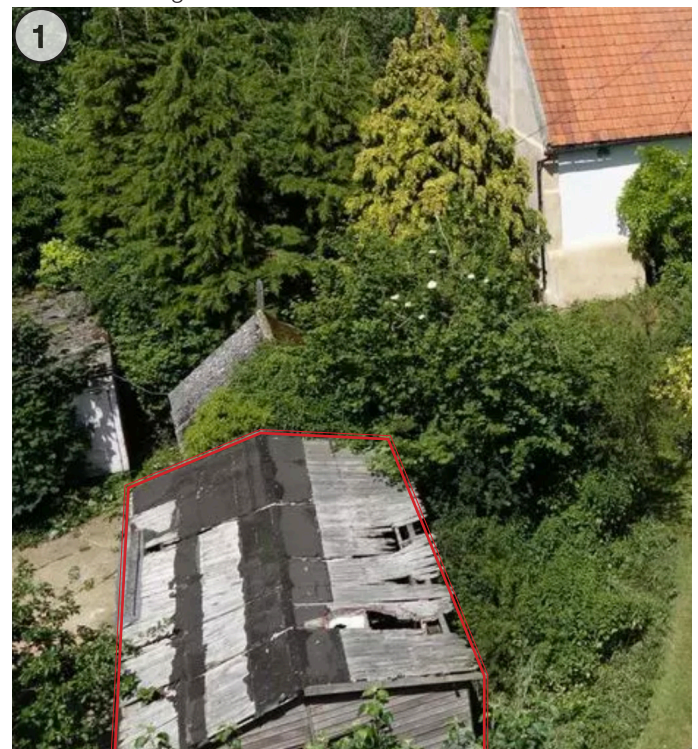
MD photo	LBC needed	support	comment	Summary Response
OTHER					
Old farm building with render above boards	82 etc			Potentially curtilage listed; hole in roof, fleeking	Outbuilding are untouched with the exception of 2 that suffered extensive damage

Existing outbuildings have not been subject to any renovation works with the except of building B and C, hi-lighted below both of which had suffered years of neglect and no maintenance. B collapsed after heavy winds and C's roof succumbed to extensive water damage resulting in collapse. At present the remaining outbuildings are being supported by external scaffolding to prevent further damage/risk of collapse and are being cleared of intrusive vegetation.

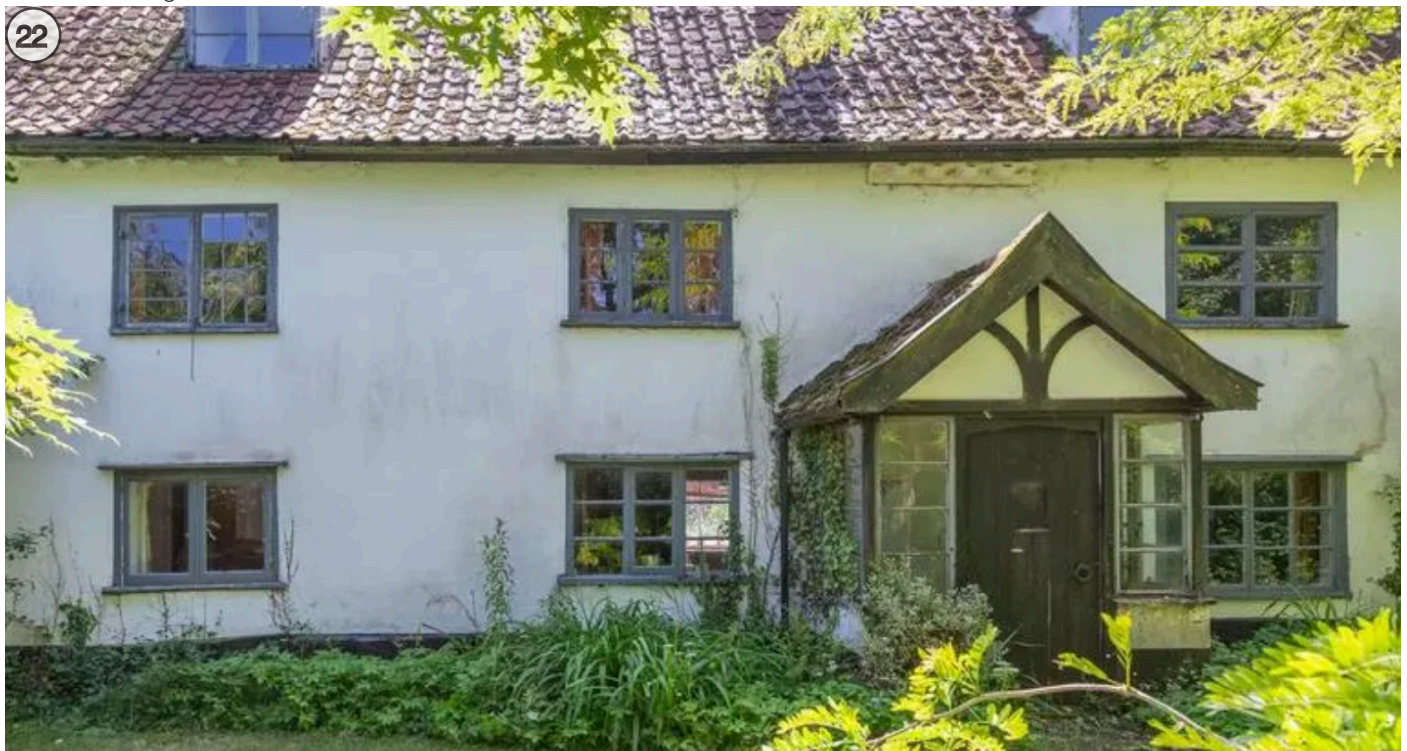
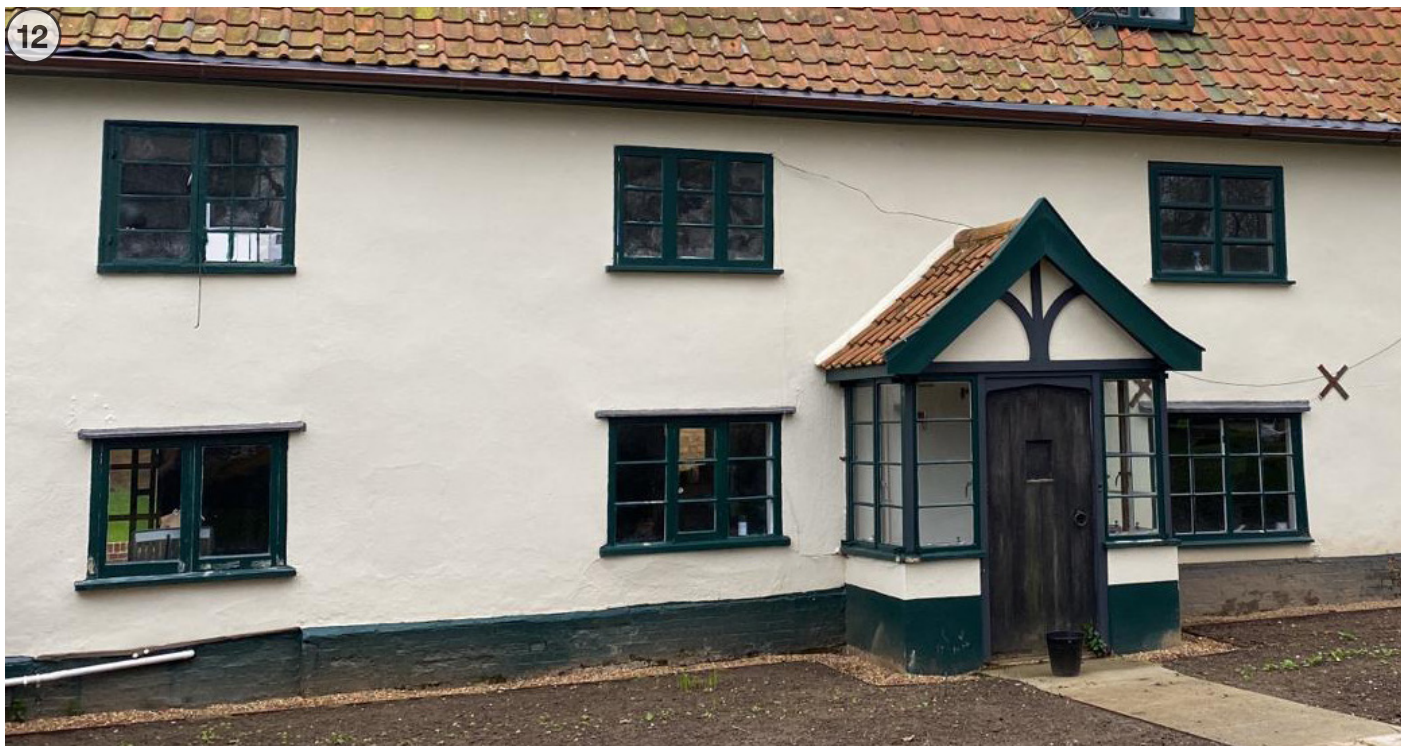
MD photo	LBC needed	support	comment	Summary Response
OTHER					
Windows to historic part – replaced or reglazed ?	-> 100 etc	Possibly	Possibly		Windows in the historic portion of the property have been repaired

Existing window timber surrounds within the C20 extensions suffered from significant water damage and have been replaced with Crittall similar substitutes. No windows within the historic part were replaced or reglazed.
