**LAND OPPOSITE THE OLD POST OFFICE,  
NEWTOWN, NEWBURY, BERKSHIRE**

**PROTECTED SPECIES SURVEY AND MITIGATION**

**Final Report**

**2<sup>nd</sup> August 2021**

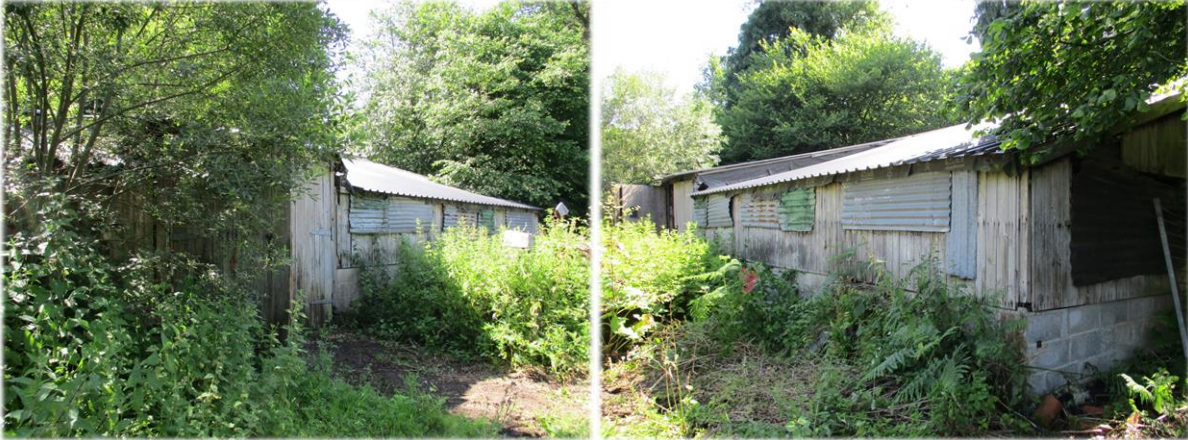
Storage barn front elevation looking south (left) and looking north (right)

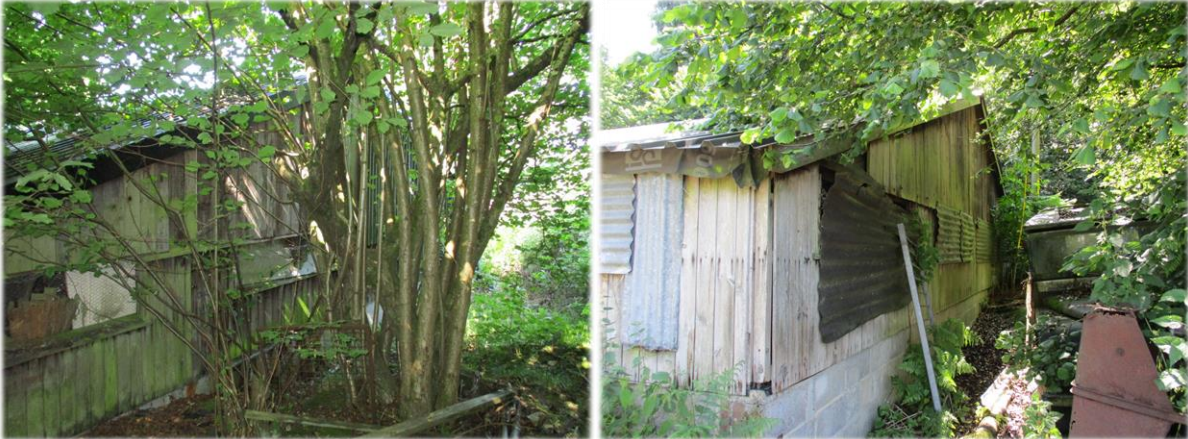
Storage barn northeast end (left) and southwest end (right)

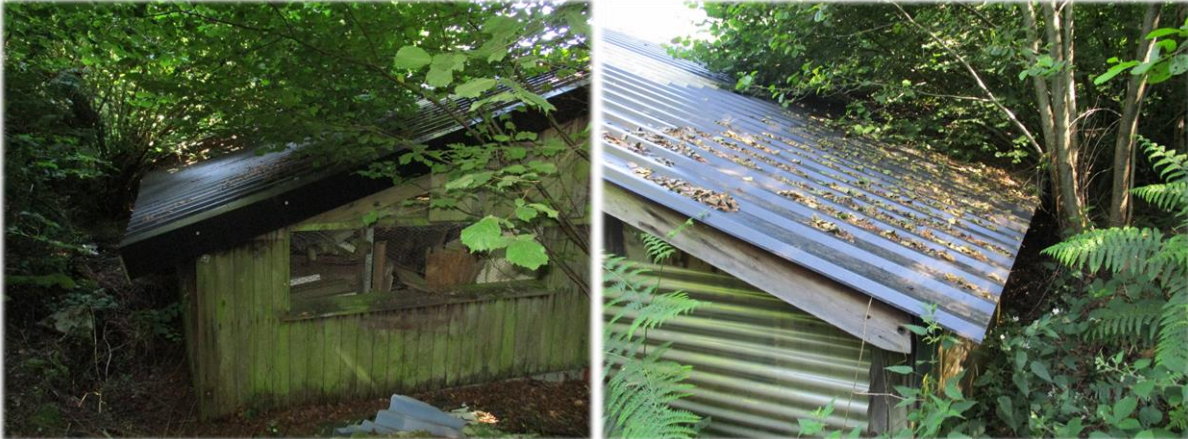
Storage barn rear elevation looking south (left) and looking north (right)

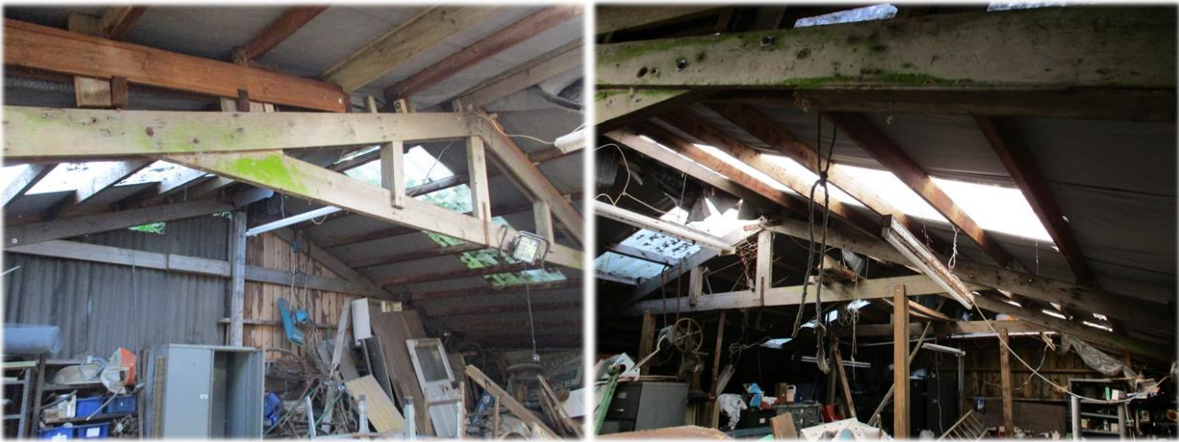
The internal roof structure comprises tight-fitting modern timbers, which include uprights, A-frame trusses and purlins. There is no ridge beam, with the roof apex being open between two widely spaced purlins. There are no gaps/recesses associated with the roof structure. Internally, the metal roof sheets are lined with synthetic roofing liner, which is affixed tightly between the roofing sheets and the timber purlins leaving no gap. The majority of the roof apex is open and unlined.

Storage barn interior

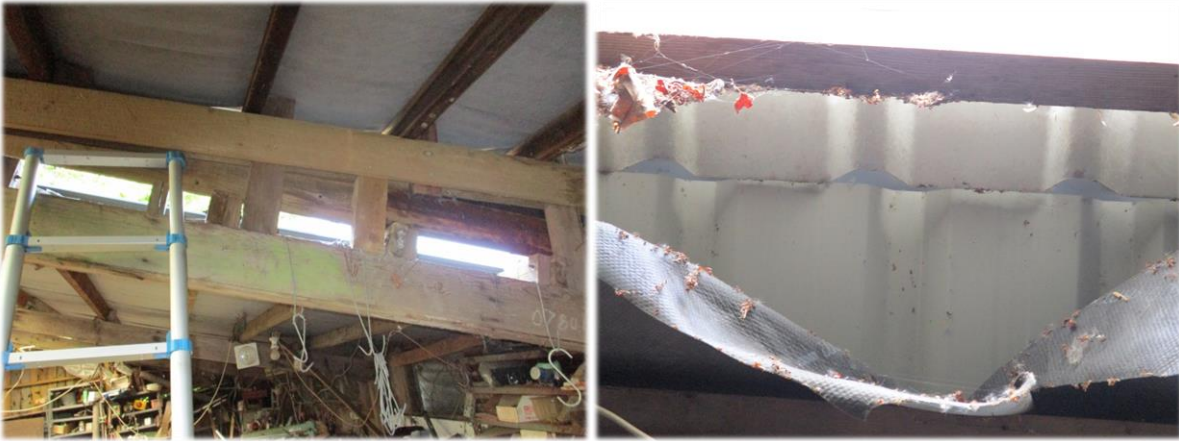
There are gaps under the ridge capping, under the gable end metal roof overlap, between a section of abutting roofing sheets, and on end walls and around the doorway, but these gaps all lead directly into the building interior and provide no suitable crevices for bats to exploit.

Storage barn gaps between adjoining roof sheets (left) and open ridge (right)

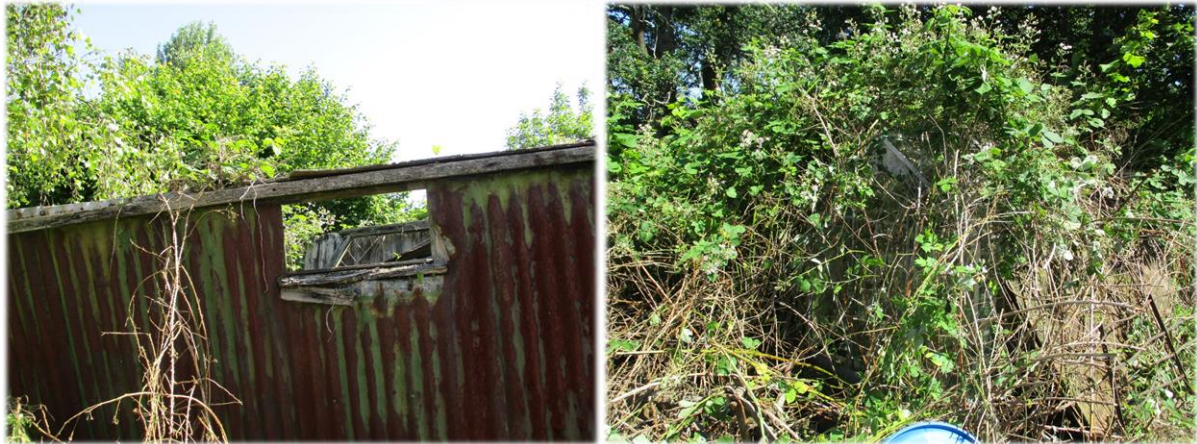
These outbuildings are totally unsuitable for supporting roosting bats.

Dilapidated waggon with no roof (left) and a small greenhouse covered in bramble (right)

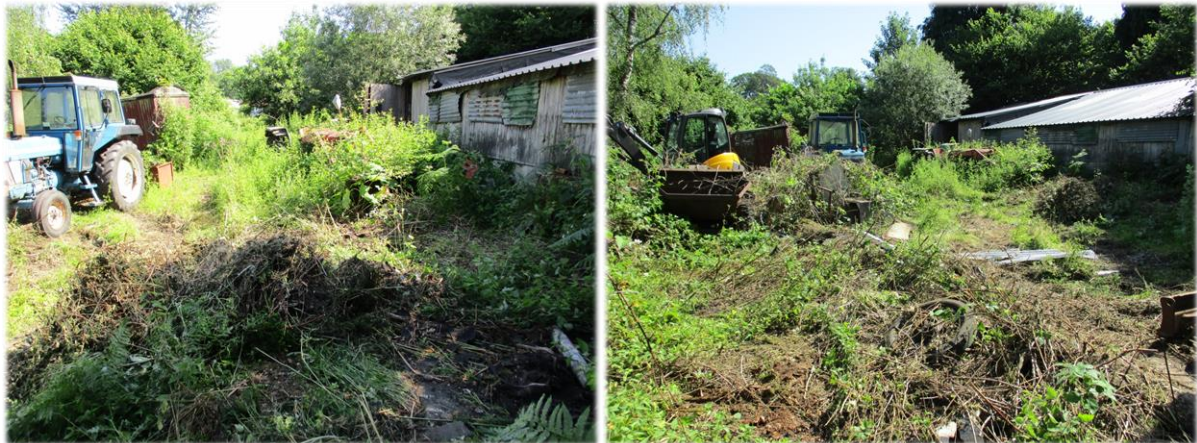
Land immediately north of storage barn recently partially cleared of bramble/nettle

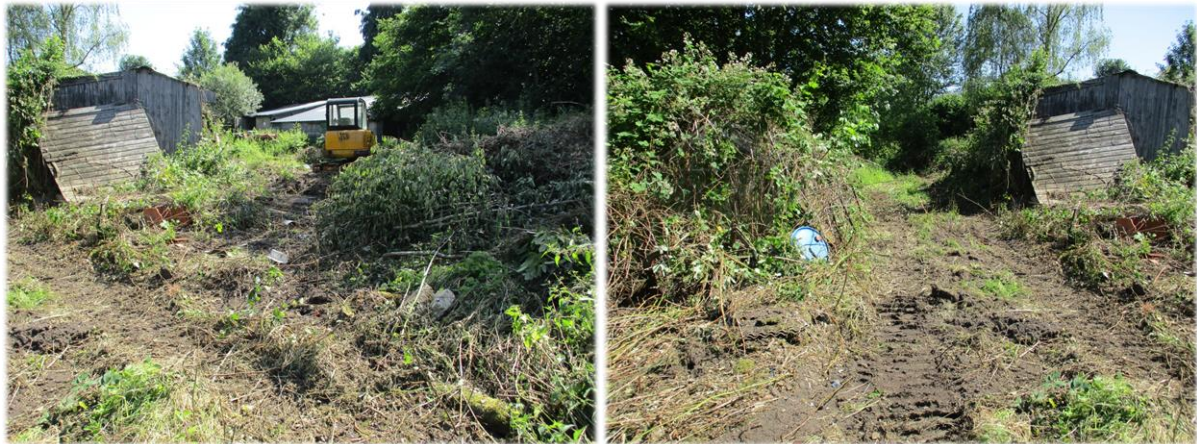
Land immediately north of storage barn around dilapidated wooden shed recently cleared

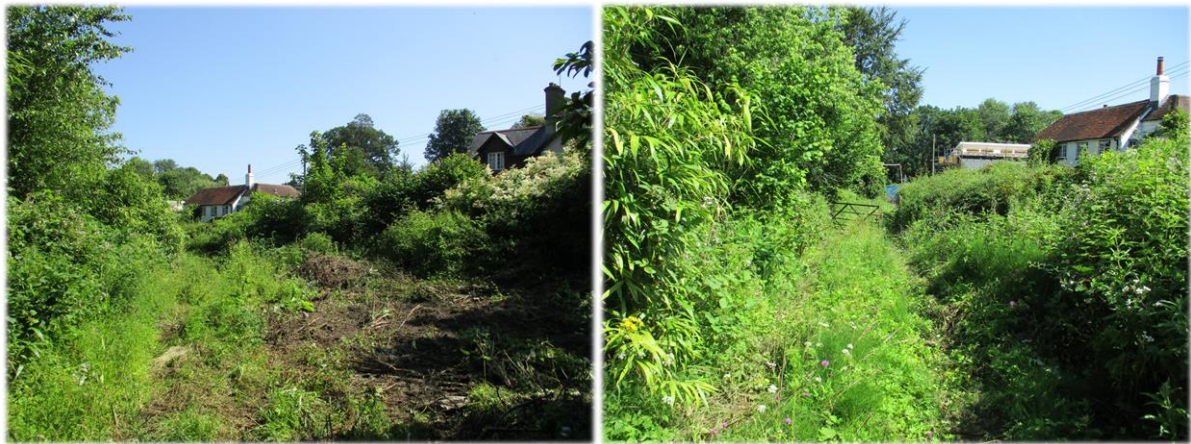
Existing vehicle access track looking north

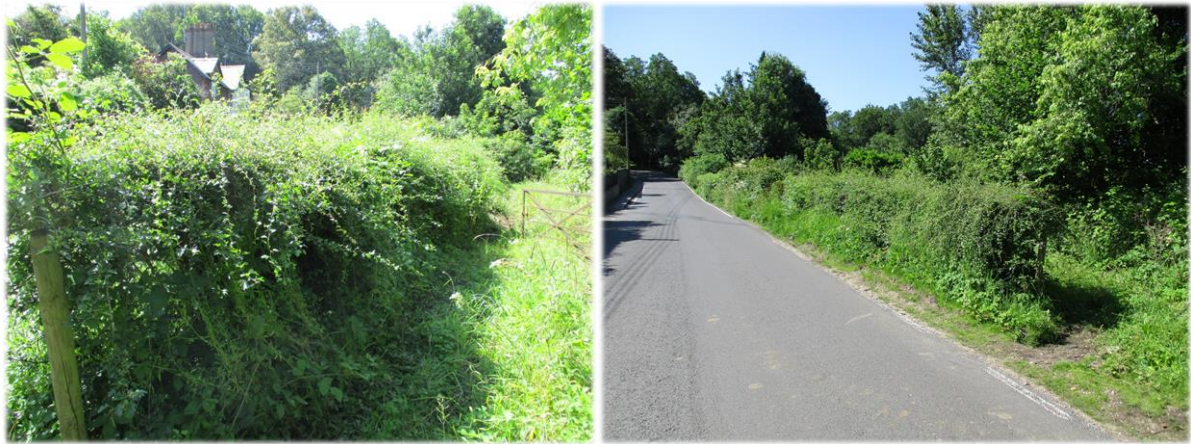
The short length of roadside hedge that is proposed to be removed to improve highways visibility comprises mainly hawthorn (*Crataegus monogyna*) with a single hazel (*Corylus avellana*), horse chestnut (*Aesculus hippocastanum*) and ash (*Fraxinus excelsior*). The hedge is maintained as a box-cut hedge approximately 1.5 high. Ground flora includes common grasses and forbs similar to those found along the track. Associated with the hedge is a short length of brick/stone wall, but this is over-shaded by the hedge and associated tall herb vegetation.

Entrance to vehicle access track looking south (left) and short length of hawthorn hedge to be removed to enhance highway visibility (right)
