CHIMNEY RE-BUILD : RIVER HOUSE, CHURCH HILL, KERSEY, SUFFOLK  
HERITAGE PLANNING DESIGN & ACCESS STATEMENT

May 2023  
ET/6262

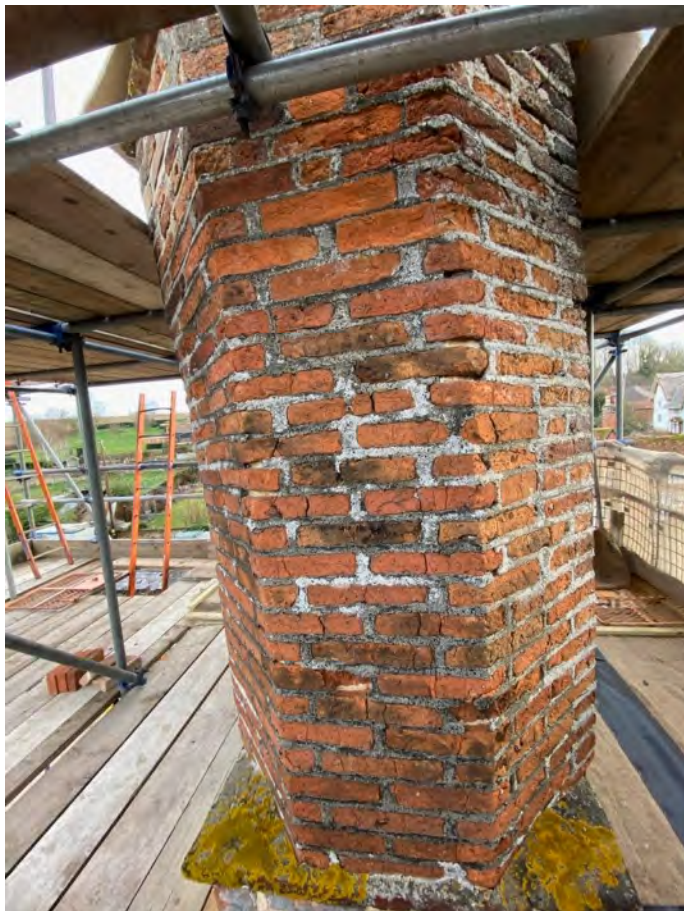
North Elevation

The chimney was capped in the C19th or possibly C20th century with a brick 'ring beam' of 8 courses, this includes iron strapping running around the perimeter of the base of the 'ringbeam.' Much of this metalwork has now rusted. We believe this was introduced to stabilise an already leaning stack and is now exacerbating the problem. However the lean and lower cracking in the brickwork is not insignificant on its own. The majority of the stack is pointed in cement mortar although in places there is evidence of lime mortar both on the face and behind the re-pointing. The cracking through the brickwork is most evident on the photo titled mid north elevation. Internally the whiff walls have collapsed leaving no lateral restraint within the chimney and although the concertina form does help 'lock' the bricks together this is not as robust as it may appear.

*This leans towards the rear roof by an estimated 130mm above the ridge line from the position the rectangular plan form changes to the "saw tooth" arrangement. There are many cracked bricks within the upper section as a result of the age, wide temperature variations and the slim brick profile. We have looked at these and consider the arrangement to be unsatisfactory structurally, although it has clearly been in this condition for a number of years.*

The following photos show each elevation of the chimney at levels B & C and illustrate the lean; exposed and rusting metalwork; cement pointing and open joints; cracked and missing brickwork.

Whilst three options were presented it was determined that the only viable alternative was to dismantle and carefully reassemble the chimney, without the pyramid structure (section C) to the top.
