BS5837 tree survey and Arboricultural Impact Assessment

1 Snode Hill, Beech, GU34 4AX ///lawful.library.chaos

Report reference J1461.03

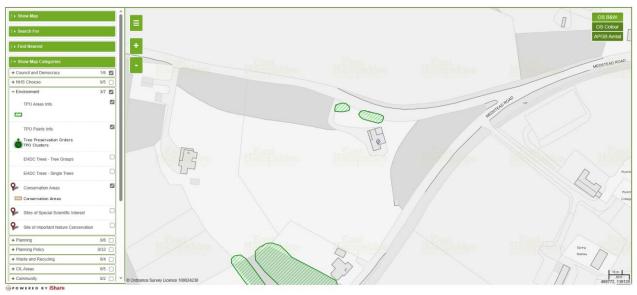
SAL1 Image taken from Council website¹

Due to the position of trees T1801B, T1802C, T1803B, and T1804C, I believe that these trees are subject to TPO.

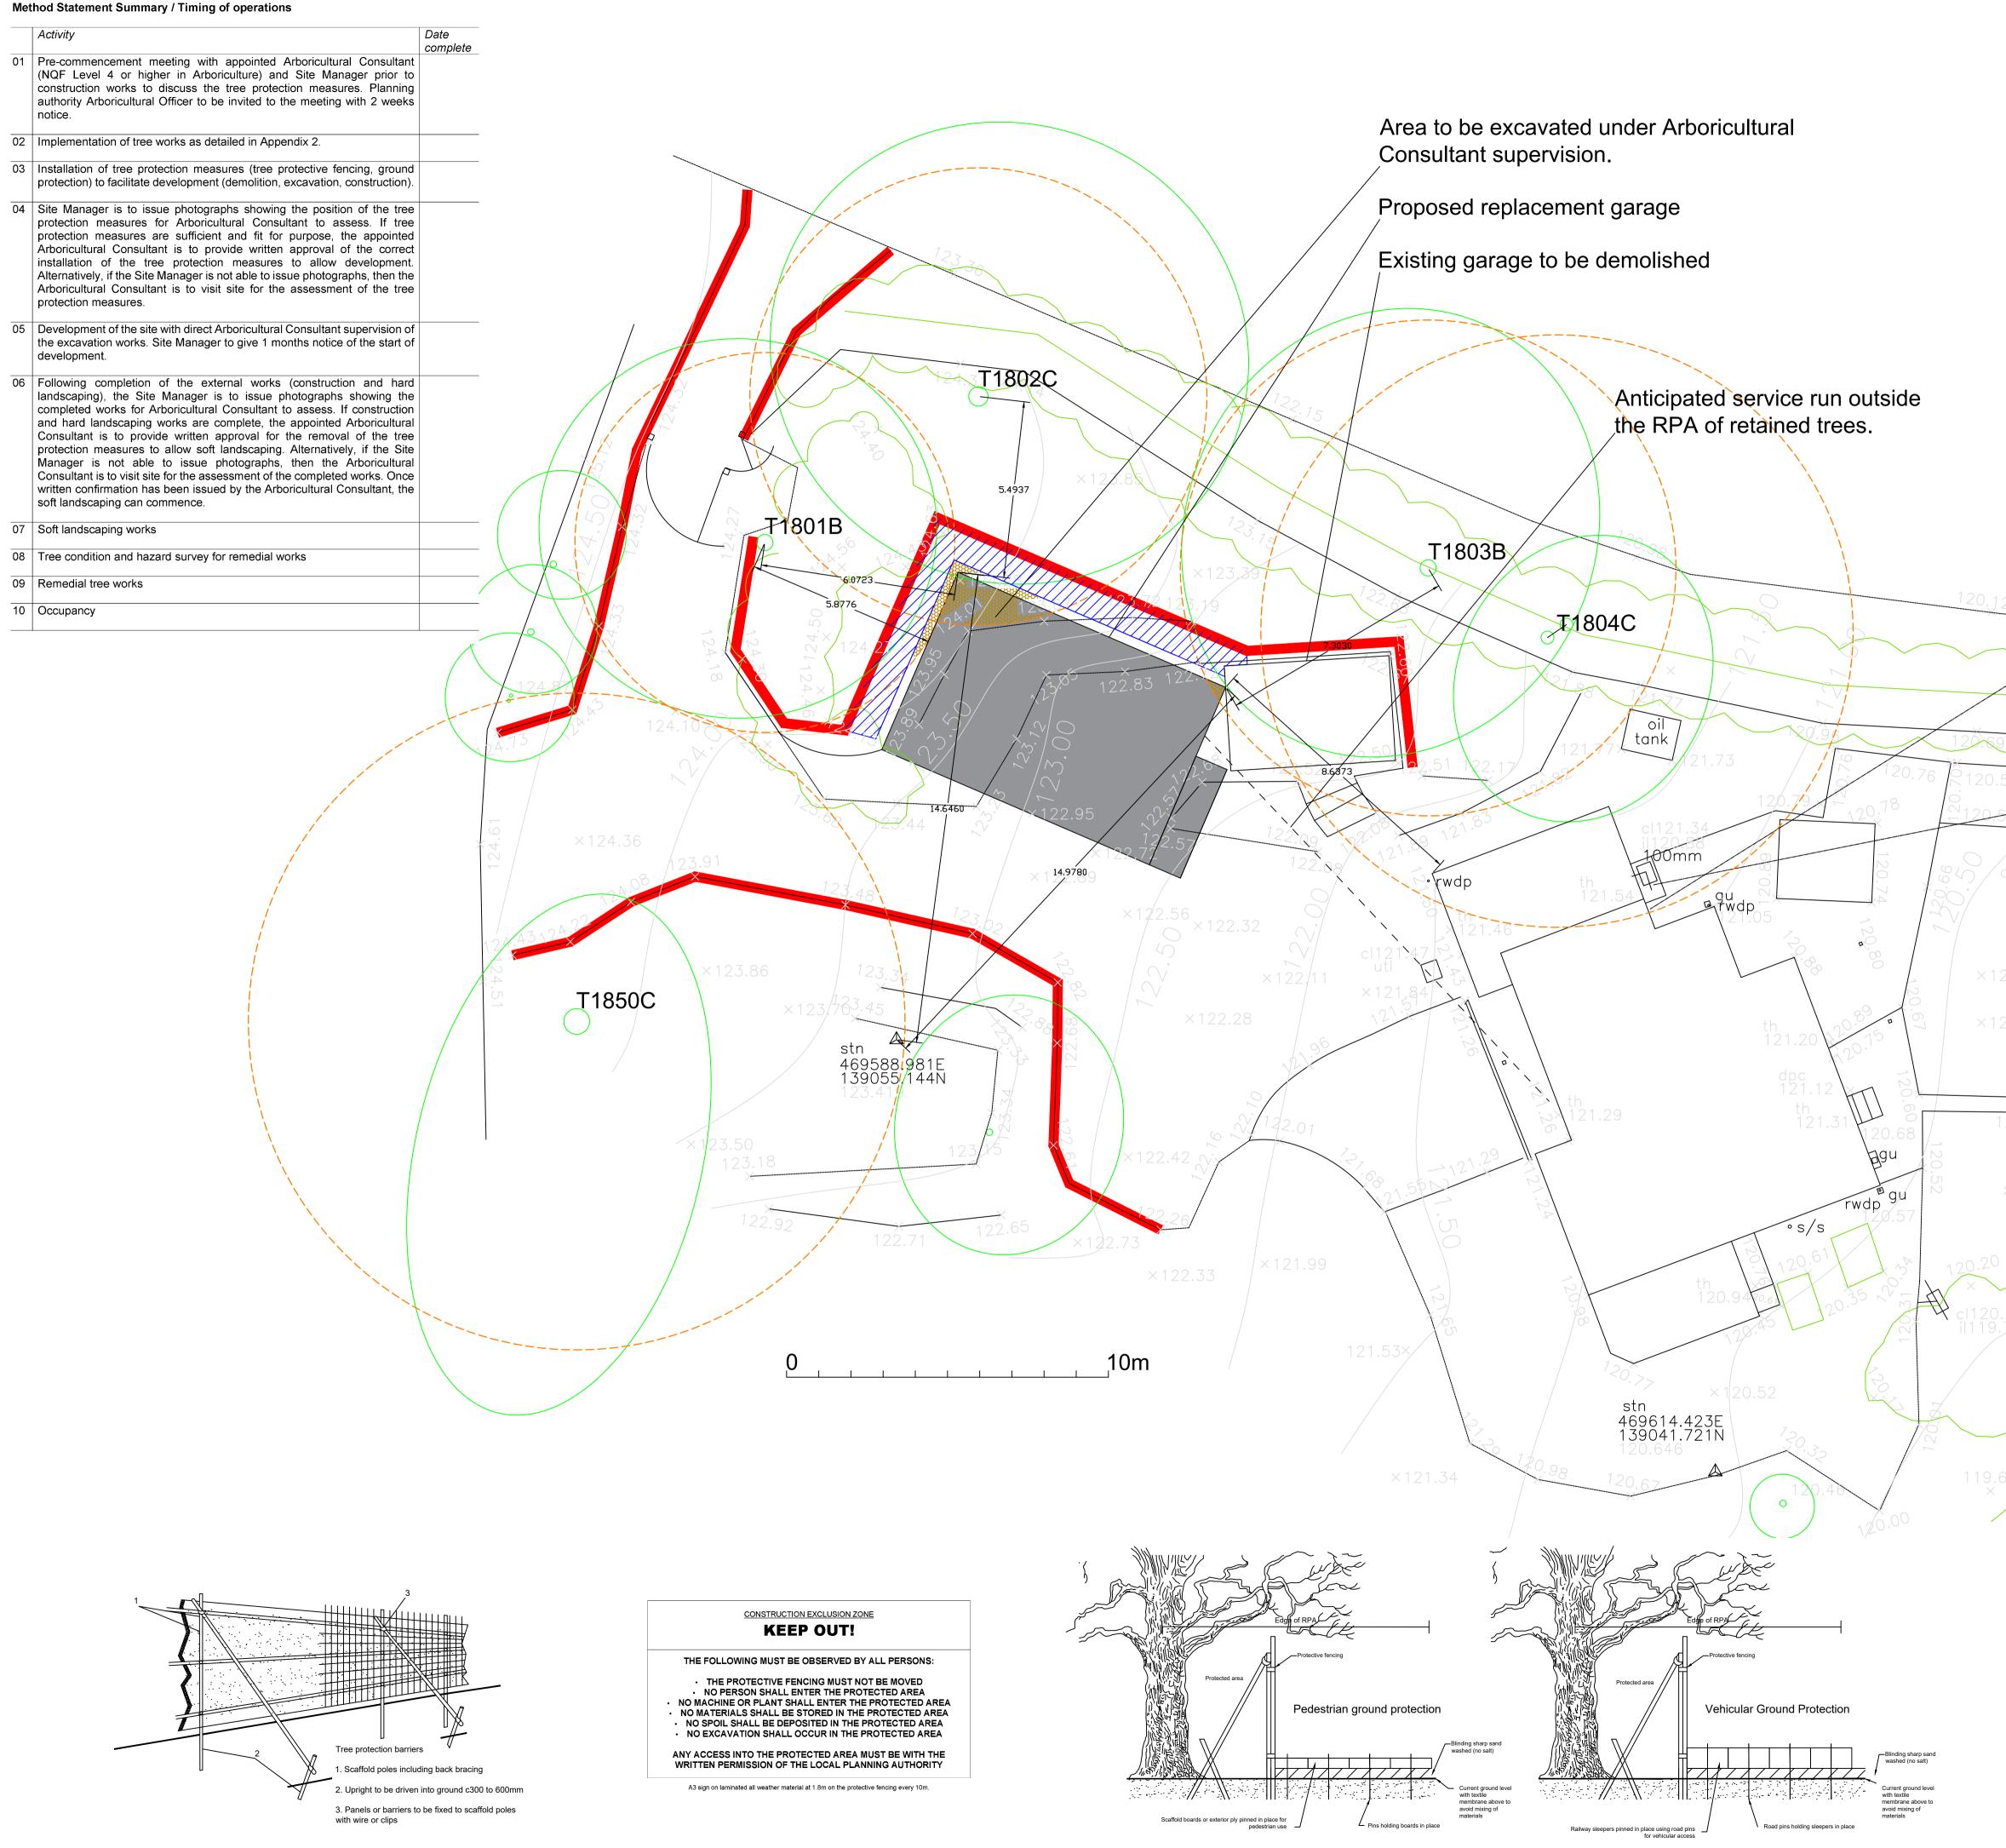
Appendix 1: Method Statement and Tree Protection Plan

The proposed replacement garage takes advantage of an area previously excavated and is principally outside the normal RPA of the retained trees. However, there are minor encroachments within RPA of some of the retained trees (T1801B by 0.7%, T1802C by 3%, and T1803B by 0.4%). This encroachment includes an allowance of a 30cm offset from the proposed replacement garage to allow for excavation and foundations. These minor encroachments are unlikely to have a significant impact upon the retained trees if the excavations are carried out in a sympathetic manner.

- 8.5 To minimise the impact of the excavation works, the excavations will need to be carried out as detailed in Appendix 1 Method Statement, section 8 and under the direct supervision of the project Arboricultural Consultant to advise upon the method of excavation, tree root pruning necessary, and to identify any potential remedial works, with priorities and timescale, where necessary
- 8.6 The proposed replacement garage is outside RPA of T1804C and T1850C and therefore I anticipate that there will be an insignificant impact upon the stability and the physiology of these two trees as a result of the proposed development.

8.8 I have shown an indicative service route outside the RPA of retained trees on the Tree Protection Plan for the anticipated underground service provision between the existing dwelling and the proposed replacement garage.
