Bat Survey Report

4 Church Road, Mendlesham, Suffolk

20231 R1 v2

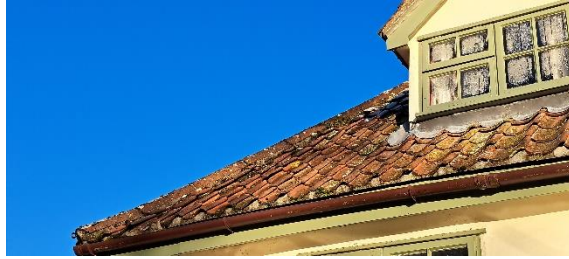
Photo 2 Northwest corner with raised tiles near ridge tiles

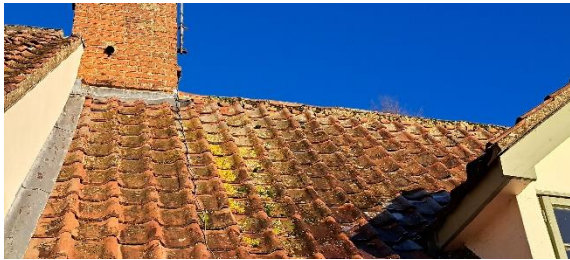
Photo 3 West elevation showing lead flashing and chimney

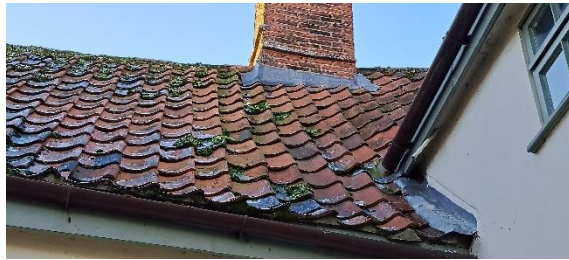
Photo 4 South east elevation showing raised tiles and flashing around chimney

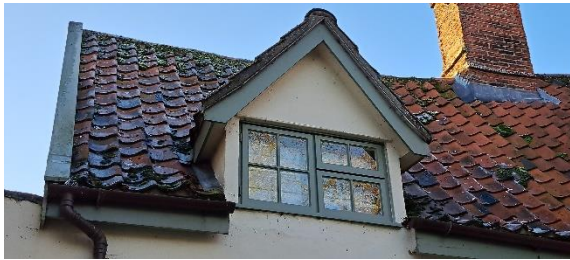
Photo 5 South east elevation – raised tiles and flashing around dormers

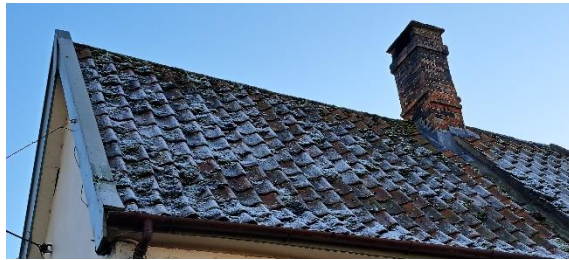
Photo 6 North elevation – raised tiles (scattered ad flashing along junction in roof)

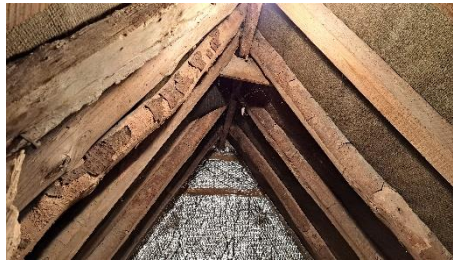
Photo 8 Interior of loft – roof details showing timber supports and bitumen felt

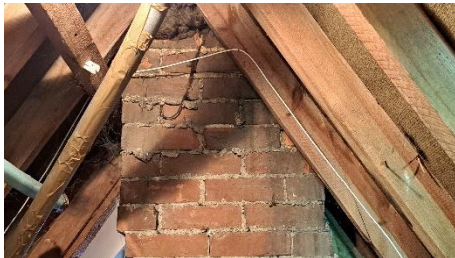
Photo 9 Interior of loft – good condition mortar on brick work on chimney
